ADA Self Evaluation and Transition Plan

MiraCosta College, **Oceanside Campus**

Board Approved on 05-18-2017

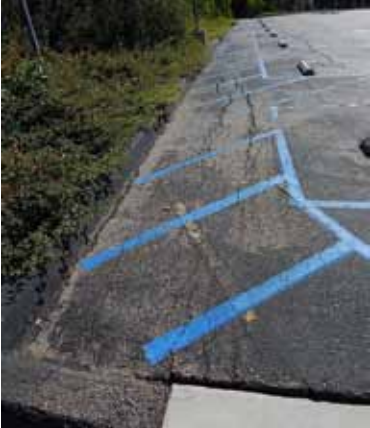
Provide a 36" deep band of DWD at the end of this walkway adjacent to the vehicular way according to Appendix A.13, A.14	P1
C66	<p>The POT from the accessible parking spaces in Lot 1C is not compliant as follows:</p> <ol style="list-style-type: none"> 1. There is a flush condition at the end of this walkway leading into the vehicular way. 2. The POT over the AC paving is too uneven and the cross-slope is too steep. 3. The transition for AC to concrete paving has an abrupt change in level.

<ol style="list-style-type: none"> 1. Provide a 36" deep band of DWD at the end of this walkway adjacent to the vehicular way according to Appendix A.13, A.14 2. Reconstruct the POT so that the surface is even and the cross-slope does not exceed 2%. 	P3

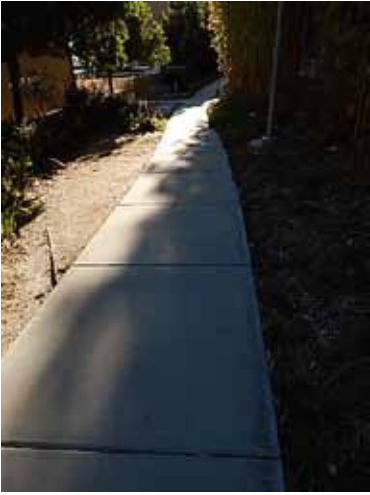
Because this walkway is not required as an accessible path to travel, a sign should be located at the top and bottom indicating this walkway is not recommended for wheelchair use.	P3
C81	There is a portion of this walkway that is too steep in the direction of travel at 6.1%

Reconstruct this portion of the walkway so that the running slope does not exceed 5% at any location and a cross slope of 2% maximum.	P3

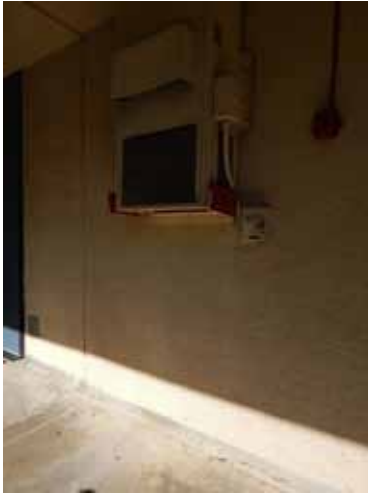
Replace the single unit with a dual height unit that meets all of the accessibility requirements.	P1
C104	This wall-mounted air-conditioning unit is mounted to low and produces an overhanging hazard to the visually impaired.

Provide a guard rail around the base of this unit mirroring the footprint of this unit with railings at 4" & 30" high.	P1
C105	The transition between the asphalt paving and the concrete walkway produces an abrupt change in level.

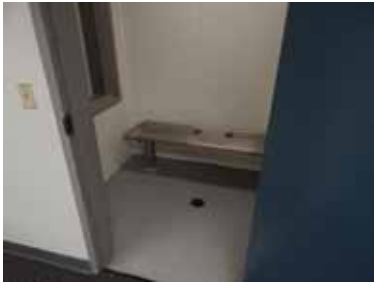
Lower the work station so that the keyboard and mouse are no higher than 34" AFF	P3
D2.4	The bench in the custody room is not compliant. The depth is not 18"

1. Replace the bench in the custody room so that the depth is 18"	P3
D2.5	The interior POT is not compliant, the required signage is not provided

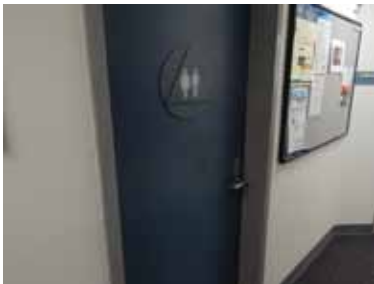
1. Install compliant signage according to appendix D.8	P3
Unisex				
D2.6	<p>The entry door to this restroom is not compliant as follows;</p> <ol style="list-style-type: none"> 1. The door operating pressure exceeds 5 pounds maximum. 2. Door symbol is not contrasting in color from the finish of the door 3. The wall signage provided on the latch side of the door is not provided at 60" AFF.

<ol style="list-style-type: none"> 1. Adjust the automatic closer on this door so that the pressure to operate does not exceed 5 pounds. 2. Replace the door symbol with a symbol that is 70% contrast in color from the finish of the door. OR Provide a white border 1" wide around the symbol. 3. Provide a compliant wall sign on the latch side of the door mounted at 60" AFF to the TOP of the sign and 4" from the jamb. (Refer to Appendix B.14- B.17) 	P3

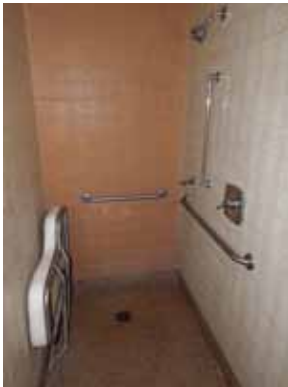
<p>Provide a tactile exit sign mounted on the wall adjacent to each exit door at 60" AFF according to Appendix D.8</p>	P3
D4.16	<p>Men's Shower, Room 2016; This wheelchair accessible shower is not compliant as follows:</p> <ol style="list-style-type: none"> 1. The adjustable shower head has been removed and the existing one is too high.

<ol style="list-style-type: none"> 1. Replace the fixed head with a movable shower head that can be used in a fixed position or handheld with a hose 59" long minimum. The spray unit shall have an on-off control with the non-positive shut-off. The spray unit shall have a device so that the water delivered through it is 120°F maximum. 	P3
D4.17	<p>Men's Locker, Room 2016; The locker room is not compliant as follows:</p> <ol style="list-style-type: none"> 1. The lockers are not within the allowable reach range. 2. The changing bench is not accessible.

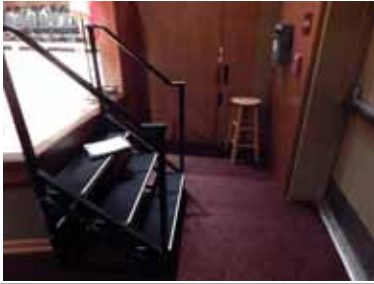
Service and maintain the lift so that it is in operating condition all of the time. Remove any locking devices so that it can be operated without a key.	P3
D8.6	Concert Hall, 2405; The portable stairway serving the right side of the stage is blocking wheelchair access to the lift.

Relocate the portable stairway so that adequate clearances provided for wheelchair access to the lift.	P3
D8.7	AV/TC Control room, 2417; Wheelchair lift in the control room and is being used for storage.

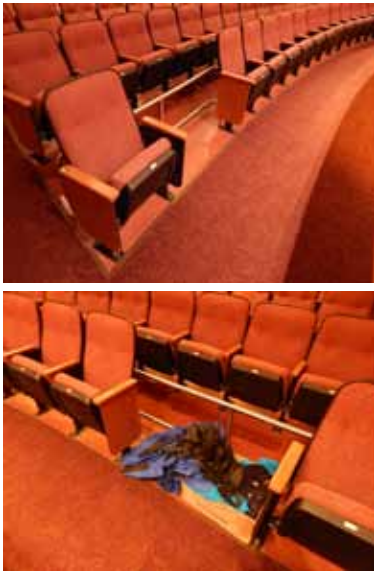
None required.	N/A
D8.9	Concert Hall, 2405; The theater seating in this facility is not compliant as follows: 1. Adequate semi ambulatory seating is not provided or designated. 2. Adequate aisle seating is not provided or designated.	[No photo provided]	1. Provide 6 minimum semi-ambulatory seats with 24" leg clearance at the front. These seats must be designated with an ISA symbol. 2. Replace a minimum of 5% of all aisle seats with accessible seats that have either lifting armrests or hinged panels on the side. These seats must be designated with an ISA symbol.	P3
D8.10	Concert Hall, 2405; The 2 wheelchair seating positions on both sides of the front row are not compliant as follows: 1. The wheelchair spaces are not clearly designated. 2. The companion seating is not clearly designated. 3. The fixed companion seating is not located properly.

1. Clearly designate the wheelchair seating spaces with an ISA symbol according to Appendix D.1 2. Clearly designate the companion seating spaces with an ISA symbol according to Appendix D.1 3. Relocate the companion seats so that the shoulder alignment point of the companion seat is 36" from the front of the wheelchair space or 12" from the back of the wheelchair space.	P3
