ADA Self Evaluation and Transition Plan

MiraCosta College
Technology Center Institute, Carlsbad, CA
05-08-2017

Client: Steinberg, Joe Sion
 Prepared by: Izor and Associates, Inc.; Greg Izor, CASp-014
 Site Name & Location: MiraCosta College, Technology Center Institute, 2075 Las Palmas Dr., Carlsbad, CA
 Scope of Review: Parking and Exterior Path of Travel, Interior Spaces and Interior Common and Staff Areas
 Dates of Site Review: 10-14-2016
 Dates of Draft Report: 10-14-2016
 Date of Final Report: 05-08-2017 CASp Determination: Inspected by a CASp
 File Name: 170508 TCI CASp Report-Final
 Adopted by MiraCosta College Board of Trustees on: TBD

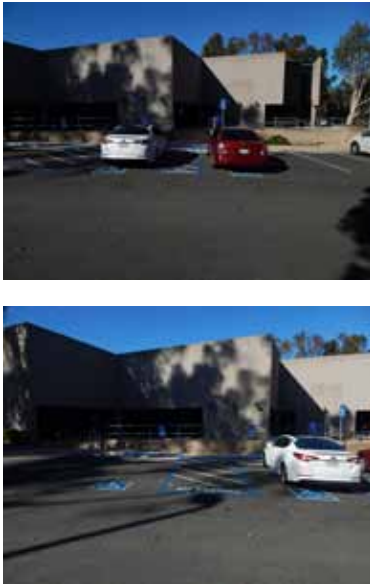
B1	<p>This parking space and the access aisle serving it is not compliant as follows:</p> <ol style="list-style-type: none"> The required signage is not provided. The current signage is not visible while a vehicle is parked in the stall. The slope is greater than 2%

<ol style="list-style-type: none"> Signage <ol style="list-style-type: none"> Mount all signage so that it is visible while a vehicle is parked in the stall. (80" high recommended) Add the "min fine of \$250" signage below the ISA sign For van accessible spaces include a mount "van accessible" sign separate, below the other signage. (See Appendix A7 & A8) Repave the parking spaces and the access aisle so that the slope does not exceed 2% in any direction 	P2
B2	<p>The POT serving the accessible parking spaces is not compliant as follows;</p> <ol style="list-style-type: none"> The cross slope exceeds 2%

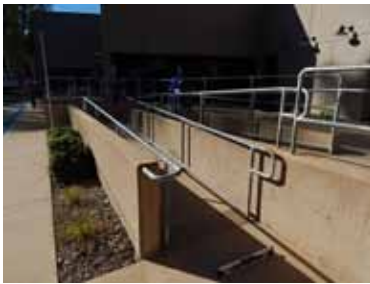
None required	N/A
C3	The ramp is not compliant. The required width of 48" is not provided. (44")

1. Reconstruct the ramp and handrails according to appendix C.2, C.3 and C.7 to provide 48" minimum width.	P2

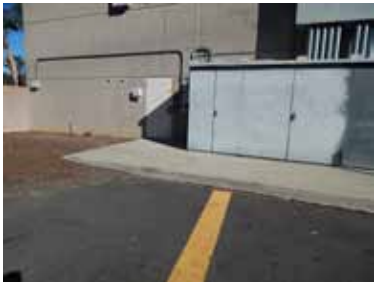
#	ITEM	PHOTO or DIAGRAM	MITIGATION MEASURE	Phase
C6	This POT is not compliant There is no curb ramp leading from the emergency exit.

Install a curb cut curb ramp according to appendix A.4 - A.6	P2
C7	The employee break area is not compliant. The table serving the area is not wheelchair accessible

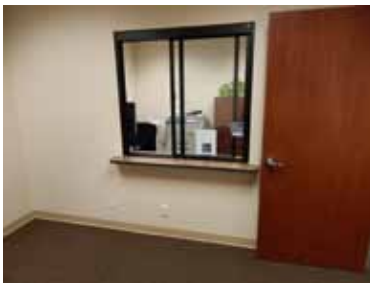
None required.	N/A
E2	SBDC Reception, Room 3; The transaction counter is too high and not compliant. (35")

Lower the existing counter OR provide an alternate transaction area at 34" AFF	P1

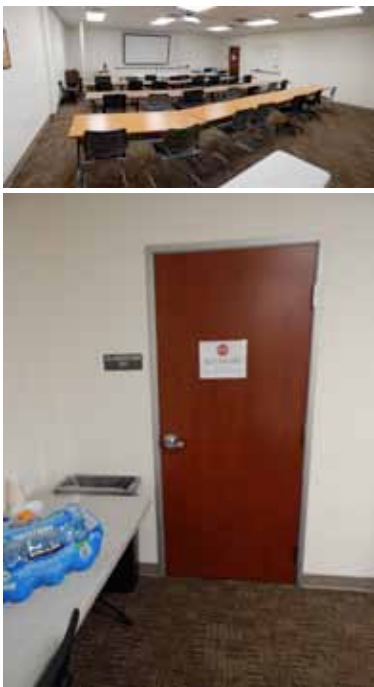
#	ITEM	PHOTO or DIAGRAM	MITIGATION MEASURE	Phase
E9	Classroom Room 100; The path of travel and seating in this classroom are compliant except as follows: 1. The required 18" pull-side clearance is not provided at the connecting door to Room 101.

1. Relocate the table located in the required 18" pull-side clearance area.	P1
E10	Classroom Room 101; The path of travel and seating in this classroom are compliant.

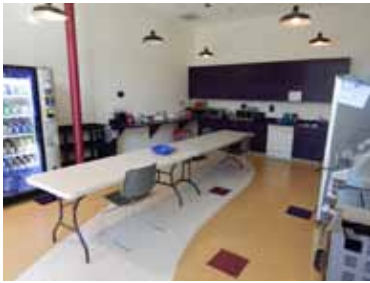
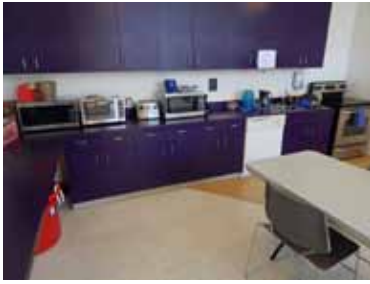
None required.	N/A
E17	Kitchen, Room 42; The path of travel, counters, sink and appliances in this room are compliant except as follows; 1. The oven/range has controls in the back of the appliance.

1. Replace the oven/range with a unit that has front controls.	P1
E18	Gym, Room 55; The path of travel and access to the equipment is compliant.

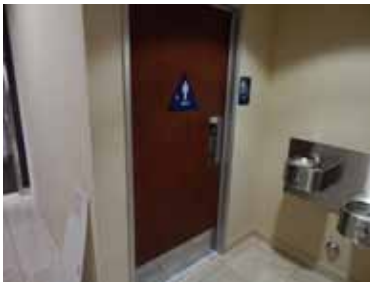
Men				
F1	The entry door to this restroom is not compliant as follows; 1. Door symbol is not contrasting in color from the finish of the door

1. Replace the door symbol with a symbol that is 70% contrast in color from the finish of the door. OR Provide a white border 1" wide around the symbol.	P1
F2	The accessible lavatory is compliant as follows

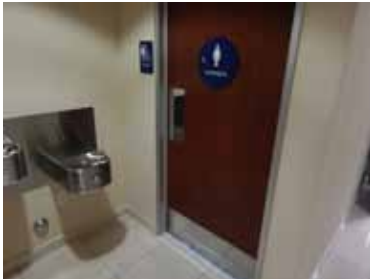
<p>1. Relocate the height of the unit to provide 27" min. knee clearance.</p>	P1
Women				
F6	<p>The entry door to this restroom is not compliant as follows;</p> <p>1. Door symbol is not contrasting in color from the finish of the door</p>

<p>1. Replace the door symbol with a symbol that is 70% contrast in color from the finish of the door. OR Provide a white border 1" wide around the symbol.</p>	P1

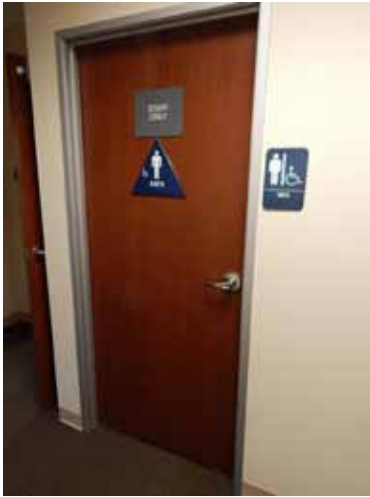
<p>1. Relocate the toilet tissue dispenser so that it is located 7"- 9" on the front of the toilet and 19" AFF. (Locate to the centerline of the dispenser)</p>	P1
Unisex Toilet, Room 16				
F9	<p>The entry door to this restroom is not compliant as follows;</p> <p>1. Door symbol is not contrasting in color from the finish of the door</p>

<p>1. Replace the door symbol with a symbol that is 70% contrast in color from the finish of the door. OR Provide a white border 1" wide around the symbol.</p>	P1
F10	<p>The accessible lavatory is compliant.</p>

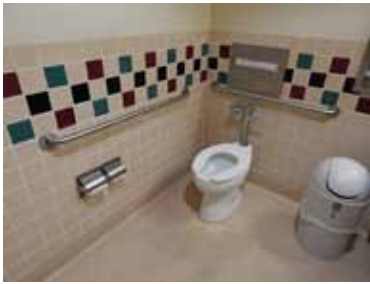
#	ITEM	PHOTO or DIAGRAM	MITIGATION MEASURE	Phase
F11	<p>The accessible toilet and stall are not compliant as follows;</p> <ol style="list-style-type: none"> 1. The rear grab bar does not extend 24" minimum beyond the centerline of the fixture on the wide side. (21") 2. The toilet tissue dispenser is located too far from the front of the toilet. (14") 3. The toilet seat tissue dispenser is not located on an accessible route.

<ol style="list-style-type: none"> 1. Replace the rear grab bar or relocate the rear grab bar so that it extends 24" beyond the centerline of the toilet to the wide side. 2. Relocate the toilet tissue dispenser so that it is located 7"- 9" on the front of the toilet and 19" AFF. (Locate to the centerline of the dispenser) 3. Relocate the toilet seat tissue dispenser so that it is located on an accessible route. (Locations above the grab bars are not accessible.) 	P1

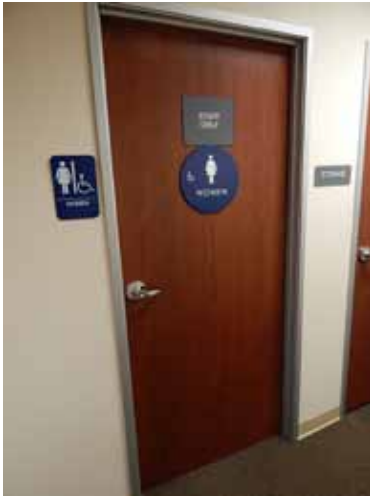
Unisex Toilet, Room 17				
F12	<p>The entry door to this restroom is not compliant as follows;</p> <ol style="list-style-type: none"> 1. Door symbol is not contrasting in color from the finish of the door

<ol style="list-style-type: none"> 1. Replace the door symbol with a symbol that is 70% contrast in color from the finish of the door. OR Provide a white border 1" wide around the symbol. 	P1
F13	<p>The accessible lavatory is compliant.</p>

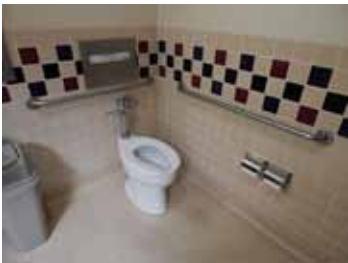
#	ITEM	PHOTO or DIAGRAM	MITIGATION MEASURE	Phase
F14	<p>The accessible toilet and stall are not compliant as follows;</p> <ol style="list-style-type: none"> 1. The rear grab bar does not extend 24" minimum beyond the centerline of the fixture on the wide side. (21") 2. The toilet tissue dispenser is located too far from the front of the toilet. (14") 3. The toilet seat tissue dispenser is not located on an accessible route.

<ol style="list-style-type: none"> 1. Replace the rear grab bar or relocate the rear grab bar so that it extends 24" beyond the centerline of the toilet to the wide side. 2. Relocate the toilet tissue dispenser so that it is located 7"- 9" on the front of the toilet and 19" AFF. (Locate to the centerline of the dispenser) 3. Relocate the toilet seat tissue dispenser so that it is located on an accessible route. (Locations above the grab bars are not accessible.) 	P1
