MiraCosta College
Facilities Master Plan Update
Executive Summary

0.0 | Executive Summary

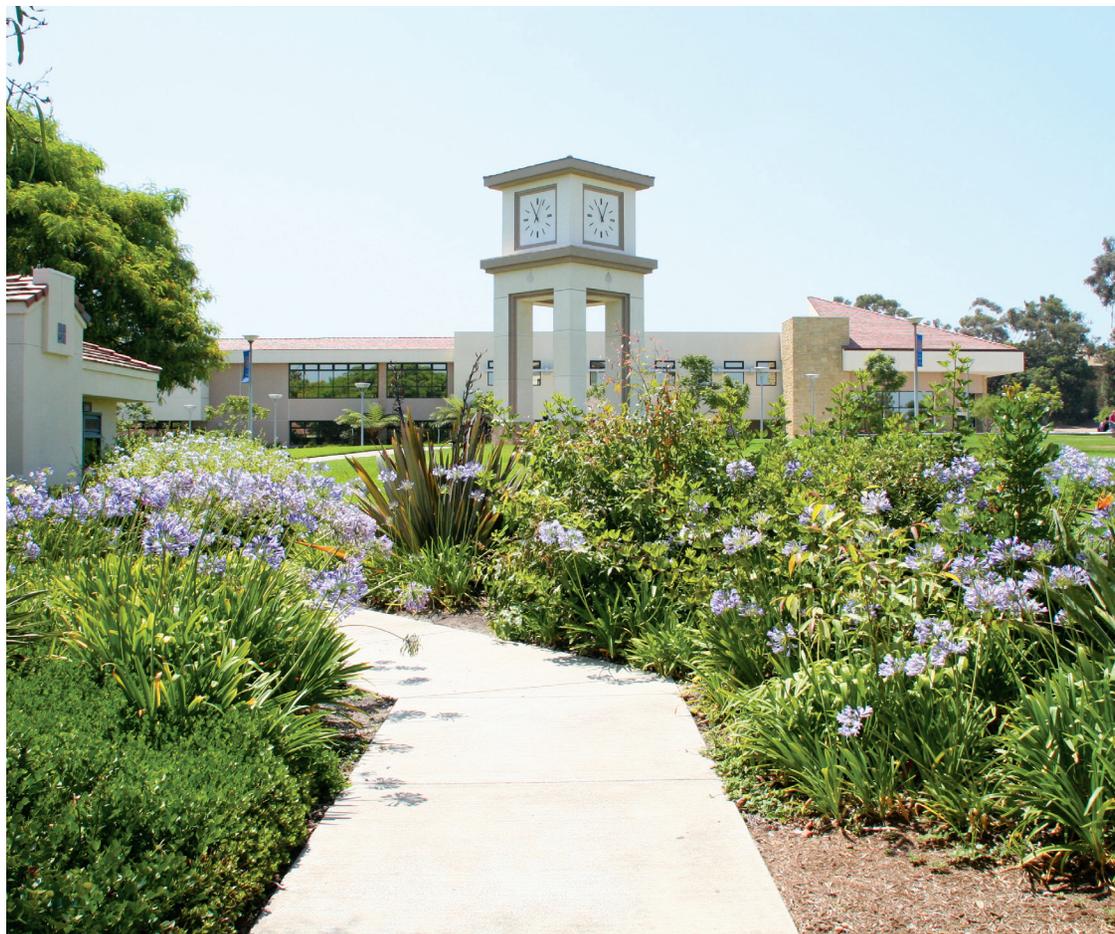
Existing Oceanside Campus

A detailed assessment of the existing campus condition was conducted through site observations, review of existing documentation, and discussions with facilities personnel, faculty, staff, and District Leadership. The following issues need to be addressed:

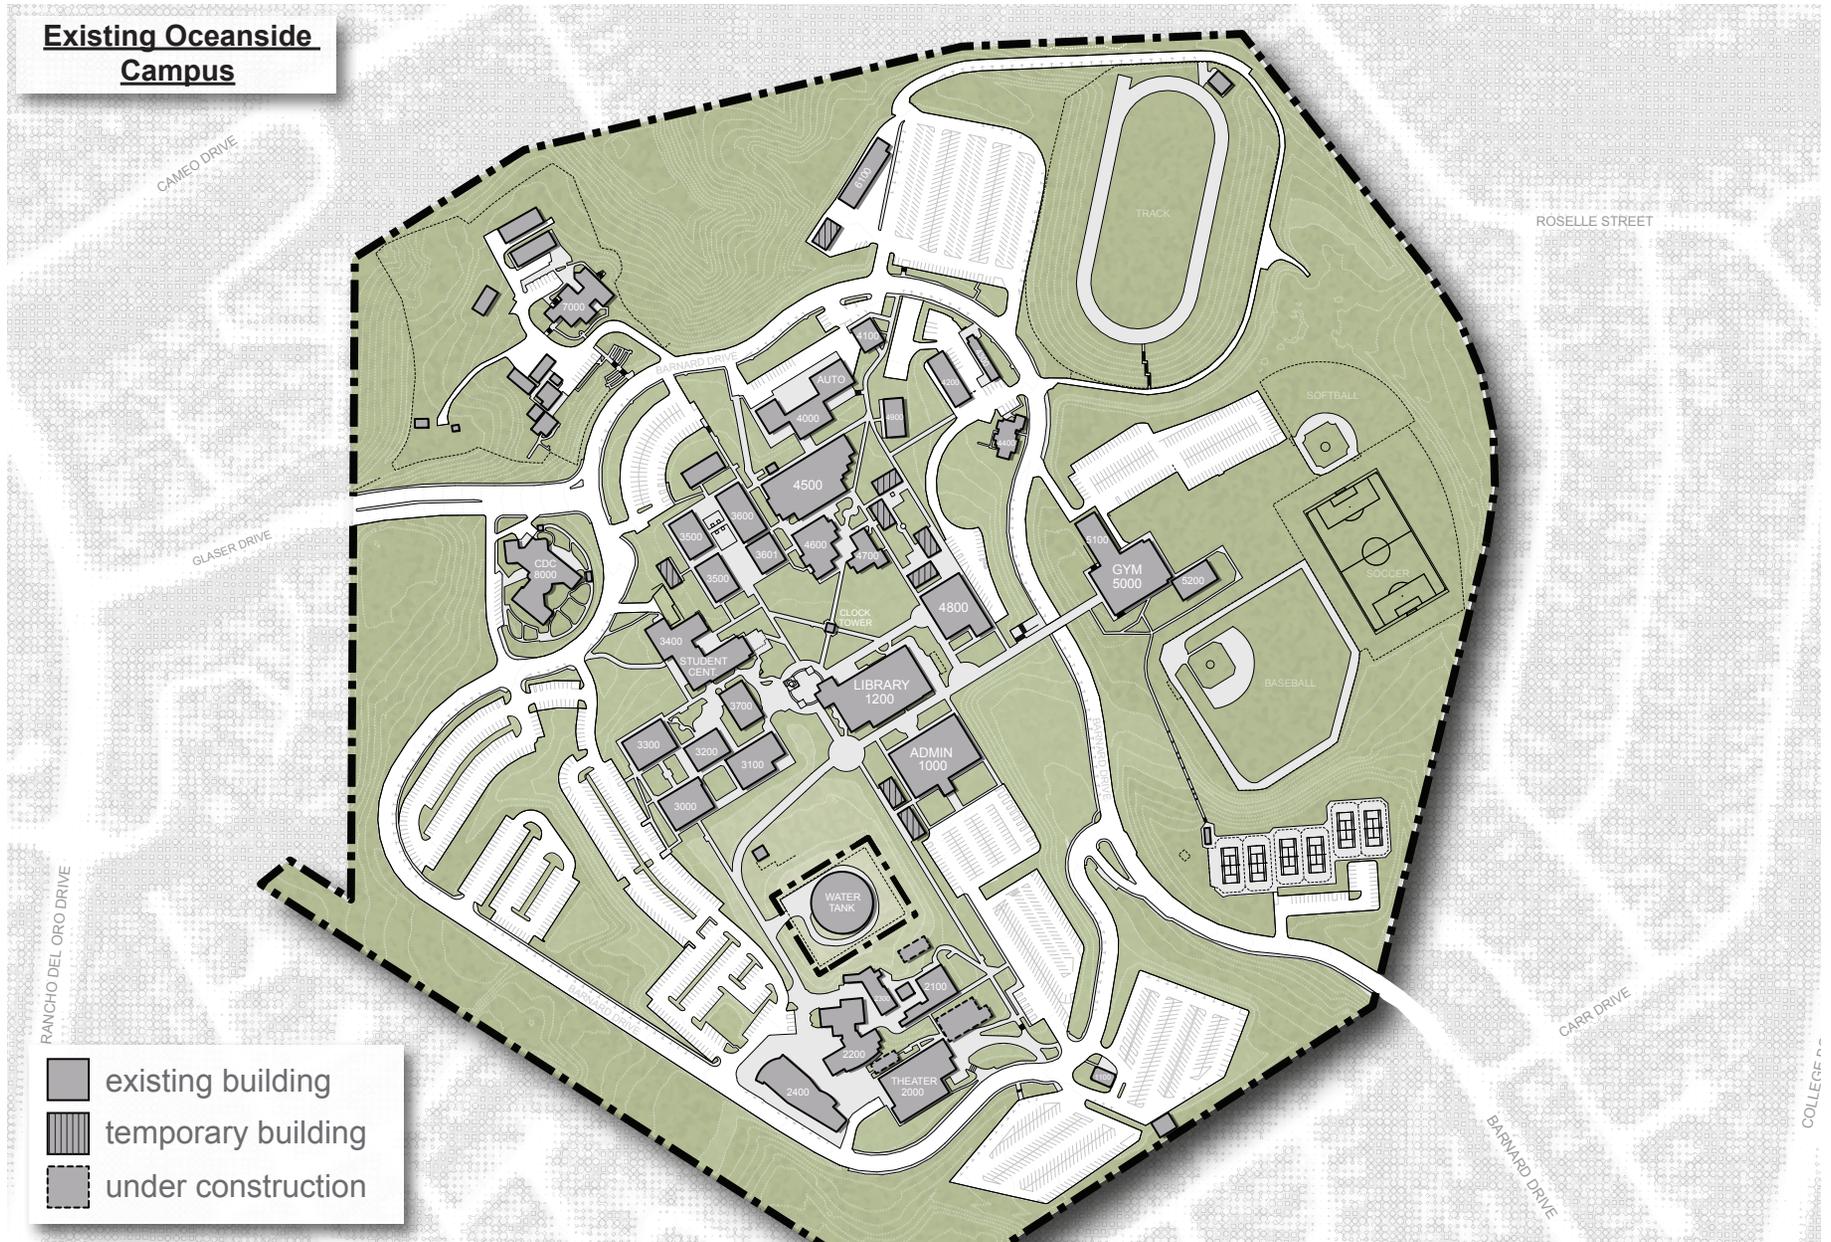
Oceanside Campus Facilities Master Plan

The Facilities Master Plan for the Oceanside Campus includes new building and renovation projects to address the identified space deficiencies and functionality issues. These projects are organized around the creation of academic hubs throughout the campus. Centered around different academic topics, like STEM or Health, each academic hub contains related instructional space, student tutoring and study space, and faculty office space—creating vibrant learning communities aimed at improving student success and excellence.

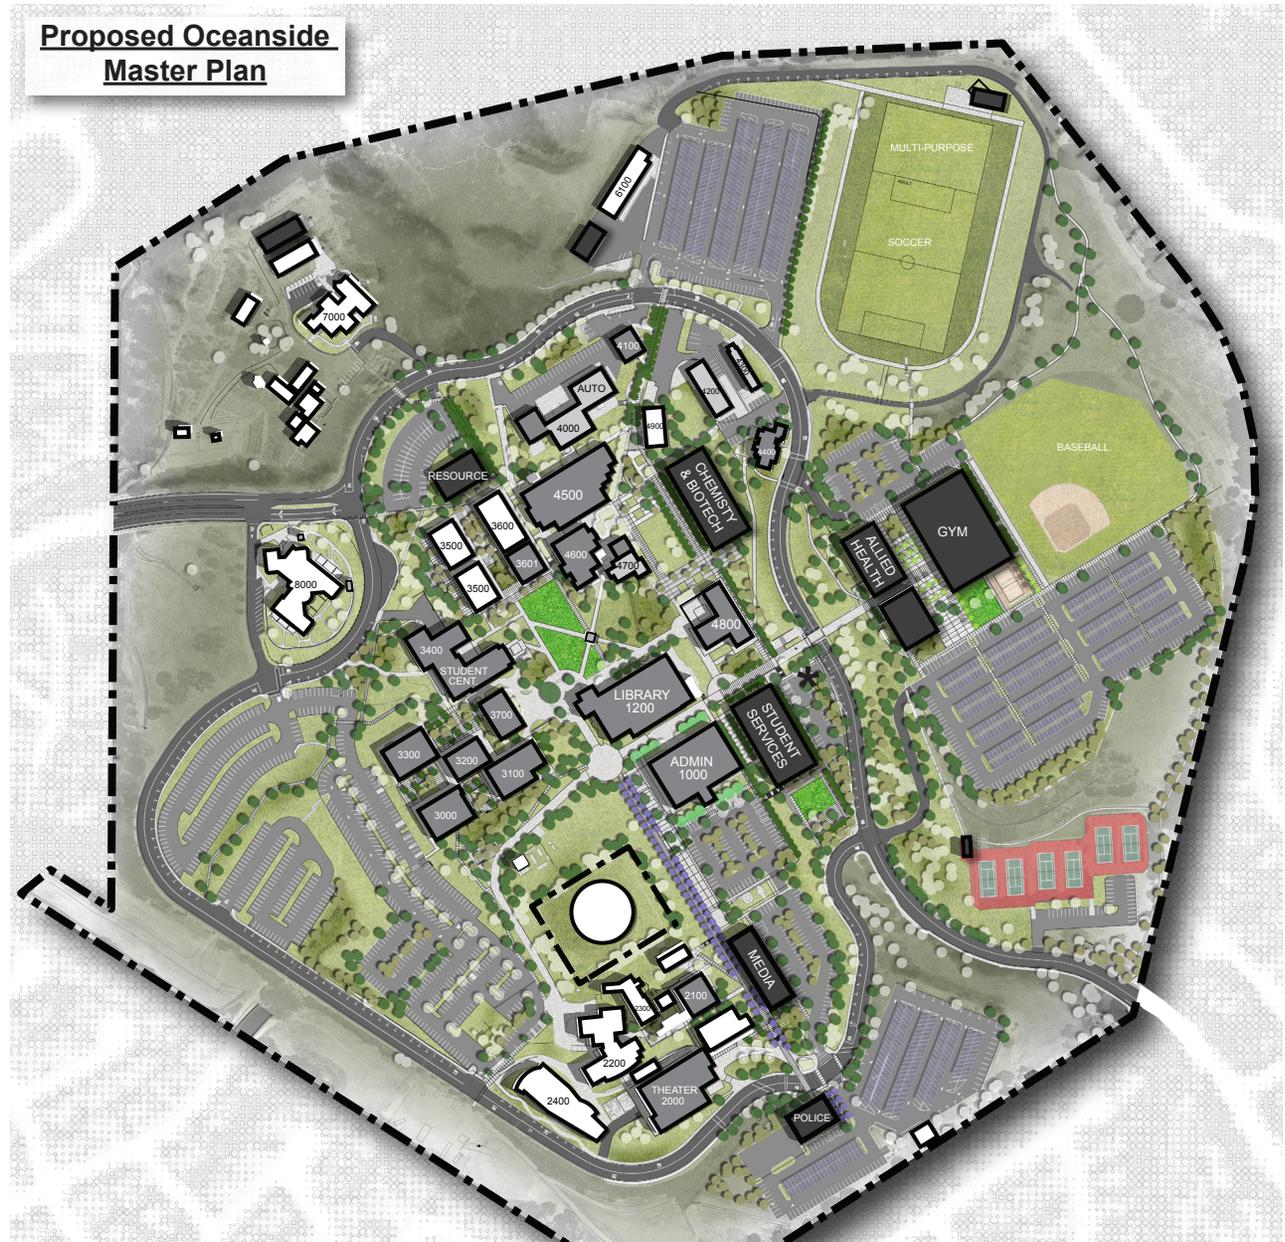
A detailed assessment of the existing campus condition was conducted through site observations, review of existing documentation, and discussions with facilities personnel, faculty, staff, and District Leadership. The following issues need to be addressed:

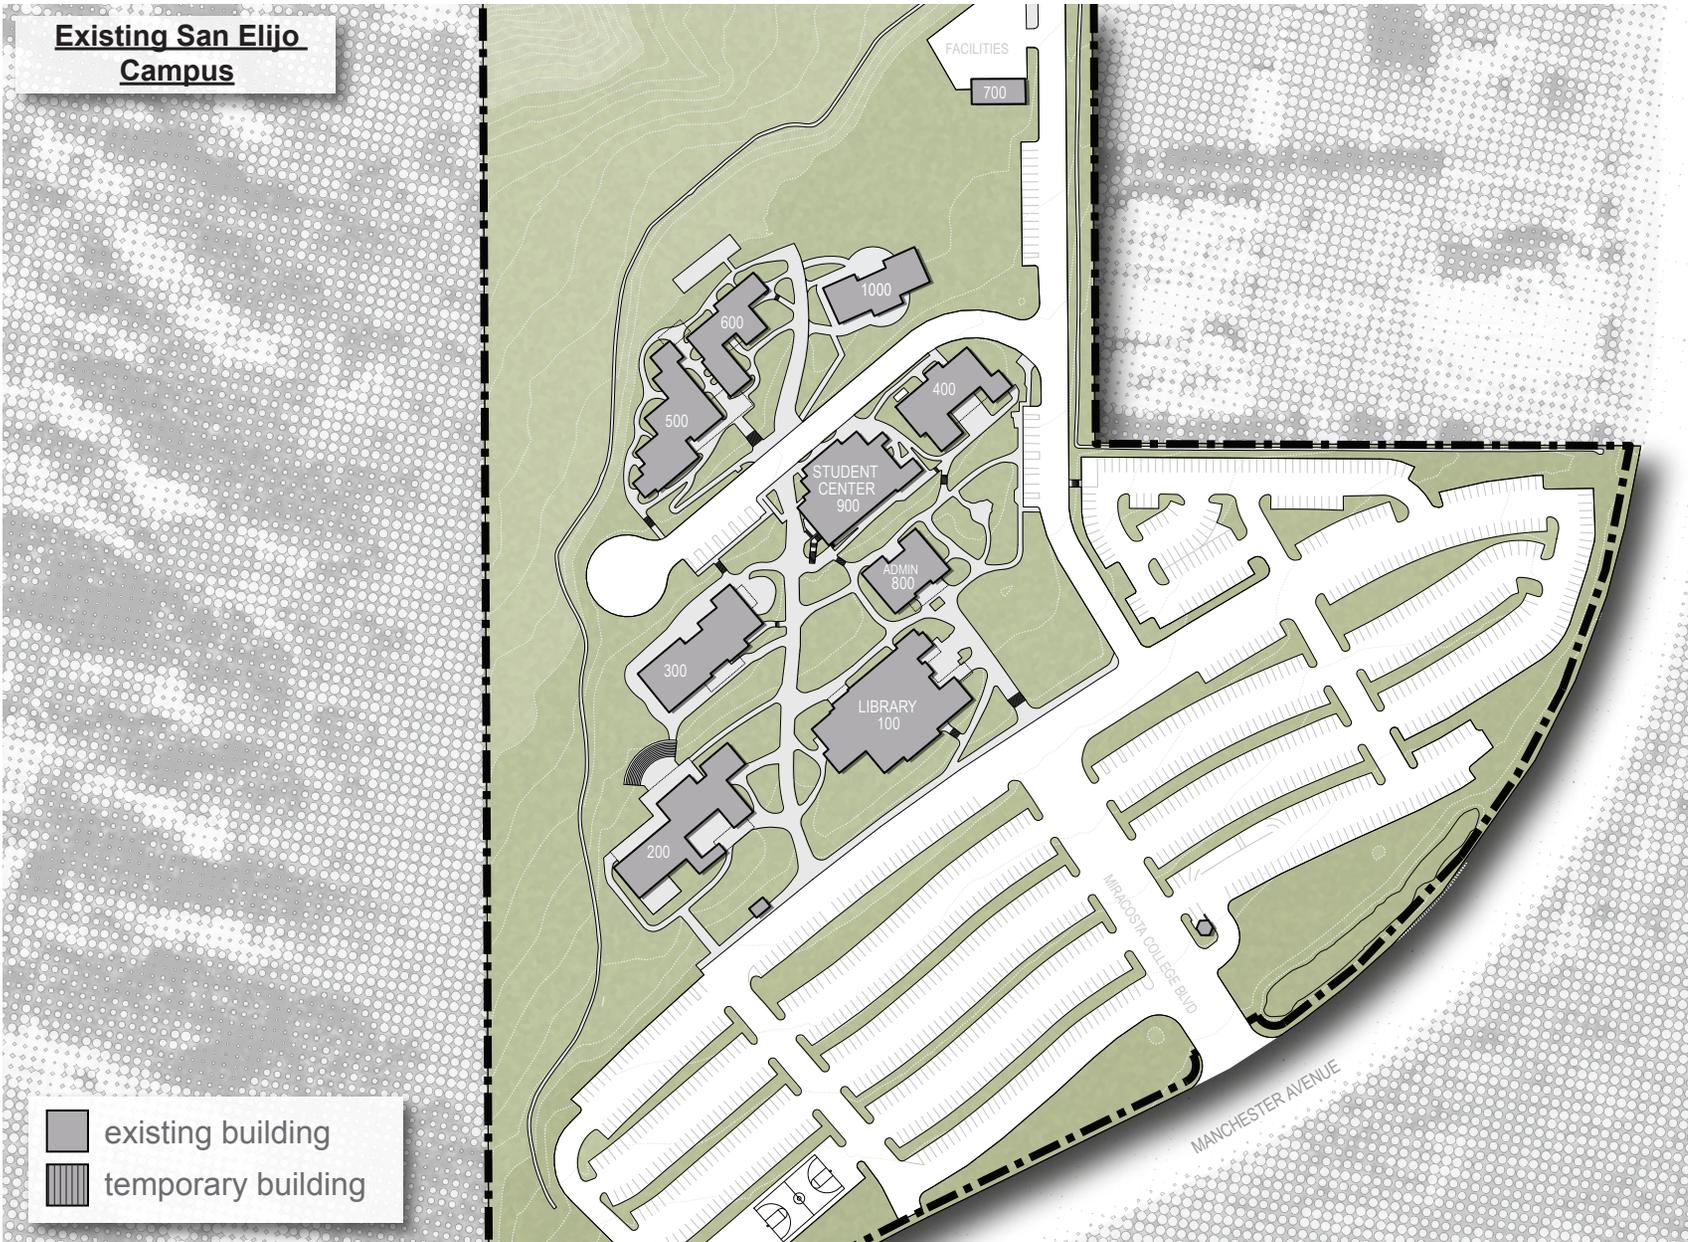
San Elijo Campus Facilities Master Plan

The Facilities Master Plan for the San Elijo Campus focuses on the renovation and modernization of existing facilities to provide flexible and interactive 21st century learning environments, both inside the classroom with finishes, furniture, and technology upgrades and outside the classroom with expanded tutoring and study space.

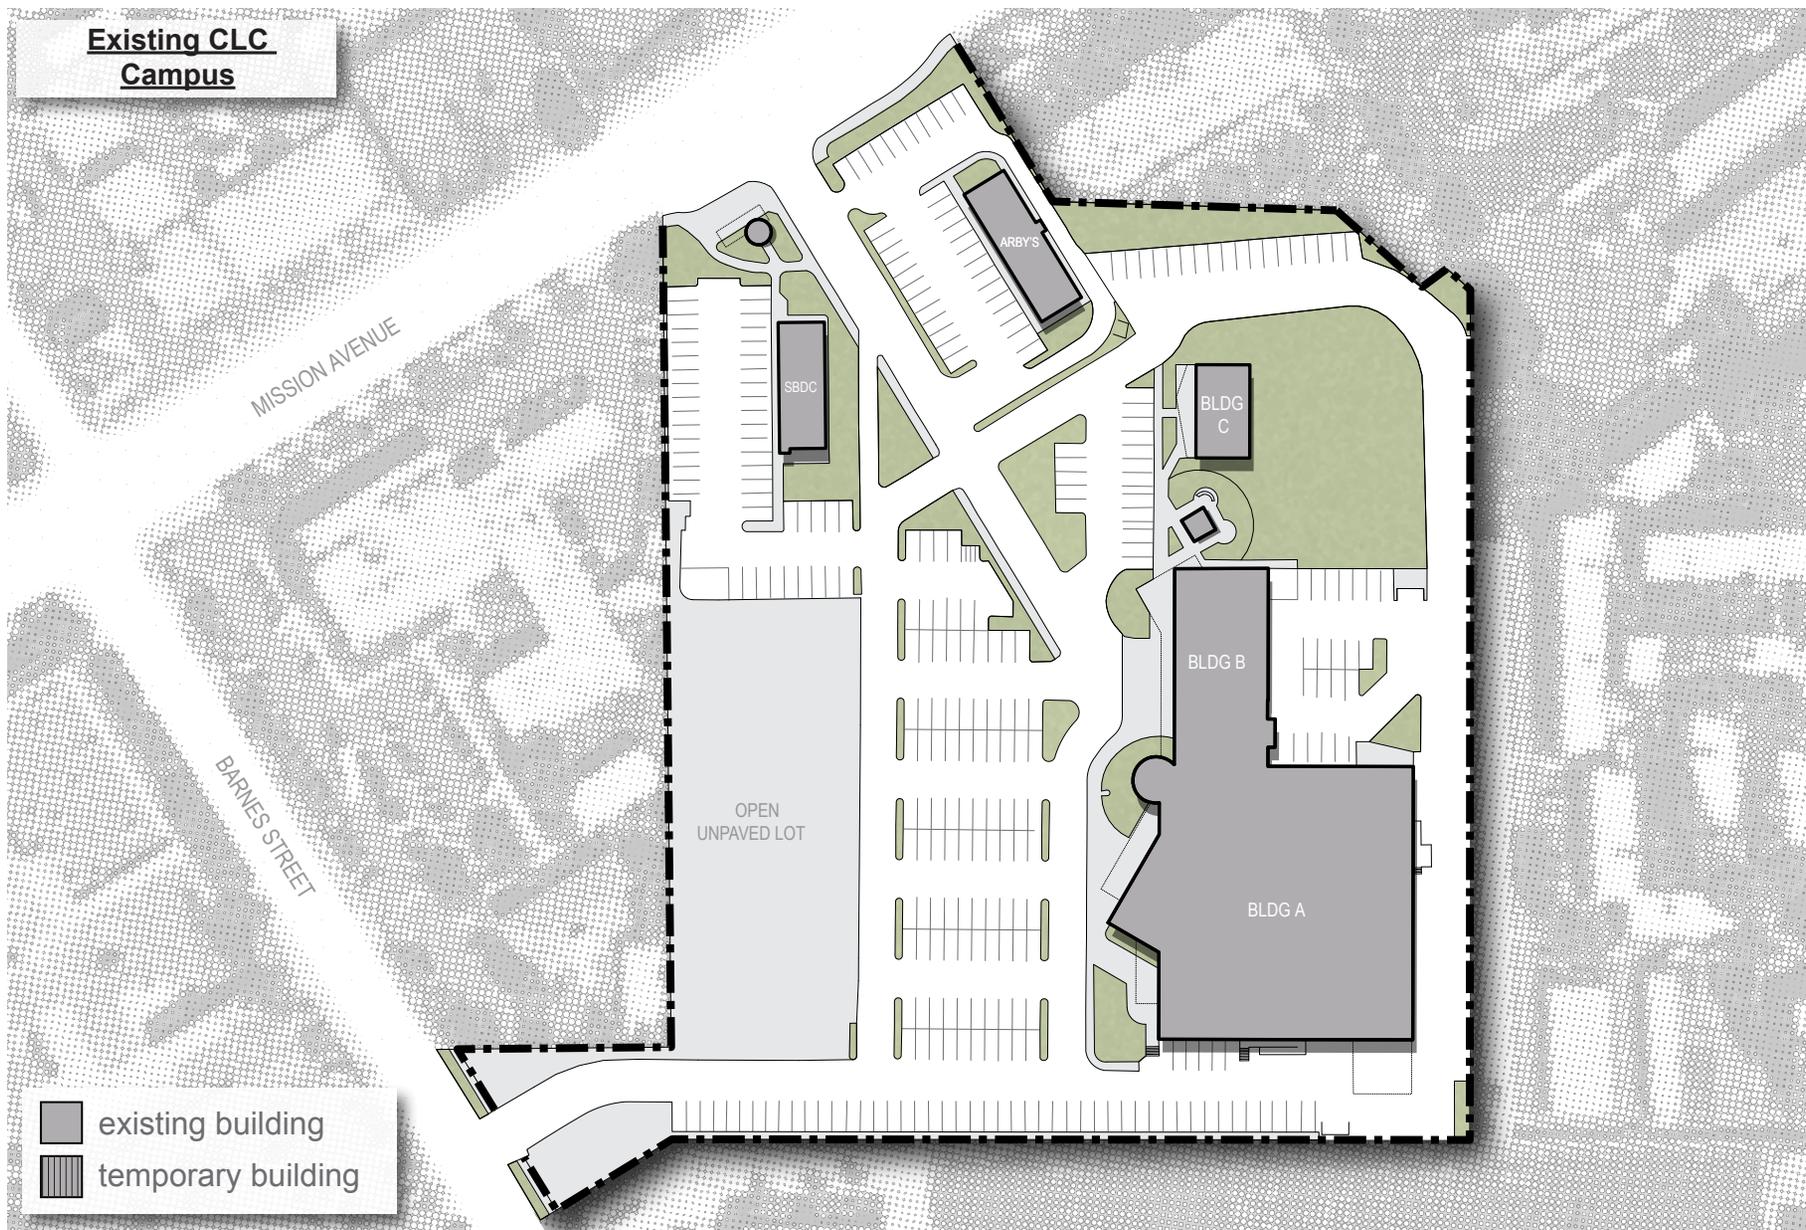
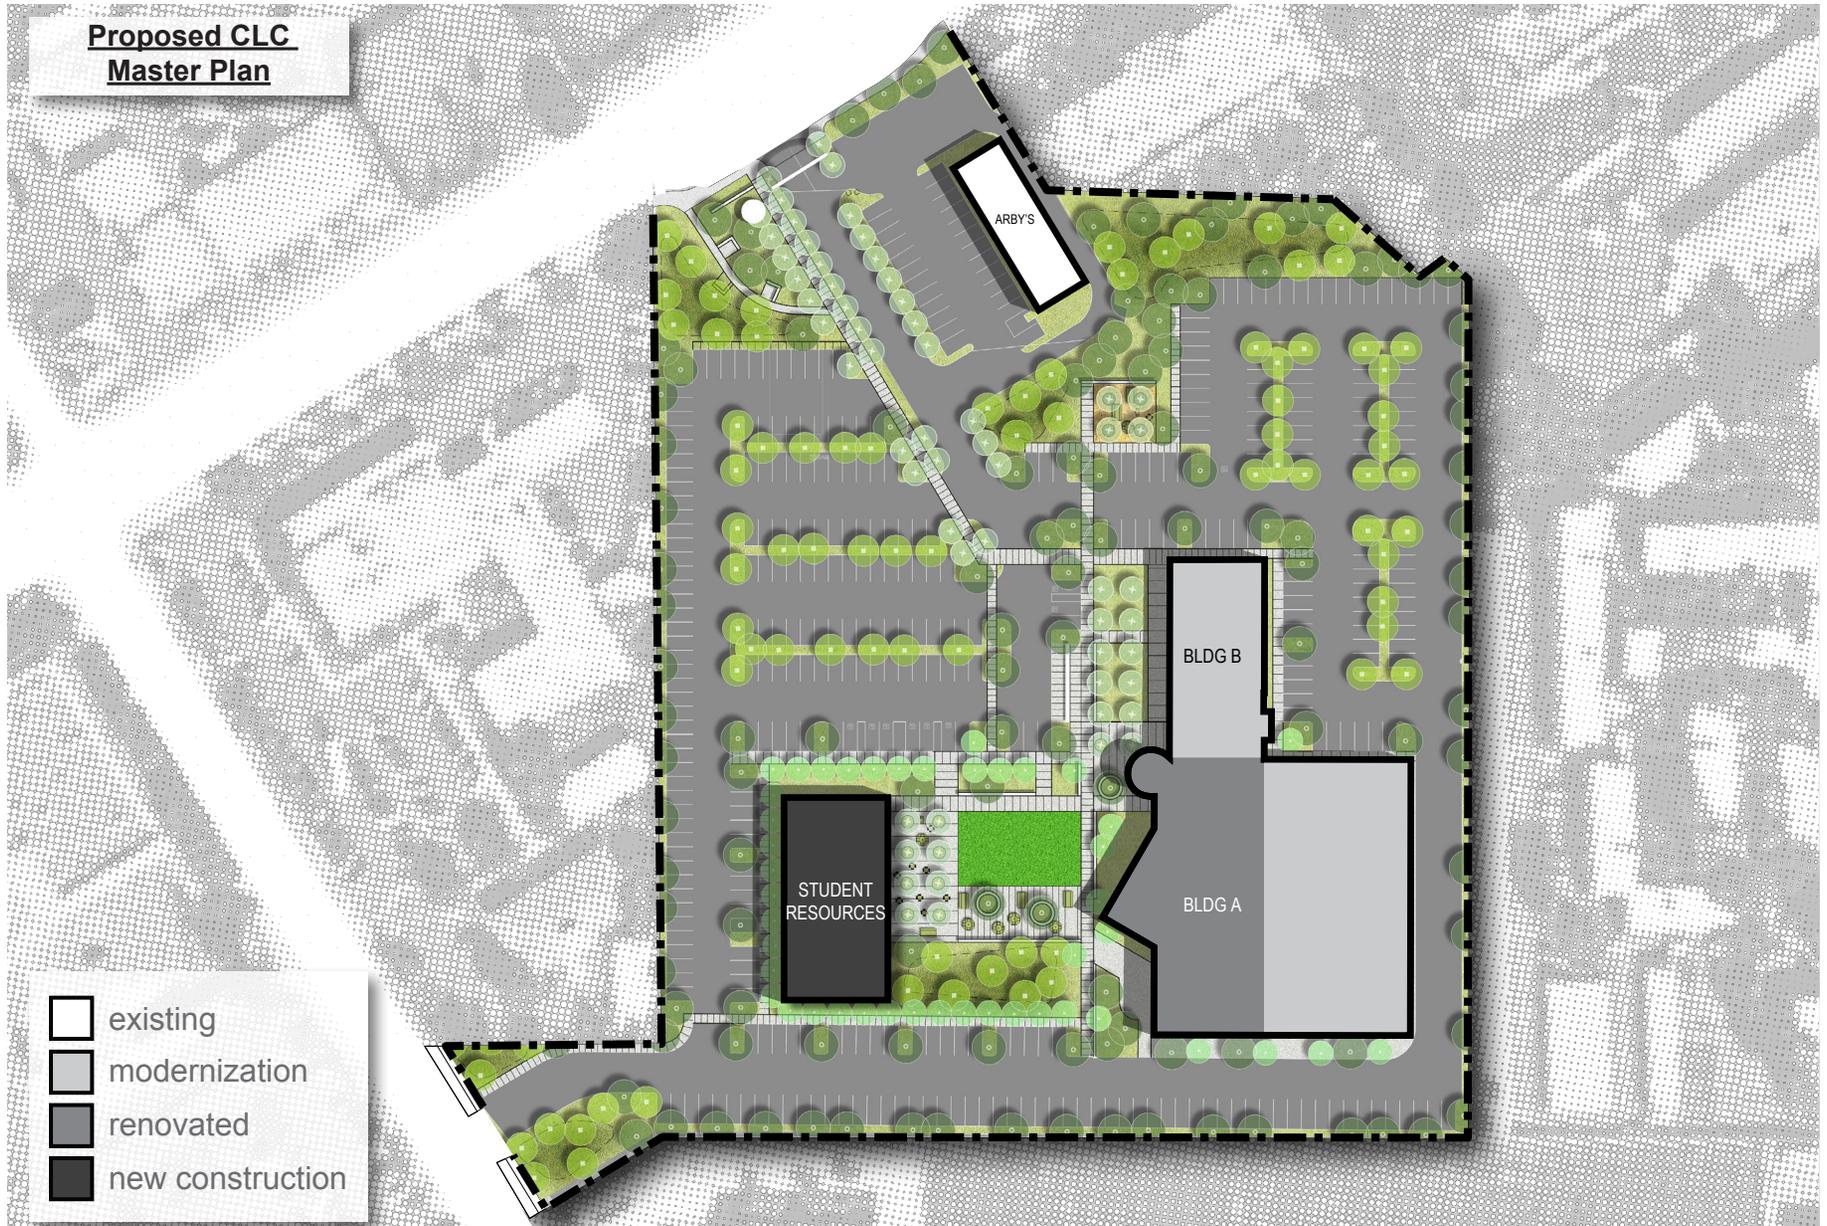
The Facilities Master Plan recommends the construction of a new Student Resources Building. In its placement, the CLC is provided with the much needed exterior campus quad and connections to parking. Both the new building and outdoor space will create a college campus that encourages student engagement, enhances the student experience, and improves safety and security on the campus. The addition of square footage will address the identified space deficiencies.
