ADA Self Evaluation and Transition Plan

MiraCosta College
Learning Center Campus

Site Name & Location: MiraCosta College, Community Learning Center, 1831 Mission Ave., Oceanside, CA 92058

Scope of Review: Parking and Exterior Path of Travel, Interior Spaces and Interior Common and Staff Areas

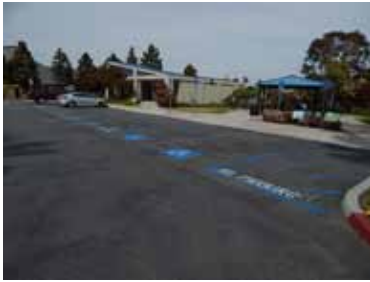
B1	<p>These parking space and the access aisles serving them is not compliant as follows:</p> <ol style="list-style-type: none"> 1. The required signage is not provided 2. The stall markings are faded and/or they do not meet the minimum requirements 3. The slope is greater than 2%

<ol style="list-style-type: none"> 1. Signage <ol style="list-style-type: none"> a. Mount all signage so that it is visible while a vehicle is parked in the stall. (80" high recommended) b. Add the "min fine of \$250" signage below the ISA sign c. For van accessible spaces include a mount "van accessible" sign separate, below the other signage. (See Appendix A7 & A8) 2. Stall Markings <ol style="list-style-type: none"> a. Re-paint the access aisle, the perimeter stripping should be blue and the cross-hatching white include the "no parking" at the base of the aisle. A minimum width 8' for van accessible spaces and 5' for non-van accessible should be provided (See appendix A1.) b. The parking stall should have a minimum width of 9' and a minimum length of 18' 3. Repave the parking spaces and the access aisle so that the slope does not exceed 2% in any direction 	P2

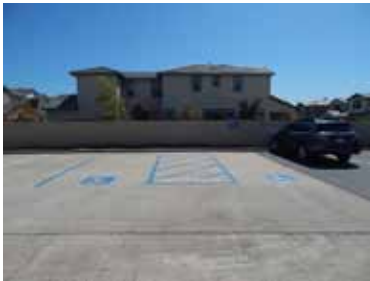
B2	<p>These parking space and the access aisles serving them is not compliant as follows:</p> <ol style="list-style-type: none"> 1. The required signage is not provided 2. The stall markings are faded and/or they do not meet the minimum requirements 3. The slope is greater than 2%

<ol style="list-style-type: none"> 1. Signage <ol style="list-style-type: none"> a. Mount all signage so that it is visible while a vehicle is parked in the stall. (80" high recommended) b. Add the "min fine of \$250" signage below the ISA sign c. For van accessible spaces include a mount "van accessible" sign separate, below the other signage. (See Appendix A7 & A8) 2. Stall Markings <ol style="list-style-type: none"> a. Re-paint the access aisle, the perimeter stripping should be blue and the cross-hatching white include the "no parking" at the base of the aisle. A minimum width 8' for van accessible spaces and 5' for non-van accessible should be provided (See appendix A1.) b. The parking stall should have a minimum width of 9' and a minimum length of 18' 3. Repave the parking spaces and the access aisle so that the slope does not exceed 2% in any direction 	P2

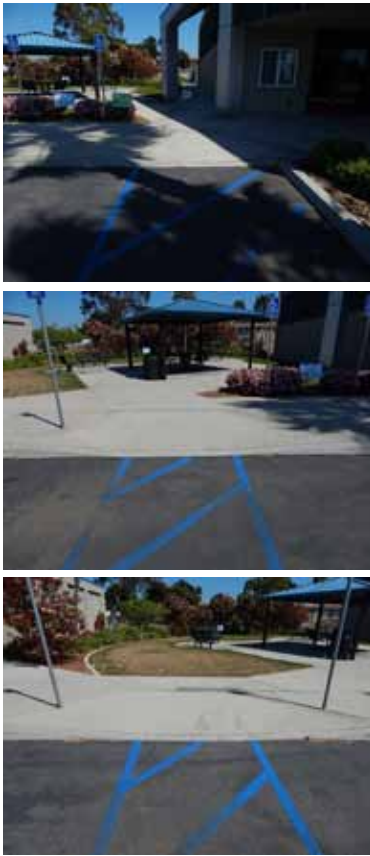
#	ITEM	PHOTO or DIAGRAM	MITIGATION MEASURE	PHASE
C2	<p>The curb cut curb ramps throughout the facility are not compliant.</p> <p>There are no DWDs provided.</p>

<p>Install a 36" deep strip of truncated domes at the base of the curb ramp, extending the full width. (<i>Appendix A.13 & 14</i>)</p>	P2
C3	<p>These stairs are not compliant.</p> <p>The required high contrasting warning stripes are not provided.</p>

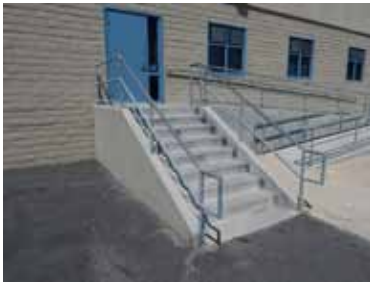
#	ITEM	PHOTO or DIAGRAM	MITIGATION MEASURE	PHASE
C4	These stairs are not compliant. The required high contrasting warning stripes are not provided.

1. Provided a 2" high contrasting warning stripe on the nosing of each tread riser.	P2
C5	The ramp is compliant.

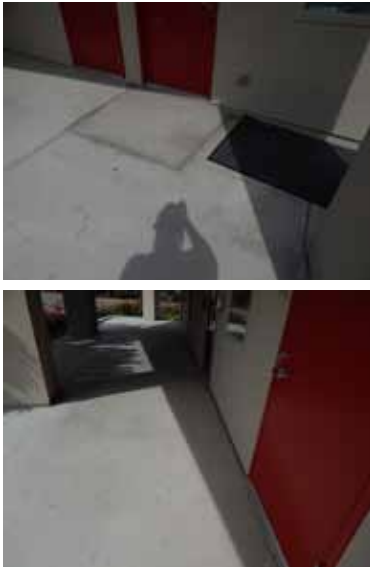
None Required	N/A
C6	The landings at the entrances to building C are not compliant. The slope exceeds 2%

Reconstruct the landings so that there is a slope of no greater than 2% in any direction, for 60" beyond the threshold, and 18" on the strike side of the jamb.	P2

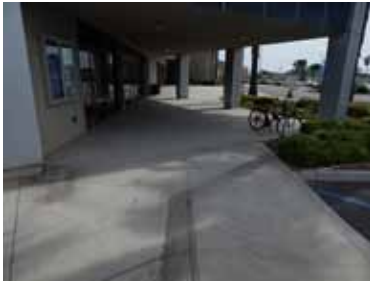
#	ITEM	PHOTO or DIAGRAM	MITIGATION MEASURE	PHASE
C7	The POT serving building B is compliant.

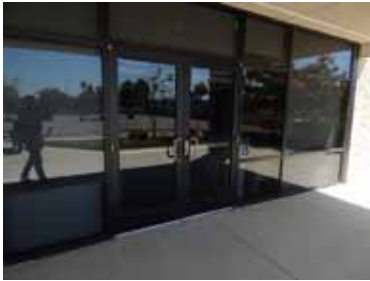
D1.1	1. The entrance to the main office is not compliant. The force to open exceeds 5 LBS. To operate.

Adjust the door closer so that the force to operate the door is less than 5 LBS.	P2
D1.2	The reception desk is compliant.

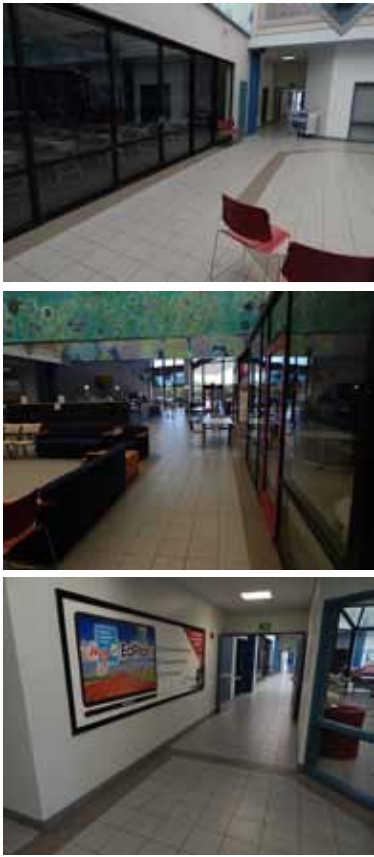
#	ITEM	PHOTO or DIAGRAM	MITIGATION MEASURE	PHASE
D1.3	<p>The interior POT is not compliant. The required exit signage is not provided.</p>

<p>Provide compliant exit signage according to appendix D.8</p>	P2

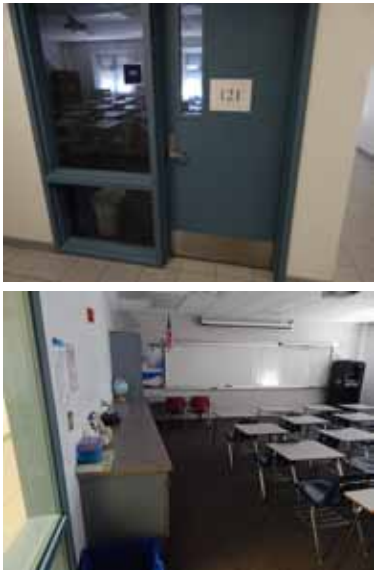
#	ITEM	PHOTO or DIAGRAM	MITIGATION MEASURE	PHASE
D1.4	<p>This Classroom is not compliant.</p> <ol style="list-style-type: none"> 1. The entry door requires more than 5 LBS. Of pressure to operate. 2. The required door signage is not provided. 3. The interior of the classroom is compliant

<ol style="list-style-type: none"> 1. Adjust the door closer so that it requires less than 5LBS of pressure to operate. 2. Install compliant door signage according to appendix B.14 - B.17 3. None required. 	P2
D1.5	<p>This Classroom is not compliant.</p> <ol style="list-style-type: none"> 1. The entry door requires more than 5 LBS. Of pressure to operate. 2. The required door signage is not provided. 3. The interior of the classroom is compliant

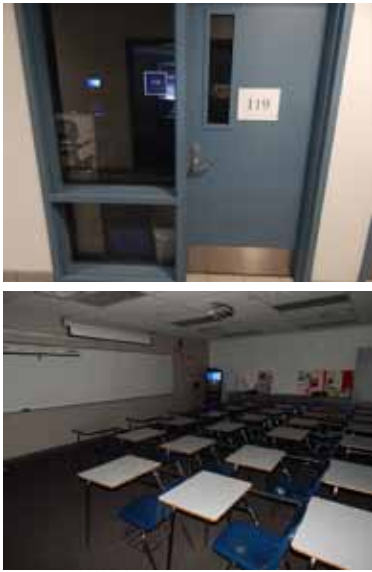
#	ITEM	PHOTO or DIAGRAM	MITIGATION MEASURE	PHASE
D1.6	<p>This Classroom is not compliant.</p> <ol style="list-style-type: none"> 1. The entry door requires more than 5 LBS. Of pressure to operate. 2. The required door signage is not provided. 3. The interior of the classroom is compliant

<ol style="list-style-type: none"> 1. Adjust the door closer so that it requires less than 5LBS of pressure to operate. 2. Install compliant door signage according to appendix B.14 - B.17 3. None required. 	P2
D1.7	<p>This Classroom is not compliant.</p> <ol style="list-style-type: none"> 1. The entry door requires more than 5 LBS. Of pressure to operate. 2. The required door signage is not provided. 3. The interior of this classroom does not have the required 36" wide POT maintained through the class room. 4. The required wheelchair accessible workstation is not provided

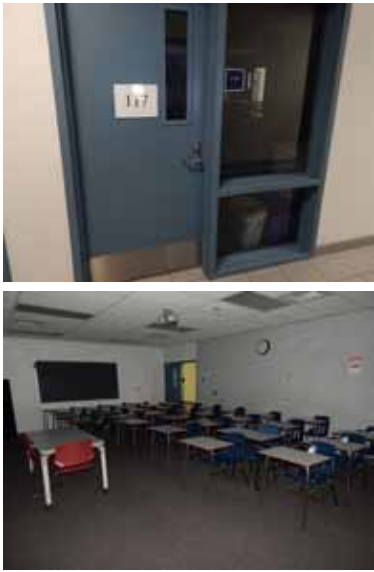
#	ITEM	PHOTO or DIAGRAM	MITIGATION MEASURE	PHASE
D1.8	<p>This Classroom is not compliant.</p> <ol style="list-style-type: none"> 1. The entry door requires more than 5 LBS. Of pressure to operate. 2. The required door signage is not provided. 3. The interior of the classroom is compliant

<ol style="list-style-type: none"> 1. Adjust the door closer so that it requires less than 5LBS of pressure to operate. 2. Install compliant door signage according to appendix B.14 - B.17 3. None required. 	P2
D1.9	<p>This Classroom is not compliant.</p> <ol style="list-style-type: none"> 1. The entry door requires more than 5 LBS. Of pressure to operate. 2. The required door signage is not provided. 3. The interior of the classroom is compliant

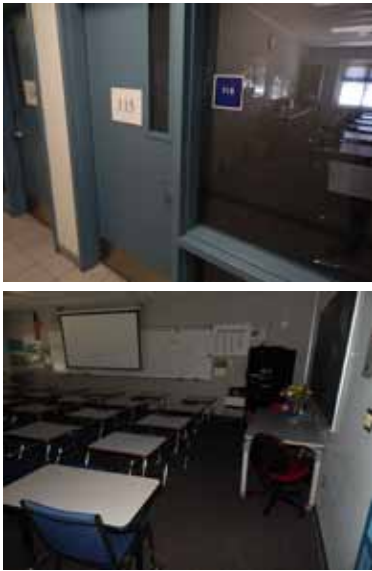
#	ITEM	PHOTO or DIAGRAM	MITIGATION MEASURE	PHASE
D1.11	<p>This Classroom is not compliant.</p> <ol style="list-style-type: none"> 1. The entry door requires more than 5 LBS. Of pressure to operate. 2. The required door signage is not provided. 3. The interior of the classroom is compliant

<ol style="list-style-type: none"> 1. Adjust the door closer so that it requires less than 5LBS of pressure to operate. 2. Install compliant door signage according to appendix B.14 - B.17 3. None required. 	P2
D1.12	<p>This Classroom is not compliant.</p> <ol style="list-style-type: none"> 1. The entry door requires more than 5 LBS. Of pressure to operate. 2. The required door signage is not provided. 3. The interior of the classroom is compliant

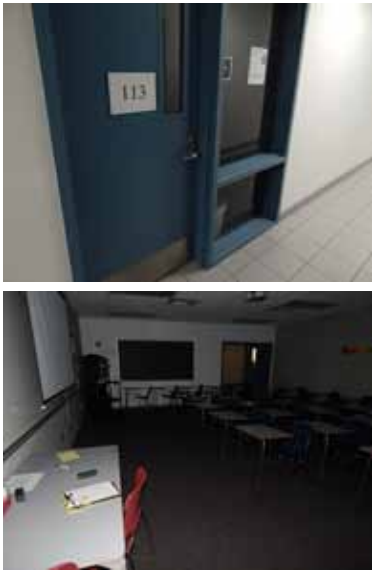
#	ITEM	PHOTO or DIAGRAM	MITIGATION MEASURE	PHASE
D1.13	<p>This Classroom is not compliant.</p> <ol style="list-style-type: none"> 1. The entry door requires more than 5 LBS. Of pressure to operate. 2. The required door signage is not provided. 3. The interior of the classroom is compliant

<ol style="list-style-type: none"> 1. Adjust the door closer so that it requires less than 5LBS of pressure to operate. 2. Install compliant door signage according to appendix B.14 - B.17 3. None required. 	P2
D1.14	<p>This Classroom is not compliant.</p> <ol style="list-style-type: none"> 1. The entry door requires more than 5 LBS. Of pressure to operate. 2. The required door signage is not provided. 3. The interior of the classroom is compliant

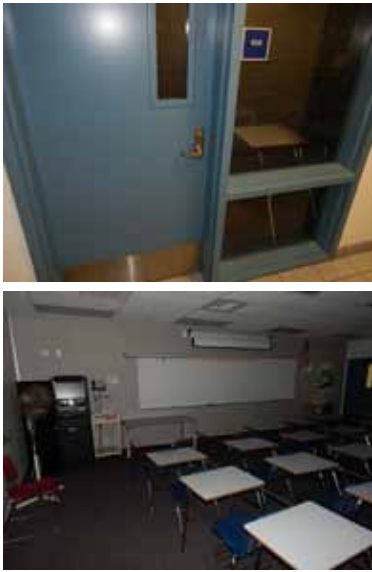
#	ITEM	PHOTO or DIAGRAM	MITIGATION MEASURE	PHASE
D1.15	<p>This Classroom is not compliant.</p> <ol style="list-style-type: none"> 1. The entry door requires more than 5 LBS. Of pressure to operate. 2. The required door signage is not provided. 3. The interior of the classroom is compliant

<ol style="list-style-type: none"> 1. Adjust the door closer so that it requires less than 5LBS of pressure to operate. 2. Install compliant door signage according to appendix B.14 - B.17 3. None required. 	P2
D1.16	<p>This Classroom is not compliant.</p> <ol style="list-style-type: none"> 1. The entry door requires more than 5 LBS. Of pressure to operate. 2. The required door signage is not provided. 3. The interior of the classroom is compliant

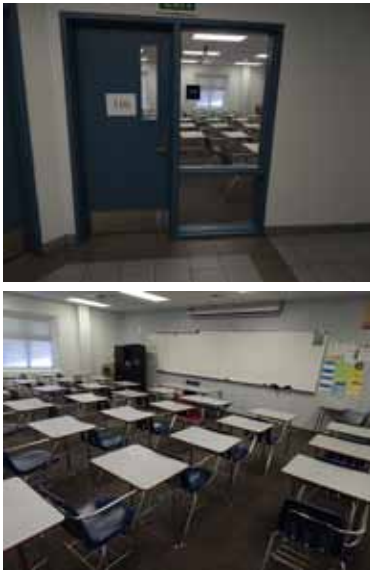
#	ITEM	PHOTO or DIAGRAM	MITIGATION MEASURE	PHASE
D1.17	<p>This Classroom is not compliant.</p> <ol style="list-style-type: none"> 1. The entry door requires more than 5 LBS. Of pressure to operate. 2. The required door signage is not provided. 3. The interior of this classroom does not have the required 36" wide POT maintained through the class room. 4. The required wheelchair accessible workstation is not provided

<ol style="list-style-type: none"> 1. Adjust the door closer so that it requires less than 5LBS of pressure to operate. 2. Install compliant door signage according to appendix B.14 - B.17 3. Maintain the desks so that a 36" wide POT is provided 4. Provide a wheel chair accessible work station. 	P2
D1.18	<p>This Classroom is not compliant.</p> <ol style="list-style-type: none"> 1. The entry door requires more than 5 LBS. Of pressure to operate. 2. The required door signage is not provided. 3. The interior of the classroom is compliant

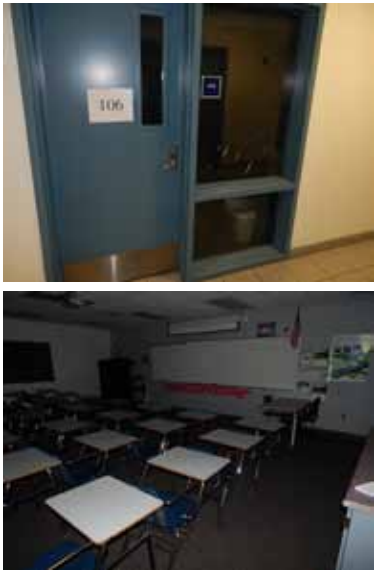
#	ITEM	PHOTO or DIAGRAM	MITIGATION MEASURE	PHASE
D1.19	<p>This Classroom is not compliant.</p> <ol style="list-style-type: none"> 1. The entry door requires more than 5 LBS. Of pressure to operate. 2. The required door signage is not provided. 3. The interior of the classroom is compliant.

<ol style="list-style-type: none"> 1. Adjust the door closer so that it requires less than 5LBS of pressure to operate. 2. Install compliant door signage according to Appendix B.14 - B.17 3. None required. 	P2
D1.20	<p>This Classroom is not compliant.</p> <ol style="list-style-type: none"> 1. The entry door requires more than 5 LBS. Of pressure to operate. 2. The required door signage is not provided. 3. The interior of the classroom is compliant.

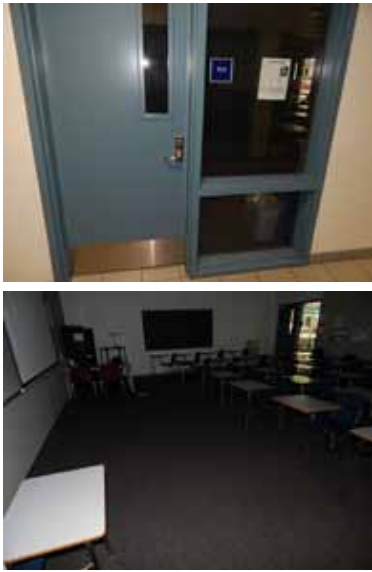
#	ITEM	PHOTO or DIAGRAM	MITIGATION MEASURE	PHASE
D1.21	<p>This Classroom is not compliant.</p> <ol style="list-style-type: none"> 1. The entry door requires more than 5 LBS. Of pressure to operate. 2. The required door signage is not provided. 3. The interior of the classroom is compliant

<ol style="list-style-type: none"> 1. Adjust the door closer so that it requires less than 5LBS of pressure to operate. 2. Install compliant door signage according to appendix B.14 - B.17 3. None required. 	P2
D1.22	<p>This Classroom is not compliant.</p> <ol style="list-style-type: none"> 1. The entry door requires more than 5 LBS. Of pressure to operate. 2. The required door signage is not provided. 3. The interior of the classroom is compliant

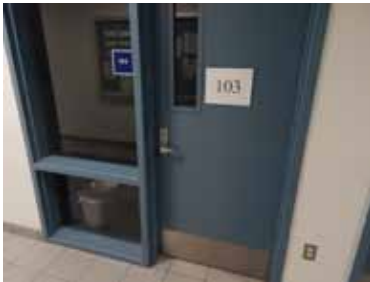
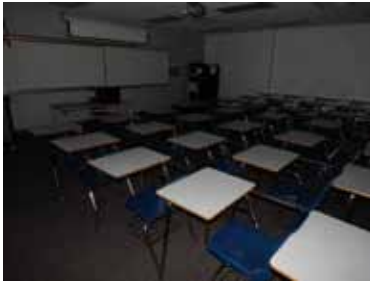
#	ITEM	PHOTO or DIAGRAM	MITIGATION MEASURE	PHASE
D1.23	<p>This Classroom is not compliant.</p> <ol style="list-style-type: none"> 1. The entry door requires more than 5 LBS. Of pressure to operate. 2. The required door signage is not provided. 3. The interior of the classroom is compliant

<ol style="list-style-type: none"> 1. Adjust the door closer so that it requires less than 5LBS of pressure to operate. 2. Install compliant door signage according to appendix B.14 - B.17 3. None required. 	P2
D1.24	<p>The student resource center is compliant.</p>

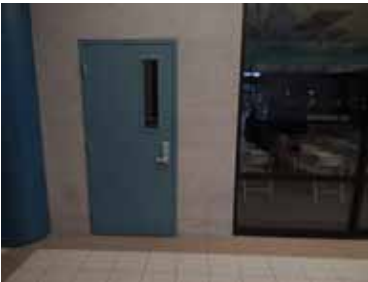
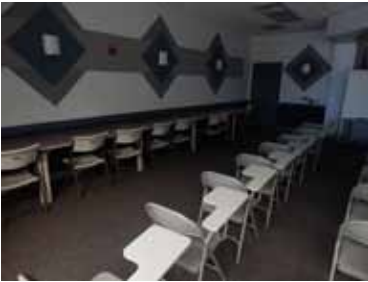
#	ITEM	PHOTO or DIAGRAM	MITIGATION MEASURE	PHASE
D1.25	<p>This Classroom is not compliant.</p> <ol style="list-style-type: none"> 1. The entry door requires more than 5 LBS. Of pressure to operate. 2. The required door signage is not provided. 3. The interior of the classroom is compliant

<ol style="list-style-type: none"> 1. Adjust the door closer so that it requires less than 5LBS of pressure to operate. 2. Install compliant door signage according to appendix B.14 - B.17 3. None required. 	P2
D1.26	<p>This Classroom is not compliant.</p> <ol style="list-style-type: none"> 1. The entry door requires more than 5 LBS. Of pressure to operate. 2. The required door signage is not provided. 3. The interior of the classroom is compliant

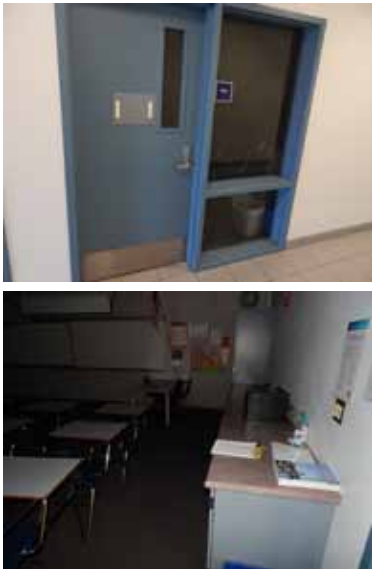
#	ITEM	PHOTO or DIAGRAM	MITIGATION MEASURE	PHASE
D1.27	<p>This Classroom is not compliant.</p> <ol style="list-style-type: none"> 1. The entry door requires more than 5 LBS. Of pressure to operate. 2. The required door signage is not provided. 3. The interior of this classroom does not have the required 36" wide POT maintained through the class room. 4. The required wheelchair accessible workstation is not provided

<ol style="list-style-type: none"> 1. Adjust the door closer so that it requires less than 5LBS of pressure to operate. 2. Install compliant door signage according to appendix B.14 - B.17 3. Maintain the desks so that a 36" wide POT is provided 4. Provide a wheel chair accessible work station. 	P2
D1.28	The drinking fountains are compliant

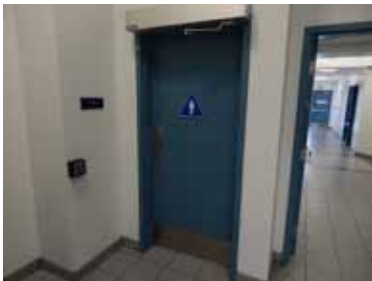
None required.	N/A
Men				
D1.29	<p>The entry door to this restroom is not compliant as follows;</p> <ol style="list-style-type: none"> 1. The door symbol is mounted incorrectly and the sign finish is not non-glare. 2. Door symbol is not contrasting in color from the finish of the door 3. The required wall signage provided on the latch side of the door is not provided at 60" AFF.

<ol style="list-style-type: none"> 1. Replace the door symbol with a non-glare contrasting finish and mount at 60" AFF. 2. Replace the door symbol with a symbol that is 70% contrast in color from the finish of the door. OR Provide a white border 1" wide around the symbol. 3. Provide a compliant wall sign on the latch side of the door mounted at 60" AFF to the TOP of the sign and 4" from the jamb. (Refer to Appendix B.14- B.17) 	P2

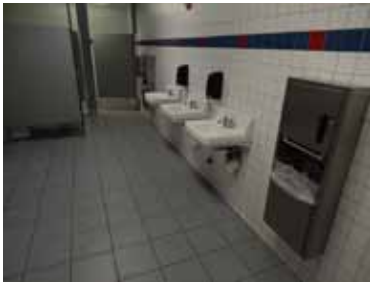
#	ITEM	PHOTO or DIAGRAM	MITIGATION MEASURE	PHASE
D1.30	<p>The accessible lavatory is not compliant as follows;</p> <ol style="list-style-type: none"> 1. The hot water and drain pipes and sharp objects under the sink have not been insulated or covered adequately.

<ol style="list-style-type: none"> 1. Provide adequate insulation and covering of all exposed pipes and sharp objects under the sink. 	P2
D1.31	The urinal is compliant

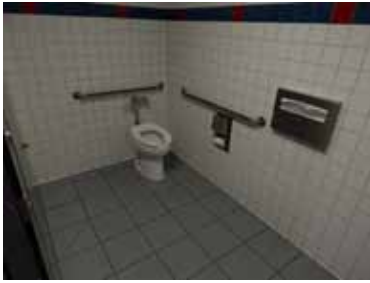
Non Required	N/A
D1.32	<p>The accessible toilet and stall are not compliant as follows;</p> <ol style="list-style-type: none"> 1. The rear grab bar does not extend 24" minimum beyond the centerline of the fixture on the wide side. (22") 2. The side grab bar does not extend 54" minimum beyond the rear wall. (52") 3. The toilet tissue dispenser is located too high or too far from the front of the toilet. 4. The stall door is not self closing.

<ol style="list-style-type: none"> 1. Replace the rear grab bar or relocate the rear grab bar so that it extends 24" beyond the centerline of the toilet to the wide side. 2. Replace the side grab bar or relocate the side grab bar so that it extends 25" beyond the Rear wall 3. Relocate the toilet tissue dispenser so that it is located 7"- 9" on the front of the toilet and 19" AFF. (Locate to the centerline of the dispenser) 4. Adjust the stall door so that it is self-closing. 	P2

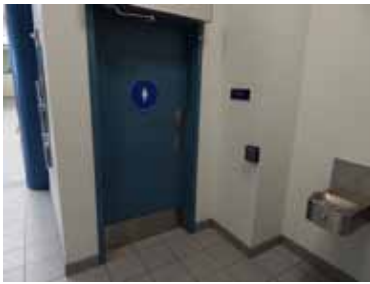
Women				
D1.33	<p>The entry door to this restroom is not compliant as follows;</p> <ol style="list-style-type: none"> 1. The door symbol is mounted incorrectly and the sign finish is not non-glare. 2. Door symbol is not contrasting in color from the finish of the door 3. The required wall signage provided on the latch side of the door is not provided at 60" AFF.

<ol style="list-style-type: none"> 1. Replace the door symbol with a non-glare contrasting finish and mount at 60" AFF. 2. Replace the door symbol with a symbol that is 70% contrast in color from the finish of the door. OR Provide a white border 1" wide around the symbol. 3. Provide a compliant wall sign on the latch side of the door mounted at 60" AFF to the TOP of the sign and 4" from the jamb. (Refer to Appendix B.14- B.17) 	P2

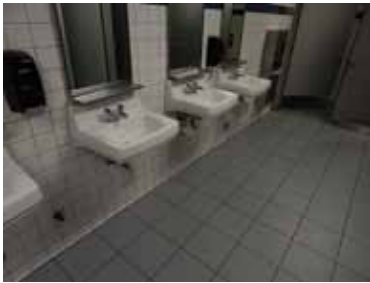
#	ITEM	PHOTO or DIAGRAM	MITIGATION MEASURE	PHASE
D1.34	<p>The accessible lavatory is not compliant as follows;</p> <ol style="list-style-type: none"> 1. The hot water and drain pipes and sharp objects under the sink have not been insulated or covered adequately.

<ol style="list-style-type: none"> 1. Provide adequate insulation and covering of all exposed pipes and sharp objects under the sink. 	P2
D1.35	<p>The accessible toilet and stall are not compliant as follows;</p> <ol style="list-style-type: none"> 1. The rear grab bar does not extend 24" minimum beyond the centerline of the fixture on the wide side. (22") 2. The side grab bar does not extend 54" minimum beyond the rear wall. (52") 3. The toilet tissue dispenser is located too high or too far from the front of the toilet. 4. The stall door is not self closing.

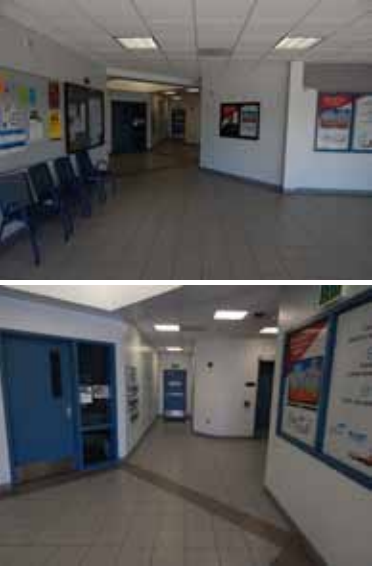
D2.01	<p>The interior POT is not compliant. The required exit signage is not provided.</p>

<p>Provide compliant exit signage according to appendix D.8</p>	P2
D2.02	<p>This Classroom is not compliant.</p> <ol style="list-style-type: none"> 1. The entry door requires more than 5 LBS. Of pressure to operate. 2. The required door signage is not provided. 3. The interior of the classroom is compliant

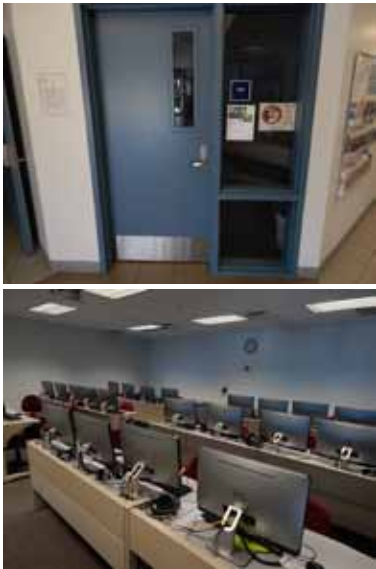
#	ITEM	PHOTO or DIAGRAM	MITIGATION MEASURE	PHASE
D2.03	<p>This Classroom is not compliant.</p> <ol style="list-style-type: none"> 1. The entry door requires more than 5 LBS. Of pressure to operate. 2. The required door signage is not provided. 3. The interior of the classroom is compliant

<ol style="list-style-type: none"> 1. Adjust the door closer so that it requires less than 5LBS of pressure to operate. 2. Install compliant door signage according to appendix B.14 - B.17 3. None required. 	P2
D2.04	<p>This Classroom is not compliant.</p> <ol style="list-style-type: none"> 1. The entry door requires more than 5 LBS. Of pressure to operate. 2. The required door signage is not provided. 3. The interior of the classroom is compliant

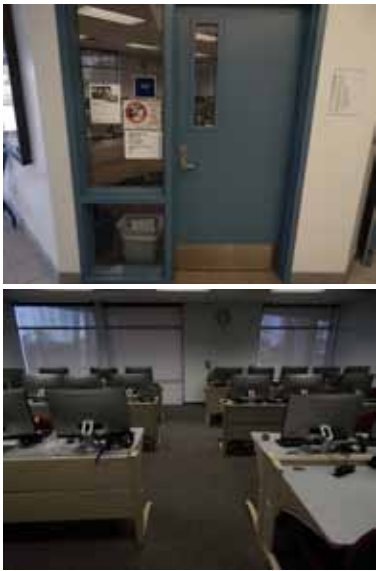
<ol style="list-style-type: none"> 1. Adjust the door closer so that it requires less than 5LBS of pressure to operate. 2. Install compliant door signage according to appendix B.14 - B.17 3. None required. 	P2
D2.06	<p>This Classroom is not compliant.</p> <ol style="list-style-type: none"> 1. The entry door requires more than 5 LBS. Of pressure to operate. 2. The required door signage is not provided. 3. The interior of the classroom is compliant

<ol style="list-style-type: none"> 1. Adjust the door closer so that it requires less than 5LBS of pressure to operate. 2. Install compliant door signage according to appendix B.14 - B.17 3. None required. 	P2

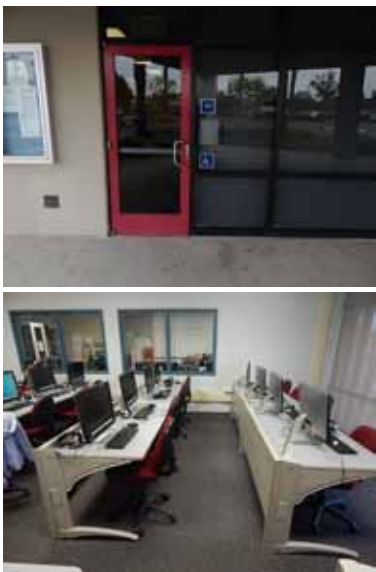
#	ITEM	PHOTO or DIAGRAM	MITIGATION MEASURE	PHASE
D2.07	<p>This Classroom is not compliant.</p> <ol style="list-style-type: none"> 1. The entry door requires more than 5 LBS. Of pressure to operate. 2. The required door signage is not provided. 3. The interior of the classroom is compliant

<ol style="list-style-type: none"> 1. Adjust the door closer so that it requires less than 5LBS of pressure to operate. 2. Install compliant door signage according to appendix B.14 - B.17 3. None required. 	P2
Men				
D2.08	<p>The entry door to this restroom is not compliant as follows;</p> <ol style="list-style-type: none"> 1. The door symbol is mounted incorrectly and the sign finish is not non-glare. 2. Door symbol is not contrasting in color from the finish of the door 3. The required wall signage provided on the latch side of the door is not provided at 60" AFF.

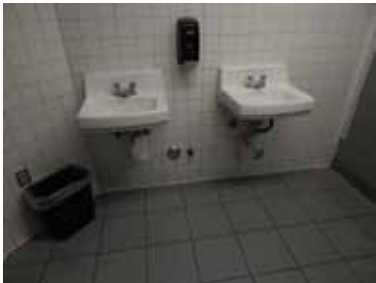
D2.09	<p>The accessible lavatory is not compliant as follows;</p> <ol style="list-style-type: none"> 1. The hot water and drain pipes and sharp objects under the sink have not been insulated or covered adequately.

<ol style="list-style-type: none"> 1. Provide adequate insulation and covering of all exposed pipes and sharp objects under the sink. 	P2

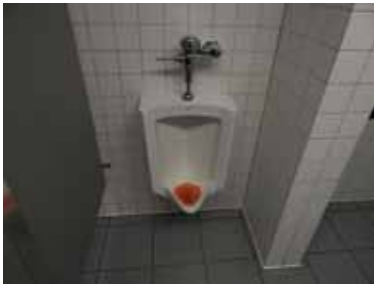
#	ITEM	PHOTO or DIAGRAM	MITIGATION MEASURE	PHASE
D2.10	The urinal is compliant

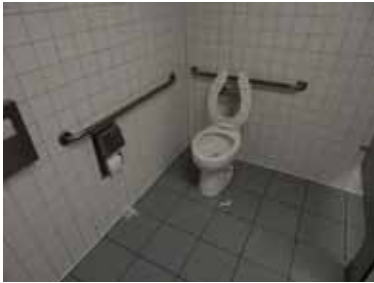
None required	N/A
D2.11	<p>The accessible toilet and stall are not compliant as follows;</p> <ol style="list-style-type: none"> 1. The rear grab bar does not extend 24" minimum beyond the centerline of the fixture on the wide side. (22") 2. The side grab bar does not extend 54" minimum beyond the rear wall. (52") 3. The toilet tissue dispenser is located too high or too far from the front of the toilet. 4. The stall door is not self closing.

<ol style="list-style-type: none"> 1. Replace the rear grab bar or relocate the rear grab bar so that it extends 24" beyond the centerline of the toilet to the wide side. 2. Replace the side grab bar or relocate the side grab bar so that it extends 25" beyond the Rear wall 3. Relocate the toilet tissue dispenser so that it is located 7"- 9" on the front of the toilet and 19" AFF. (Locate to the centerline of the dispenser) 4. Adjust the stall door so that it is self-closing. 	P2

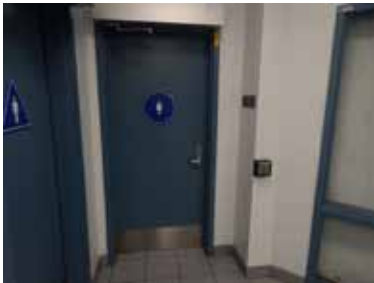
Women				
D2.12	<p>The entry door to this restroom is not compliant as follows;</p> <ol style="list-style-type: none"> 1. The door symbol is mounted incorrectly and the sign finish is not non-glare. 2. Door symbol is not contrasting in color from the finish of the door 3. The required wall signage provided on the latch side of the door is not provided at 60" AFF.

<ol style="list-style-type: none"> 1. Replace the door symbol with a non-glare contrasting finish and mount at 60" AFF. 2. Replace the door symbol with a symbol that is 70% contrast in color from the finish of the door. OR Provide a white border 1" wide around the symbol. 3. Provide a compliant wall sign on the latch side of the door mounted at 60" AFF to the TOP of the sign and 4" from the jamb. (Refer to Appendix B.14- B.17) 	P2
D2.13	<p>The accessible lavatory is not compliant as follows;</p> <ol style="list-style-type: none"> 1. The hot water and drain pipes and sharp objects under the sink have not been insulated or covered adequately.

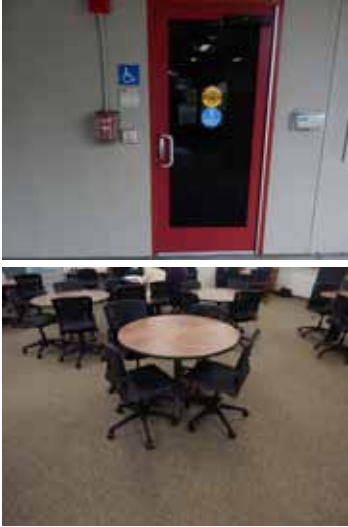
D3.01	<p>This Classroom is not compliant.</p> <ol style="list-style-type: none"> 1. The entry door requires more than 5 LBS. Of pressure to operate. 2. The interior of the classroom is compliant

<ol style="list-style-type: none"> 1. Adjust the door closer so that it requires less than 5LBS of pressure to operate. 2. None Required 	P2
-------	--	---	--	----

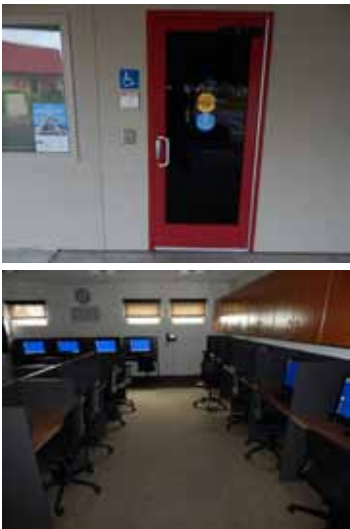
#	ITEM	PHOTO or DIAGRAM	MITIGATION MEASURE	PHASE
D3.02	<p>This Classroom is not compliant.</p> <ol style="list-style-type: none"> 1. The entry door requires more than 5 LBS. Of pressure to operate. 2. The interior of the classroom is compliant

<ol style="list-style-type: none"> 1. Adjust the door closer so that it requires less than 5LBS of pressure to operate. 2. None Required 	P2
