ADA Self Evaluation and Transition Plan

MiraCosta College, **Oceanside Campus**

Board Approved on 05-18-2017

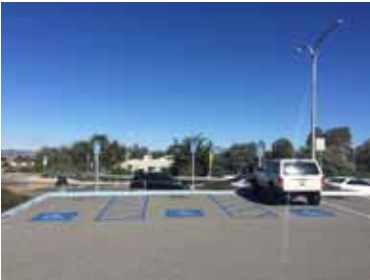
Parking Lot 3B					
Parking Resume:	Disabled Spaces Provided:	3	Van Provided:	0	The total number of disabled spaces is not compliant and requires 1 additional van space and 3 standard spaces.
Total Spaces: 183	Disabled Spaces Required:	6	Van Required:	1	
B1	<p>This parking spaces and the access aisles serving them are not compliant as follows:</p> <ol style="list-style-type: none"> 1. The required signage is not provided 2. The stall markings are faded and/or they do not meet the minimum requirements 3. The slope is greater than 2% (5.4%) 4. There is no wheelchair accessible POT connecting these spaces to the onsite POT

<ol style="list-style-type: none"> 1. Signage <ol style="list-style-type: none"> a. Mount all signage so that it is visible while a vehicle is parked in the stall. (80" high recommended) b. Add the "min fine of \$250" signage below the ISA sign c. For van accessible spaces include a separate "van accessible" sign below the other signage. (See Appendix A7 & A8) 2. Stall Markings <ol style="list-style-type: none"> a. Re-paint the access aisles, the perimeter stripping should be blue and the cross-hatching white include the "no parking" at the base of the aisle. A minimum width 8' for van accessible spaces and 5' for non-van accessible should be provided (See appendix A1 & A2.) b. The parking stall should have a minimum width of 9' and a minimum length of 18' 3. Repave the parking spaces and the access aisles so that the slope does not exceed 2% in any direction 4. Provide a wheelchair accessible POT connecting these spaces to the onsite POT that does not route disabled individuals behind other parked vehicles. 	P3

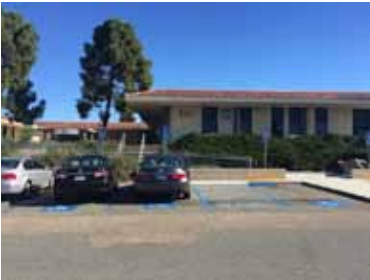
Parking Lot 3C					
Parking Resume:	Disabled Spaces Provided:	10	Van Provided:	1	The total number of disabled spaces is compliant. The total number of disabled spaces is not compliant and requires _ additional van spaces added.
Total Spaces: 159	Disabled Spaces Required:	6	Van Required:	2	
B2	<p>These parking spaces and the access aisles serving them are not compliant as follows:</p> <ol style="list-style-type: none"> 1. The required signage is not provided 2. The stall markings are faded and/or they do not meet the minimum requirements 3. One of the spaces does not have an access aisle provided

<ol style="list-style-type: none"> 1. Signage <ol style="list-style-type: none"> a. Mount all signage so that it is visible while a vehicle is parked in the stall. (80" high recommended) b. Add the "min fine of \$250" signage below the ISA sign c. For van accessible spaces include a separate "van accessible" sign, below the other signage. (See Appendix A7 & A8) 2. Stall Markings <ol style="list-style-type: none"> a. Re-paint the access aisles, the perimeter stripping should be blue and the cross-hatching white include the "no parking" at the base of the aisle. A minimum width 8' for van accessible spaces and 5' for non-van accessible should be provided (See appendix A1 & A2.) b. The parking stall should have a minimum width of 9' and a minimum length of 18' 3. Provide access aisles at each space (See appendix A1 & A2.) 	P3

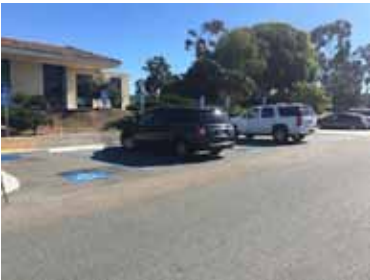
B3	<p>These parking spaces and the access aisles serving them are not compliant as follows:</p> <ol style="list-style-type: none"> 1. The required signage is not provided 2. The stall markings are faded and/or they do not meet the minimum requirements 3. The slope is greater than 2% (3.1%)

<ol style="list-style-type: none"> 1. Signage <ol style="list-style-type: none"> a. Mount all signage so that it is visible while a vehicle is parked in the stall. (80" high recommended) b. Add the "min fine of \$250" signage below the ISA sign c. For van accessible spaces include a separate "van accessible" sign, below the other signage. (See Appendix A7 & A8) 2. Stall Markings <ol style="list-style-type: none"> a. Re-paint the access aisles, the perimeter stripping should be blue and the cross-hatching white include the "no parking" at the base of the aisle. A minimum width 8' for van accessible spaces and 5' for non-van accessible should be provided (See appendix A1 & A2.) b. The parking stall should have a minimum width of 9' and a minimum length of 18' 3. Repave the parking spaces and the access aisles so that the slope does not exceed 2% in any direction 	P3

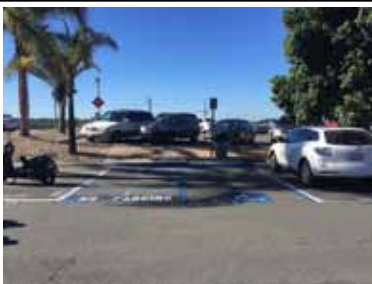
#	ITEM	PHOTO or DIAGRAM		MITIGATION MEASURE		SCHEDULE
B4	<p>This parking space and the access aisles are not compliant as follows:</p> <ol style="list-style-type: none">1. The required signage is not provided2. The stall markings are faded and/or they do not meet the minimum requirements3. The access aisles is not in the correct location4. The slope is greater than 2% (2.9%)

<ol style="list-style-type: none">1. Signage<ol style="list-style-type: none">a. Mount all signage so that it is visible while a vehicle is parked in the stall. (80" high recommended)b. Add the "min fine of \$250" signage below the ISA signc. For van accessible spaces include a separate "van accessible" sign, below the other signage. (See Appendix A7 & A8)2. Stall Markings<ol style="list-style-type: none">a. Re-paint the access aisles, the perimeter stripping should be blue and the cross-hatching white include the "no parking" at the base of the aisle. A minimum width 8' for van accessible spaces and 5' for non-van accessible should be provided (See appendix A1 & A2.)b. The parking stall should have a minimum width of 9' and a minimum length of 18'3. Relocate the access aisle on the right side of the parking stall (See appendix A1 & A2.)4. Repave the parking spaces and the access aisles so that the slope does not exceed 2% in any direction		P3

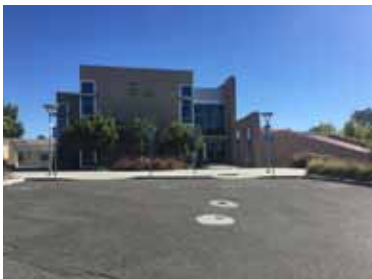
Parking Lot 2B						
Parking Resume:		Disabled Spaces Provided:	9	Van Provided:	1	The total number of disabled spaces is compliant. The total number of disabled spaces is not compliant and requires 1 additional van spaces and 3 standard spaces.
Total Spaces: 126		Disabled Spaces Required:	5	Van Required:	1	
B5	<p>These parking spaces and the access aisles serving them are not compliant as follows:</p> <ol style="list-style-type: none">1. The required signage is not provided2. The stall markings are faded and/or they do not meet the minimum requirements

<ol style="list-style-type: none">1. Signage<ol style="list-style-type: none">a. Mount all signage so that it is visible while a vehicle is parked in the stall. (80" high recommended)b. Add the "min fine of \$250" signage below the ISA signc. For van accessible spaces include a separate "van accessible" sign, below the other signage. (See Appendix A7 & A8)2. Stall Markings<ol style="list-style-type: none">a. Re-paint the access aisles, the perimeter stripping should be blue and the cross-hatching white include the "no parking" at the base of the aisle. A minimum width 8' for van accessible spaces and 5' for non-van accessible should be provided (See appendix A1 & A2.)b. The parking stall should have a minimum width of 9' and a minimum length of 18'		P3

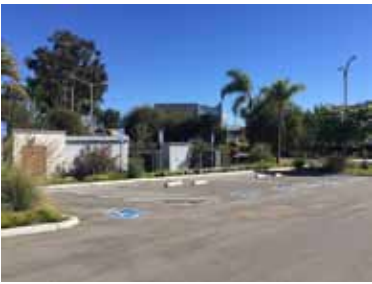
#	ITEM	PHOTO or DIAGRAM		MITIGATION MEASURE	SCHEDULE
B6	<p>These parking spaces and the access aisles serving them are not compliant as follows:</p> <p>1. The slope is greater than 2% (2.4%)</p>

1. Repave the parking spaces and the access aisle so that the slope does not exceed 2% in any direction	P3
Parking Lot 3A					
Parking Resume:		Disabled Spaces Provided:	0	Van Provided:	0
Total Spaces: 121		Disabled Spaces Required:	0	Van Required:	0
B7	This parking area does not have disabled parking

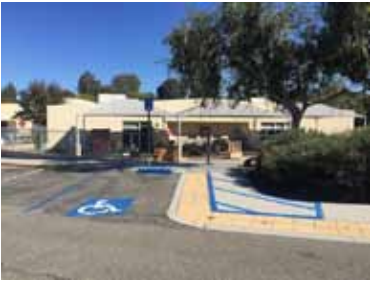
Parking Child Development Center					
Parking Resume:	Disabled Spaces Provided:	1	Van Provided:	1	The total number of disabled spaces is compliant.
Total Spaces: 11	Disabled Spaces Required:	1	Van Required:	1	
B8	<p>This parking space and the access aisle serving it is not compliant as follows:</p> <ol style="list-style-type: none"> 1. The required signage is not provided 2. The stall markings are faded and/or they do not meet the minimum requirements 3. The slope is greater than 2%

<ol style="list-style-type: none"> 1. Signage <ol style="list-style-type: none"> a. Mount all signage so that it is visible while a vehicle is parked in the stall. (80" high recommended) b. Add the "min fine of \$250" signage below the ISA sign c. For van accessible spaces include a separate "van accessible" sign, below the other signage. (See Appendix A7 & A8) 2. Stall Markings <ol style="list-style-type: none"> a. Re-paint the access aisle, the perimeter stripping should be blue and the cross-hatching white include the "no parking" at the base of the aisle. A minimum width 8' for van accessible spaces and 5' for non-van accessible should be provided (See appendix A1 & A2.) b. The parking stall should have a minimum width of 9' and a minimum length of 18' c. The access aisle should not protrude into the adjacent POT 3. Repave the parking spaces and the access aisle so that the slope does not exceed 2% in any direction 	P3

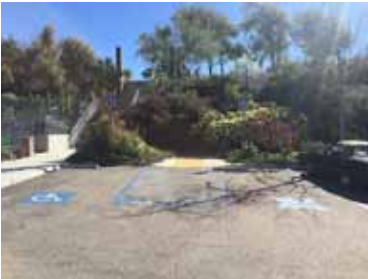
1. None required	N/A
Parking Lot 7A					
Parking Resume:	Disabled Spaces Provided:	3	Van Provided:	2	The total number of disabled spaces is compliant.
Total Spaces: 16	Disabled Spaces Required:	1	Van Required:	1	
B11	The parking spaces and the access aisle serving them are not compliant as follows: 1. The required signage is not provided 2. The stall markings are faded and/or they do not meet the minimum requirements 3. The slope is greater than 2% (2.9)

1. Signage <ul style="list-style-type: none"> a. Mount all signage so that it is visible while a vehicle is parked in the stall. (80" high recommended) b. Add the "min fine of \$250" signage below the ISA sign c. For van accessible spaces include a separate "van accessible" sign, below the other signage. (See Appendix A7 & A8) 2. Stall Markings <ul style="list-style-type: none"> a. Re-paint the access aisles, the perimeter stripping should be blue and the cross-hatching white include the "no parking" at the base of the aisle. A minimum width 8' for van accessible spaces and 5' for non-van accessible should be provided (See appendix A1 & A2.) b. The parking stall should have a minimum width of 9' and a minimum length of 18' 3. Repave the parking spaces and the access aisles so that the slope does not exceed 2% in any direction	P3

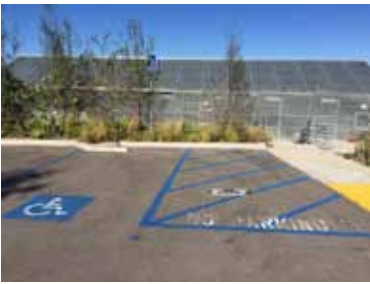
#	ITEM	PHOTO or DIAGRAM		MITIGATION MEASURE	SCHEDULE
B12	<p>This parking space and the access aisles serving them are not compliant as follows:</p> <ol style="list-style-type: none"> 1. The required signage is not provided 2. The stall markings are faded and/or they do not meet the minimum requirements 3. The slope is greater than 2% (2.5)

<ol style="list-style-type: none"> 1. Signage <ol style="list-style-type: none"> a. Mount all signage so that it is visible while a vehicle is parked in the stall. (80" high recommended) b. Add the "min fine of \$250" signage below the ISA sign c. For van accessible spaces include a separate "van accessible" sign, below the other signage. (See Appendix A7 & A8) 2. Stall Markings <ol style="list-style-type: none"> a. Re-paint the access aisles, the perimeter stripping should be blue and the cross-hatching white include the "no parking" at the base of the aisle. A minimum width 8' for van accessible spaces and 5' for non-van accessible should be provided (See appendix A1 & A2.) b. The parking stall should have a minimum width of 9' and a minimum length of 18' 3. Repave the parking spaces and the access aisles so that the slope does not exceed 2% in any direction 	P3

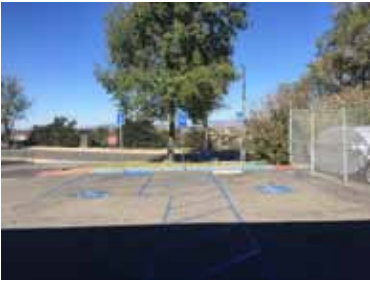
Parking Lot Biotech building					
Parking Resume:	Disabled Spaces Provided:	2	Van Provided:	1	The total number of disabled spaces is compliant.
Total Spaces: 34	Disabled Spaces Required:	2	Van Required:	1	
B13	<p>The parking spaces and the access aisles serving them are not compliant as follows:</p> <ol style="list-style-type: none"> 1. The required signage is not provided 2. The stall markings are faded and/or they do not meet the minimum requirements 3. The slope is greater than 2%

<ol style="list-style-type: none"> 1. Signage <ol style="list-style-type: none"> a. Mount all signage so that it is visible while a vehicle is parked in the stall. (80" high recommended) b. Add the "min fine of \$250" signage below the ISA sign c. For van accessible spaces include a separate "van accessible" sign, below the other signage. (See Appendix A7 & A8) 2. Stall Markings <ol style="list-style-type: none"> a. Re-paint the access aisles, the perimeter stripping should be blue and the cross-hatching white include the "no parking" at the base of the aisle. A minimum width 8' for van accessible spaces and 5' for non-van accessible should be provided (See appendix A1 & A2.) b. The parking stall should have a minimum width of 9' and a minimum length of 18' 3. Repave the parking spaces and the access aisles so that the slope does not exceed 2% in any direction 	P3

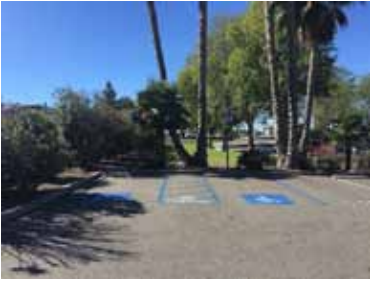
Parking Lot 4B						
Parking Resume:	Disabled Spaces Provided:	2	Van Provided:	0	The total number of disabled spaces is not compliant and requires 1 additional van space.	
Total Spaces: 8	Disabled Spaces Required:	1	Van Required:	1		
B14	<p>The parking spaces and the access aisles serving them are not compliant as follows:</p> <ol style="list-style-type: none"> 1. The required signage is not provided 2. The stall markings are faded and/or they do not meet the minimum requirements 3. The slope is greater than 2%

<ol style="list-style-type: none"> 1. Signage <ol style="list-style-type: none"> a. Mount all signage so that it is visible while a vehicle is parked in the stall. (80" high recommended) b. Add the "min fine of \$250" signage below the ISA sign c. For van accessible spaces include a separate "van accessible" sign, below the other signage. (See Appendix A7 & A8) 2. Stall Markings <ol style="list-style-type: none"> a. Re-paint the access aisles, the perimeter stripping should be blue and the cross-hatching white include the "no parking" at the base of the aisle. A minimum width 8' for van accessible spaces and 5' for non-van accessible should be provided (See appendix A1 & A2.) b. The parking stall should have a minimum width of 9' and a minimum length of 18' 3. Repave the parking spaces and the access aisles so that the slope does not exceed 2% in any direction 	P2

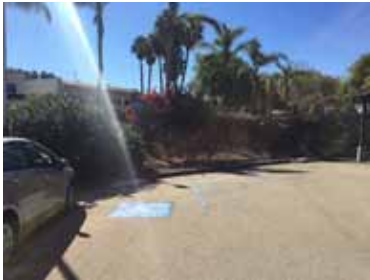
Parking Lot 4C					
Parking Resume:	Disabled Spaces Provided:	1	Van Provided:	0	The total number of disabled spaces is compliant. The total number of disabled spaces is not compliant and requires 2 additional van spaces and 5 standard spaces.
Total Spaces: 316	Disabled Spaces Required:	8	Van Required:	2	
B15	<p>The parking space and the access aisles serving them are not compliant as follows:</p> <ol style="list-style-type: none"> 1. The required signage is not provided 2. The stall markings are faded and/or they do not meet the minimum requirements 3. The slope is greater than 2% (3.1)

<ol style="list-style-type: none"> 1. Signage <ol style="list-style-type: none"> a. Mount all signage so that it is visible while a vehicle is parked in the stall. (80" high recommended) b. Add the "min fine of \$250" signage below the ISA sign c. For van accessible spaces include a separate "van accessible" sign, below the other signage. (See Appendix A7 & A8) 2. Stall Markings <ol style="list-style-type: none"> a. Re-paint the access aisles, the perimeter stripping should be blue and the cross-hatching white include the "no parking" at the base of the aisle. A minimum width 8' for van accessible spaces and 5' for non-van accessible should be provided (See appendix A1, A2 & A3.) b. The parking stall should have a minimum width of 9' and a minimum length of 18' 3. Repave the parking spaces and the access aisles so that the slope does not exceed 2% in any direction 	P1

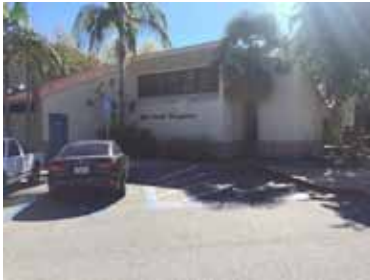
Parking Lot 4D					
Parking Resume:	Disabled Spaces Provided:	1	Van Provided:	1	The total number of disabled spaces is compliant.
Total Spaces: 9	Disabled Spaces Required:	1	Van Required:	1	
B16	<p>This parking space and the access aisle serving it is not compliant as follows:</p> <ol style="list-style-type: none"> 1. The required signage is not provided 2. The stall markings are faded and/or they do not meet the minimum requirements 3. The slope is greater than 2% (2.9) 4. The built up curb ramp protrudes into the parking space and does not have the required DWDs

<ol style="list-style-type: none"> 1. Signage <ol style="list-style-type: none"> a. Mount all signage so that it is visible while a vehicle is parked in the stall. (80" high recommended) b. Add the "min fine of \$250" signage below the ISA sign c. For van accessible spaces include a separate "van accessible" sign, below the other signage. (See Appendix A7 & A8) 2. Stall Markings <ol style="list-style-type: none"> a. Re-paint the access aisle, the perimeter stripping should be blue and the cross-hatching white include the "no parking" at the base of the aisle. A minimum width 8' for van accessible spaces and 5' for non-van accessible should be provided (See appendix A1 & A2) b. The parking stall should have a minimum width of 9' and a minimum length of 18' 3. Repave the parking spaces and the access aisle so that the slope does not exceed 2% in any direction 4. Curb ramp <ol style="list-style-type: none"> a. Replace the built up curb ramp with a curb cut curb ramp according to Appendix A.4 - A.6 b. Install a 36" deep band of DWD at the base of the curb ramp, extending the full width. (Appendix A13 & A14) 	P3

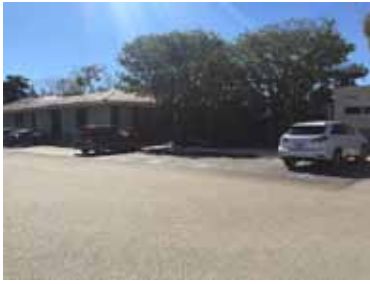
Parking Lot 4E						
Parking Resume:	Disabled Spaces Provided:	7	Van Provided:	1	The total number of disabled spaces is compliant.	
Total Spaces: 24	Disabled Spaces Required:	1	Van Required:	1		
B17	<p>The parking spaces and the access aisles serving them not compliant as follows:</p> <p>1. The stall markings do not meet the minimum requirements</p>

<p>Stall Markings</p> <p>a. Re-paint the access aisles, the perimeter stripping should be blue and the cross-hatching white include the "no parking" at the base of the aisle. A minimum width 8' for van accessible spaces and 5' for non-van accessible should be provided (See appendix A1 & A2.)</p> <p>b. The parking stall should have a minimum width of 9' and a minimum length of 18'</p>	P2
Parking Lot 5A						
Parking Resume:	Disabled Spaces Provided:	4	Van Provided:	0	The total number of disabled spaces is not compliant and requires 1 additional van space and 1 standard space.

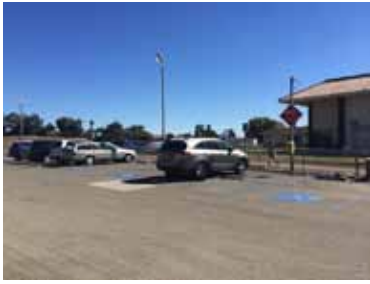
Total Spaces: 177	Disabled Spaces Required:	6	Van Required:	1		
B18	<p>The parking spaces and the access aisles serving them are not compliant as follows:</p> <p>1. The required signage is not provided</p> <p>2. The stall markings are faded and/or they do not meet the minimum requirements</p> <p>3. The slope is greater than 2% (2.4 - 3.3)</p>

<p>1. Signage</p> <p>a. Mount all signage so that it is visible while a vehicle is parked in the stall. (80" high recommended)</p> <p>b. Add the "min fine of \$250" signage below the ISA sign</p> <p>c. For van accessible spaces include a separate "van accessible" sign, below the other signage. (See Appendix A7 & A8)</p> <p>2. Stall Markings</p> <p>a. Re-paint the access aisles, the perimeter stripping should be blue and the cross-hatching white include the "no parking" at the base of the aisle. A minimum width 8' for van accessible spaces and 5' for non-van accessible should be provided (See appendix A1 & A2.)</p> <p>b. The parking stall should have a minimum width of 9' and a minimum length of 18'</p> <p>3. Repave the parking spaces and the access aisles so that the slope does not exceed 2% in any direction</p>	P1

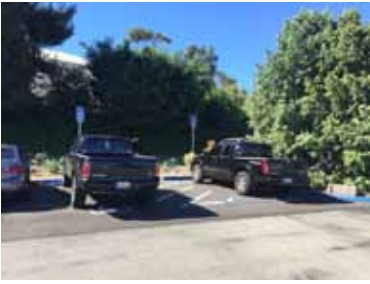
Parking Lot 1C					
Parking Resume:	Disabled Spaces Provided:	9	Van Provided:	3	The total number of disabled spaces is compliant.
Total Spaces: 77	Disabled Spaces Required:	4	Van Required:	1	
B19	These parking spaces are compliant

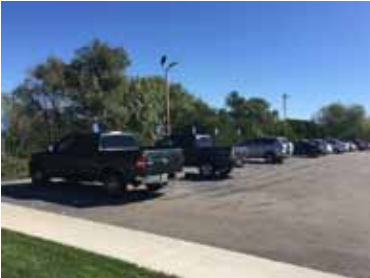
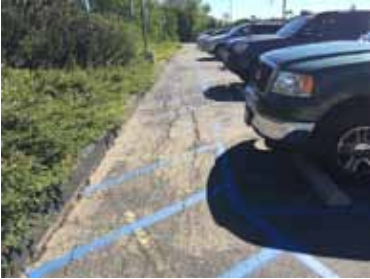
1. None required	N/A
B20	<p>The parking spaces and the access aisles serving them are not compliant as follows:</p> <ol style="list-style-type: none"> 1. The required signage is not provided 2. The stall markings are faded and/or they do not meet the minimum requirements 3. The slope is greater than 2% (3.9) 4. The POT serving these spaces have a cross slope greater than 2%

<ol style="list-style-type: none"> 1. Signage <ol style="list-style-type: none"> a. Mount all signage so that it is visible while a vehicle is parked in the stall. (80" high recommended) b. Add the "min fine of \$250" signage below the ISA sign c. For van accessible spaces include a separate "van accessible" sign, below the other signage. (See Appendix A7 & A8) 2. Stall Markings <ol style="list-style-type: none"> a. Re-paint the access aisles, the perimeter stripping should be blue and the cross-hatching white include the "no parking" at the base of the aisle. A minimum width 8' for van accessible spaces and 5' for non-van accessible should be provided (See appendix A1 & A2.) b. The parking stall should have a minimum width of 9' and a minimum length of 18' 3. Repave the parking spaces and the access aisles so that the slope does not exceed 2% in any direction 4. Repave the POT so that the slope does not exceed 2% in any direction 	P3

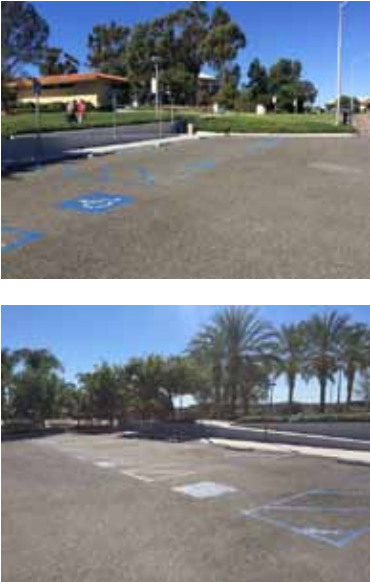
Parking Lot 1B					
Parking Resume:	Disabled Spaces Provided:	6	Van Provided:	1	The total number of disabled spaces is compliant.
Total Spaces: 115	Disabled Spaces Required:	5	Van Required:	1	
B21	<p>The parking spaces and the access aisles serving them are not compliant as follows:</p> <ol style="list-style-type: none"> 1. The required signage is not provided 2. The stall markings are faded and/or they do not meet the minimum requirements

<ol style="list-style-type: none"> 1. Signage <ol style="list-style-type: none"> a. Mount all signage so that it is visible while a vehicle is parked in the stall. (80" high recommended) b. Add the "min fine of \$250" signage below the ISA sign c. For van accessible spaces include a separate "van accessible" sign, below the other signage. (See Appendix A7 & A8) 2. Stall Markings <ol style="list-style-type: none"> a. Re-paint the access aisles, the perimeter stripping should be blue and the cross-hatching white include the "no parking" at the base of the aisle. A minimum width 8' for van accessible spaces and 5' for non-van accessible should be provided (See appendix A1 & A2.) b. The parking stall should have a minimum width of 9' and a minimum length of 18' 	P2

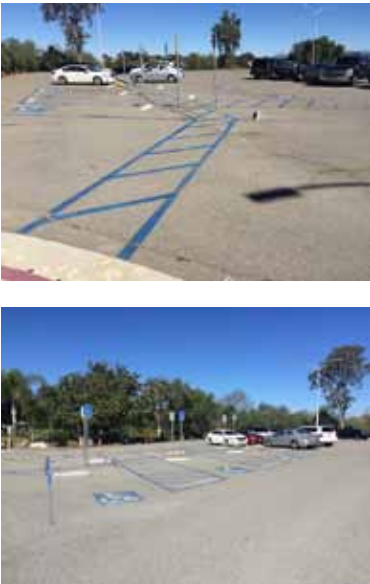
Parking Lot 1A					
Parking Resume:	Disabled Spaces Provided:	6	Van Provided:	6	The total number of disabled spaces is compliant.
Total Spaces: 171	Disabled Spaces Required:	6	Van Required:	1	
B22	<p>The parking spaces and the access aisles serving them are not compliant as follows:</p> <ol style="list-style-type: none"> 1. The required signage is not provided 2. The stall markings are faded and/or they do not meet the minimum requirements 3. The slope is greater than 2% (2.2 - 2.5) 4. The POT serving these spaces have a cross slope greater than 2%

<ol style="list-style-type: none"> 1. Signage <ol style="list-style-type: none"> a. Mount all signage so that it is visible while a vehicle is parked in the stall. (80" high recommended) b. Add the "min fine of \$250" signage below the ISA sign c. For van accessible spaces include a separate "van accessible" sign, below the other signage. (See Appendix A7 & A8) 2. Stall Markings <ol style="list-style-type: none"> a. Re-paint the access aisles, the perimeter stripping should be blue and the cross-hatching white include the "no parking" at the base of the aisle. A minimum width 8' for van accessible spaces and 5' for non-van accessible should be provided (See appendix A1 & A2) b. The parking stall should have a minimum width of 9' and a minimum length of 18' 3. Repave the parking spaces and the access aisles so that the slope does not exceed 2% in any direction 4. Repave the POT so that the slope does not exceed 2% in any direction 	P3

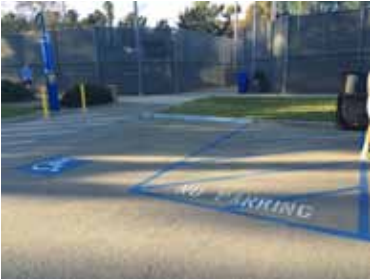
Parking Lot Tennis Courts					
Parking Resume:	Disabled Spaces Provided:	1	Van Provided:	1	The total number of disabled spaces is not compliant and requires 1 additional standard space.
Total Spaces: 34	Disabled Spaces Required:	2	Van Required:	1	
B24	<p>The parking spaces and the access aisles serving them are not compliant as follows:</p> <ol style="list-style-type: none"> 1. The required signage is not provided 2. The stall markings are faded and/or they do not meet the minimum requirements

<ol style="list-style-type: none"> 1. Signage <ol style="list-style-type: none"> a. Mount all signage so that it is visible while a vehicle is parked in the stall. (80" high recommended) b. Add the "min fine of \$250" signage below the ISA sign c. For van accessible spaces include a separate "van accessible" sign, below the other signage. (See Appendix A7 & A8) 2. Stall Markings <ol style="list-style-type: none"> a. Re-paint the access aisles, the perimeter stripping should be blue and the cross-hatching white include the "no parking" at the base of the aisle. A minimum width 8' for van accessible spaces and 5' for non-van accessible should be provided (See appendix A1 & A2.) b. The parking stall should have a minimum width of 9' and a minimum length of 18' 	P3

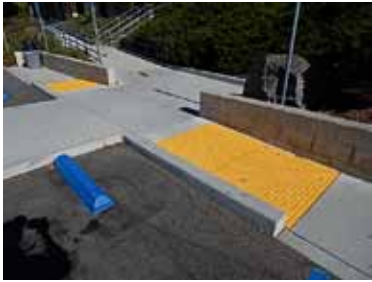
None required.	N/A
C5	These curb ramps are compliant in slope but too narrow in width at 45" and 47" respectively.

Reconstruct these ramps to provide a minimum of 48" clear width between the wall and the curb.	P3
C6	These stairs are compliant in configuration except as follows: 1. Contrasting colored warning stripes are not provided.

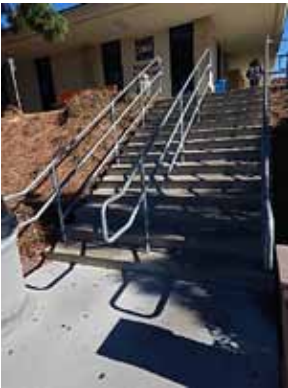
#	ITEM	PHOTO or DIAGRAM	MITIGATION MEASURE	SCHEDULE
C7	<p>These stairs are compliant in configuration except as follows:</p> <p>1. Contrasting colored warning stripes are not provided.</p>

<p>1. Provide contrasting colored warning stripes on each nosing of the stairs according to Appendix C .4</p>	P3
C8	<p>This drinking fountain is compliant. (Building 3000)</p>

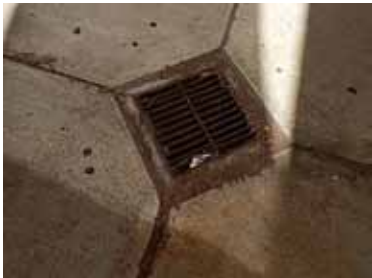
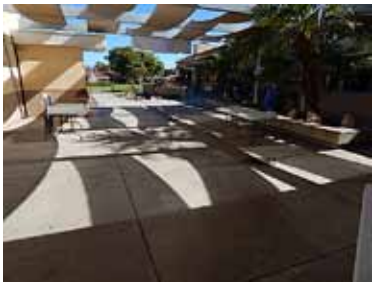
None required.	N/A
C11	The two area drains in the paving are not compliant. The openings are too wide at 1". (Building 3400, Northeast patio)

Replace the two area drain grates with compliant ones that do not have more than 1/2" wide openings.	P3
C12	This curb ramp and sidewalk area are not compliant as follows: 1. The cross slope in this area is too steep at 5.2%. 2. The curb ramp does not have DWD.

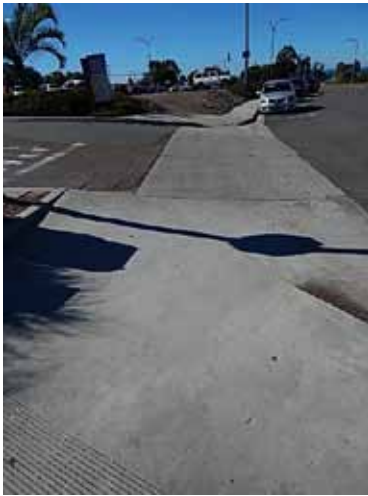
#	ITEM	PHOTO or DIAGRAM	MITIGATION MEASURE	SCHEDULE
C13	The cross slope at this street crossing is too steep at 8.7%

Reconstruct the street paving so that the crosswalk does not have a cross slope that exceeds 2%.	P3
C14	This curb ramp is not compliant as follows: 1. The cross slope at the curb ramp is too steep at 9.7%. 2. The curb ramp does not have DWD. 3. The landing at the top of the ramp is too narrow and not level.

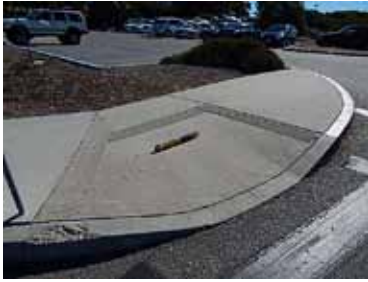
1. Reconstruct the curb ramp so that the cross slope in the direction of the POT does not exceed 2%. 2. Provide a 36" deep band of DWD at the bottom of the curb ramp. 3. Extend the paving beyond the top of the ramp a minimum of 48" and provide a level landing with 2% maximum slope in any direction.	P3
C15	This curb ramp is not compliant as follows: 1. The cross slope at the curb ramp is too steep at 6.0%. 2. The curb ramp does not have DWD. 3. The landing at the top of the ramp is too narrow and not level. 4. There is no accessible POT connecting the disabled parking spaces adjacent to this area to this walkway.

1. Reconstruct the curb ramp so that the cross slope in the direction of the POT does not exceed 2%. 2. Provide a 36" deep band of DWD at the bottom of the curb ramp. 3. Extend the paving beyond the top of the ramp a minimum of 48" and provide a level landing with 2% maximum slope in any direction. 4. Reconstruct the disabled parking and the paving in this area to provide a wheelchair compliant POT from the parking area to the walkway leading to the Student Center.	P3

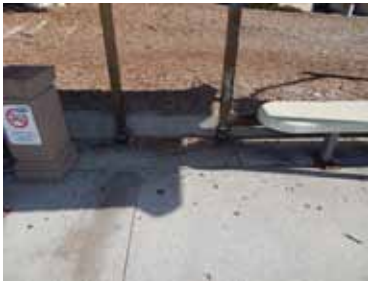
#	ITEM	PHOTO or DIAGRAM	MITIGATION MEASURE	SCHEDULE
C16	The slope in the direction of the POT in this area of the walkway is too steep at 7.3%.	[No photo provided, see site diagrams for location]	Because this is not a wheelchair entrance into the student union, a sign should be placed at the beginning of this walkway indicating it is not wheelchair accessible with a directional arrow to the right indicating the wheelchair access to this building.	P3
C17	This transit stop is not compliant. The wheelchair space next to the bench is not level with a cross slope of 4%.

Reconstruct the paving in this transit stop area to provide a wheelchair space 30" X 48" that has a slope in any direction not more than 2%.	P3
C18	These stairs are compliant in configuration except as follows: 1. Contrasting colored warning stripes are not provided.

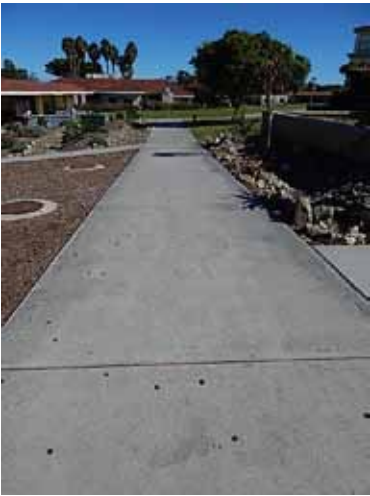
#	ITEM	PHOTO or DIAGRAM	MITIGATION MEASURE	SCHEDULE
C19	This portion of the walkway is too steep at 5.8% slope in the direction of travel.

Reconstruct this portion of the walkway so that the running slope does not exceed 5% at any location and a cross slope of 2% maximum.	P3
C20	There is no level landing at the intersection of this intervening walkway. The landing area is too steep at 5.8%.

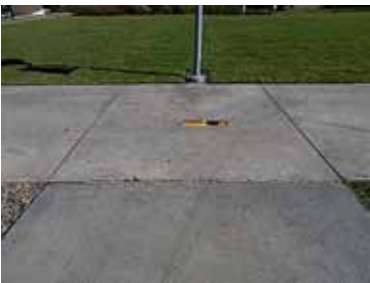
Reconstruct the landing at this intersection so that no portion exceeds 2% slope in any direction.	P3
C21	This portion of walkway is too steep 10.9%-12.7%	[No photo provided, see site diagrams for location]	Provide warning signs at the top and the bottom of this steep walkway indicating that it is not wheelchair accessible.	P3
C22	There is no level landing at the intersection of this intervening walkway. The landing area is too steep at 3.7%.

Reconstruct the landing at this intersection so that no portion exceeds 2% slope in any direction.	P3

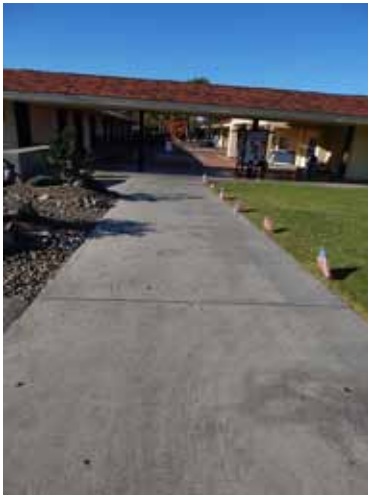
#	ITEM	PHOTO or DIAGRAM	MITIGATION MEASURE	SCHEDULE
C23	This portion of the walkway is too steep at 5.8% - 6.3% slope in the direction of travel.

Reconstruct this portion of the walkway so that the running slope does not exceed 5% at any location and a cross slope of 2% maximum.	P3
C24	This drinking fountain is compliant. (Classroom Building 3600)

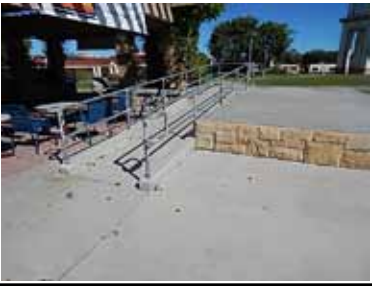
None required.	N/A
C27	This ramp up to the stage area is compliant. However, the edge of the stage platform does not have a contrasting colored warning stripe

Provide a 2" wide contrasting colored warning stripe at the edge of the stage platform.	P3
C28	This wheelchair ramp is compliant with a slope of 7.2% - 8.0%.

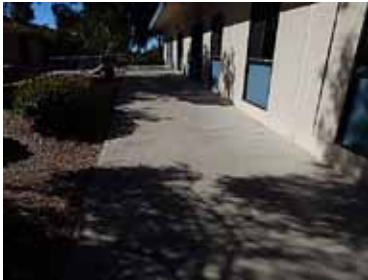
None required.	N/A
C30	This portion of the walkway in front of Building T300 is too steep at 5.8 % - 7.0%

Reconstruct this portion of the walkway that exceeds 5% slope in the direction of travel into a wheelchair ramp meeting the requirements of Appendix C.2 and C.3 or reduce the overall slope to 5% maximum.	P3
C31	This portion of the walkway in front of Building T300 is too steep at 9.9 % - 6.6%

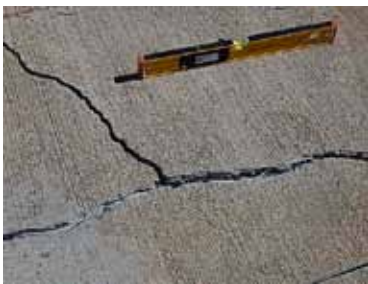
#	ITEM	PHOTO or DIAGRAM	MITIGATION MEASURE	SCHEDULE
C34	The surface of this wheelchair ramp is not compliant. There are numerous cracks and uneven surfaces.

Repair this and other areas of the ramp so that the surface is smooth without any abrupt change that exceeds 1/4"	P3
C35	The handrails at the bottom of this ramp are not compliant. They stop short and do not extend 12" beyond the bottom of the ramp.

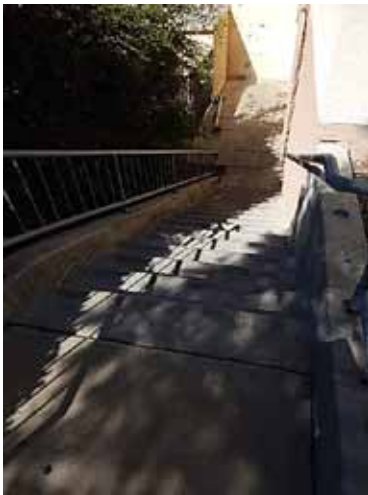
Reconfigure and extend the handrail so that they extend 12" beyond the bottom of the ramp as indicated in Appendix C.2	P3
C36	This stairway at Building 4000 is not compliant as follows: 1. The handrails are not configured correctly. 2. The nosing do not have contrasting colored warning stripes.

1. Replace the existing handrails with compliant handrails that meet the requirements of Appendix C.4 2. Provide contrasting color warning stripes at each nosing according to Appendix C.4	P3

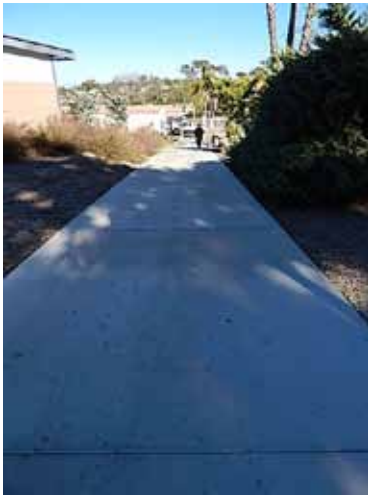
None required.	N/A
C38	This walkway adjacent to Building 4900 is not compliant. It is too steep for a walkway or a ramp with slopes between 7.2% - 11.6% with no landings.

Reconstruct the entire length of this walkway from the top to the bottom to meet all of the requirements of a ramp according to Appendix C.2, C.3, C.7	P3
C39	This portion of walkway near the end of Building 4500 is too steep with slopes of 6.5%-8.5% in the direction of travel.

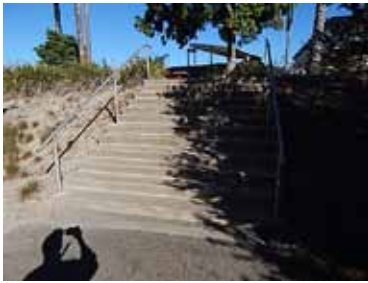
#	ITEM	PHOTO or DIAGRAM	MITIGATION MEASURE	SCHEDULE
C40	<p>This stairway down to the rear entrance of Building 4000 is not compliant as follows:</p> <ol style="list-style-type: none"> 1. The handrails are not configured correctly. 2. The nosing do not have contrasting colored warning stripes.

<ol style="list-style-type: none"> 1. Replace the existing handrails with compliant handrails that meet the requirements of Appendix C.4 2. Provide contrasting color warning stripes at each nosing according to Appendix C.4 	P3
C41	<p>This crosswalk is not compliant. It does not have curb ramps at each end.</p>

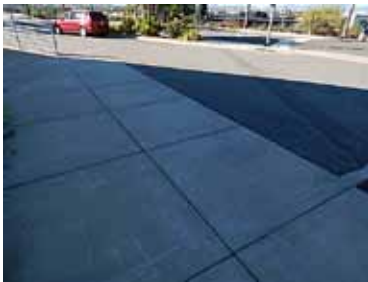
Provide curb ramps at each end of this crosswalk according to the requirements of Appendix A.4, A.5, A.6.	P3
C42	<p>This walkway leading to the north side of Building 4100 is not compliant. There is a flush transition between the walkway and the vehicular way.</p>

Provide a 36" deep band of DWD the full length of the flush condition according to Appendix A.13, A.14	P2

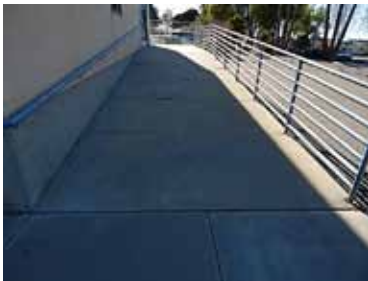
C43	<p>This ramp up to the rear entrance of Building 4100 is not compliant as follows:</p> <ol style="list-style-type: none"> 1. The slope of the ramp is too steep at 8.1%-9.6%. 2. There is no intermediate landing at 30" of vertical rise.

Reconstruct this ramp according to the requirements of Appendix C.2, C.3, C.7	P2

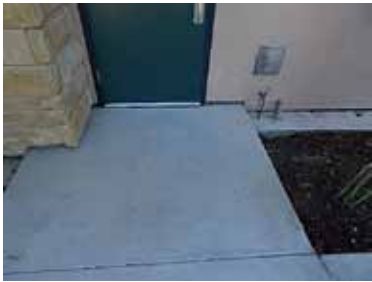
None required.	N/A
C45	This door into Building 1200 is not compliant. It does not have the required 24" pull-side clearance at the exterior.

Extend the concrete paving to a minimum of 24" beyond the strike edge of the door.	P3
C46	The stairway is compliant.

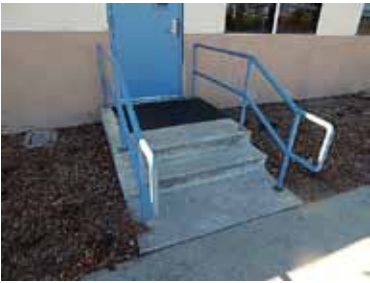
#	ITEM	PHOTO or DIAGRAM	MITIGATION MEASURE	SCHEDULE
C48	<p>This stairway at the end of Building T420 is not compliant as follows:</p> <ol style="list-style-type: none"> 1. The nosing do not have contrasting colored warning stripes.

<ol style="list-style-type: none"> 1. Provide contrasting color warning stripes at each nosing according to Appendix C.4 	P3
C49	<p>This stairway at the end of Building T410 is not compliant as follows:</p> <ol style="list-style-type: none"> 1. The nosing do not have contrasting colored warning stripes.

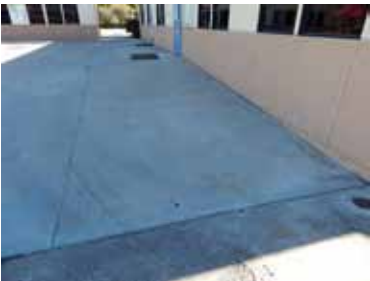
<ol style="list-style-type: none"> 1. Provide contrasting color warning stripes at each nosing according to Appendix C.4 	P3
C50	<p>The small portion of walkway at the northwest corner of Building T430 is too steep at 6.6%</p>

<p>Reconstruct this portion of the walkway so that the running slope does not exceed 5% in the direction of travel and a cross slope of 2% maximum.</p>	P3

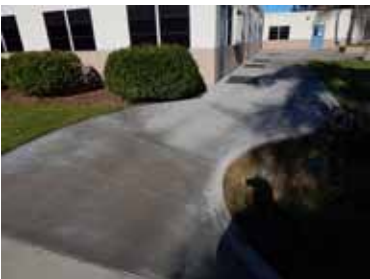
C51	<p>The small portion of walkway at the southeast corner of Building T410 is too steep at 6.6%</p>

<p>Reconstruct this portion of the walkway so that the running slope does not exceed 5% in the direction of travel and a cross slope of 2% maximum.</p>	P3

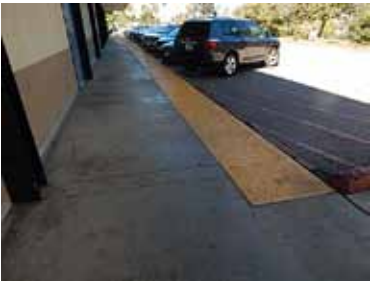
#	ITEM	PHOTO or DIAGRAM	MITIGATION MEASURE	SCHEDULE
C52	The cross slope of this walkway area is too steep at 2.5%

Reconstruct this portion of the walkway so that the cross slope does not exceed 2%	P3
C53	This drinking fountain is not compliant. It is wheelchair accessible but does not have dual height access.	 	Replace this unit with a dual height unit or provide an additional high unit and additional paving directly adjacent to the existing drinking fountain.	P3
C54	The small portion of walkway at the northeast corner of Building 4700 is too steep at 6.1%

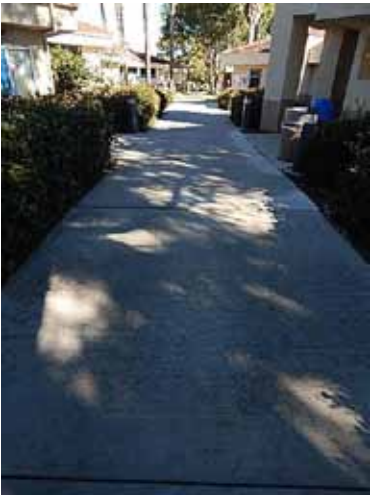
#	ITEM	PHOTO or DIAGRAM	MITIGATION MEASURE	SCHEDULE
C56	The walkway between Buildings 4600 and 4700 is not compliant. The cross slope is too steep at 3.2%-2.8%

Reconstruct this portion of the walkway so that the running slope does not exceed 5% in the direction of travel and a cross slope of 2% maximum.	P3
C57	The walkway 4600 is not compliant. The slope is too steep in the direction of travel at 6.0%

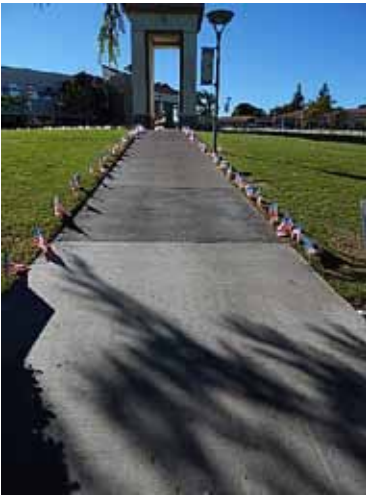
#	ITEM	PHOTO or DIAGRAM	MITIGATION MEASURE	SCHEDULE
C58	The walkway leading up from Building 4600 to the central tower is too steep at 6.1% - 8.5% and not compliant.

Reconstruct this portion of walkway into a wheelchair compliant ramp according to the requirements of Appendix C.2, C.3, C.7	P2
C59	The intersection of the two walkways does not have a level landing.

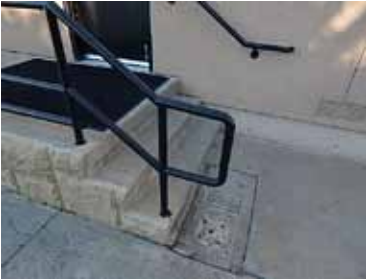
Reconstruct the landing at this intersection so that no portion exceeds 2% slope in any direction.	P3
C60	This stairway at the end of Building T100 is not compliant as follows: 1. The handrails are not configured correctly. 2. The nosing do not have contrasting colored warning stripes.

1. Replace the existing handrails with compliant handrails that meet the requirements of Appendix C.4 2. Provide contrasting color warning stripes at each nosing according to Appendix C.4	P2

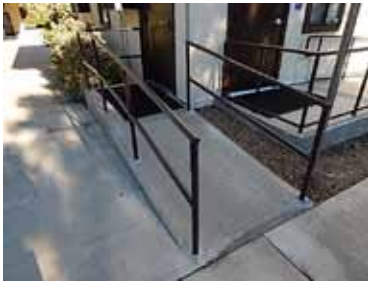
#	ITEM	PHOTO or DIAGRAM	MITIGATION MEASURE	SCHEDULE
C61	This wheelchair ramp at Building T110 is not compliant

Reconstruct this ramp so that it meets all of the requirements for the ramp and/or clearances as indicated in Appendix C.2, C.3, C.7, D.8	P2
C62	This wheelchair ramp at Building T100 is compliant.

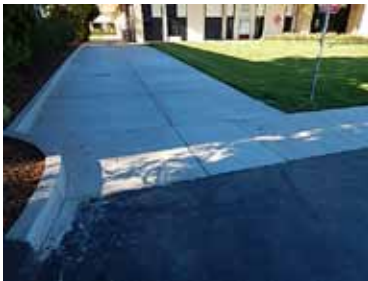
None required.	N/A
C64	There is a flush condition at the end of this walkway leading into the vehicular way.

Provide a 36" deep band of DWD at the end of this walkway adjacent to the vehicular way according to Appendix A.13, A.14	P2

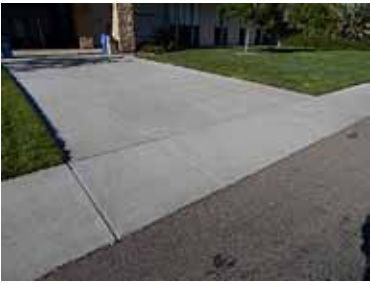
#	ITEM	PHOTO or DIAGRAM	MITIGATION MEASURE	SCHEDULE
C65	There is a flush condition at the end of this walkway leading into the vehicular way.

Provide a 36" deep band of DWD at the end of this walkway adjacent to the vehicular way according to Appendix A.13, A.14	P1
C66	<p>The POT from the accessible parking spaces in Lot 1C is not compliant as follows:</p> <ol style="list-style-type: none"> 1. There is a flush condition at the end of this walkway leading into the vehicular way. 2. The POT over the AC paving is too uneven and the cross-slope is too steep. 3. The transition for AC to concrete paving has an abrupt change in level.

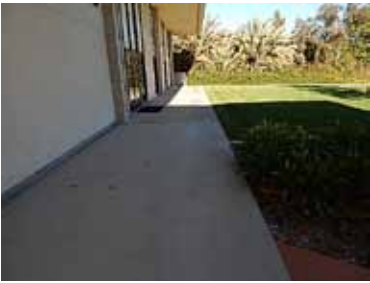
#	ITEM	PHOTO or DIAGRAM	MITIGATION MEASURE	SCHEDULE
C67	A portion of this walkway across the south side of Building 1000 is not compliant. The cross slope is too steep at 3%

Reconstruct this portion of the walkway so that the cross slope does not exceed 2%	P1
C68	The first portion of this walkway leading up the hill from the circular quad at the southwest corner of Building 1200 is too steep at 8.1% - 9.7%.

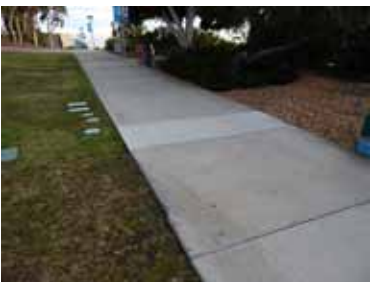
Reconstruct a portion of this walkway 48" wide minimum to meet the requirements of a wheelchair accessible ramp according to Appendix C.1, C.3, C.7	P3
C69	The first portion of this walkway leading up the hill from the ramp at the southwest corner of Building 3000 is too steep at 5.5% - 6.0%.

Reconstruct this walkway to meet the requirements of a wheelchair accessible ramp according to Appendix C.1, C.3, C.7	P3
C70	The landing at the top of the existing wheelchair ramp is not level at 2.5% in the direction of travel.

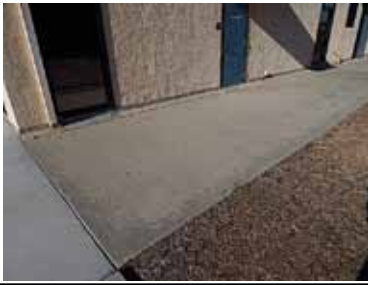
None required.	N/A
C72	This portion of walkway adjacent to Building 3000 is not compliant. The cross slope is too steep at 3.7%

Reconstruct this portion of the walkway so that cross slope of 2% maximum.	P2
C73	This curb ramp is not compliant. The slope and direction travel is too steep at 9.8%

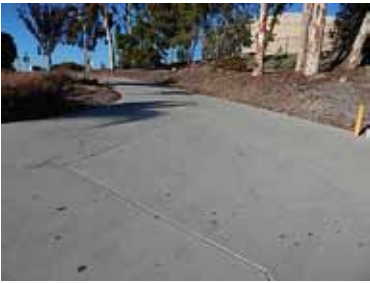
#	ITEM	PHOTO or DIAGRAM	MITIGATION MEASURE	SCHEDULE
C75	There is a large portion of this walkway that is too steep in the direction of travel at 8.3%

Reconstruct this walkway so that the running slope does not exceed 5% in the direction of travel at any location and a cross slope does not exceed 2%.	P3
C76	The two curb ramps at the disabled parking spaces in front of Building 2200 are not compliant as follows: 1. There are no DWD at the base of the ramp.

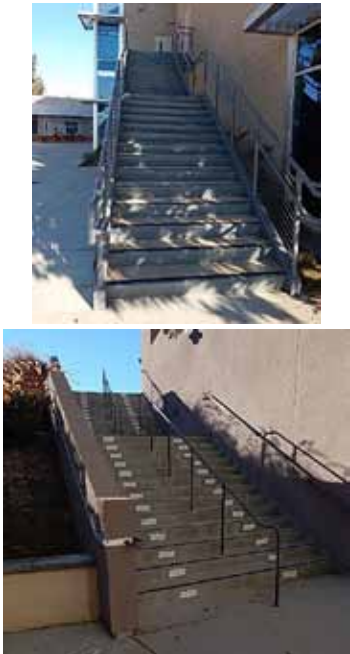
C77	These stairway are compliant.

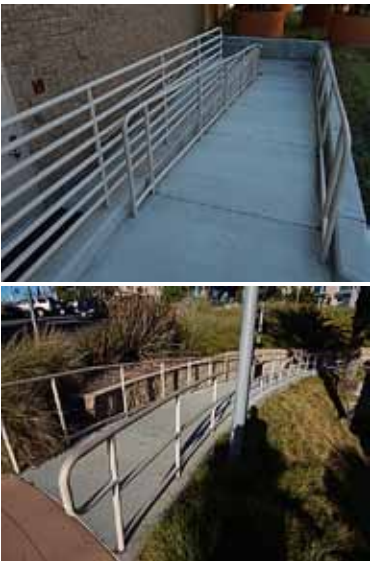
None required.	N/A
C78	These wheelchair ramps are compliant.

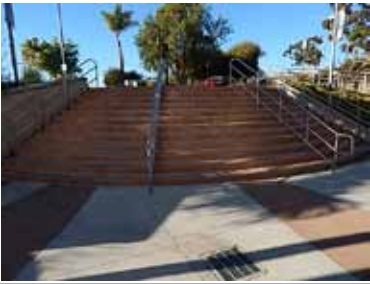
#	ITEM	PHOTO or DIAGRAM	MITIGATION MEASURE	SCHEDULE
C79	This stairway is compliant.

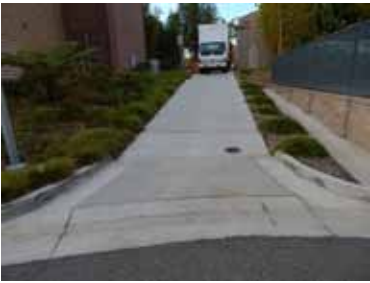
None required.	N/A
C80	This portion of the walkway is too steep at 12.9% slope in the direction of travel.

Because this walkway is not required as an accessible path to travel, a sign should be located at the top and bottom indicating this walkway is not recommended for wheelchair use.	P3
C81	There is a portion of this walkway that is too steep in the direction of travel at 6.1%

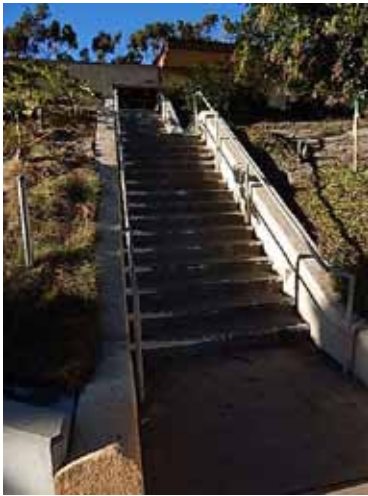
#	ITEM	PHOTO or DIAGRAM	MITIGATION MEASURE	SCHEDULE
C82	<p>This stairway Leading up from building 2000 to building 2100 is not compliant as follows:</p> <ol style="list-style-type: none"> 1. The nosing do not have contrasting colored warning stripes.

<ol style="list-style-type: none"> 1. Provide contrasting color warning stripes at each nosing according to Appendix C.4 	P3
C83	<p>This portion of walkway is not compliant as follows:</p> <ol style="list-style-type: none"> 1. It is too steep at 9.8% 2. There are no DWD where it abuts the vehicular way in parking lot 1B.

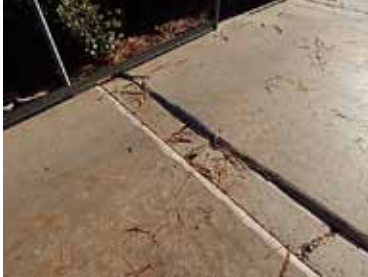
<ol style="list-style-type: none"> 1. Place a warning sign at the top and bottom of this walkway clearly indicating that it is not wheelchair accessible. 2. Provide a 36" deep band of DWD at the end of this walkway adjacent to the vehicular way according to Appendix A.13, A.14 	P2
C84	<p>The surface of this ramp adjacent to Building 2100 is on even and has an abrupt change in level greater than 1/4"</p>

<p>Repair this and other areas of the ramp so that the surface is smooth without any abrupt change that exceeds 1/4"</p>	P3

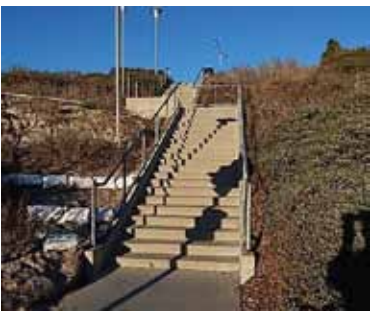
#	ITEM	PHOTO or DIAGRAM	MITIGATION MEASURE	SCHEDULE
C88	<p>This stairway leading up from parking lot 3A is not compliant as follows:</p> <ol style="list-style-type: none"> 1. The handrails are not configured correctly. 2. The nosing do not have contrasting colored warning stripes.

<ol style="list-style-type: none"> 1. Replace the existing handrails with compliant handrails that meet the requirements of Appendix C.4 2. Provide contrasting color warning stripes at each nosing according to Appendix C.4 	P3
C89	<p>This portion of the walkway has a large gap in the paving.</p>

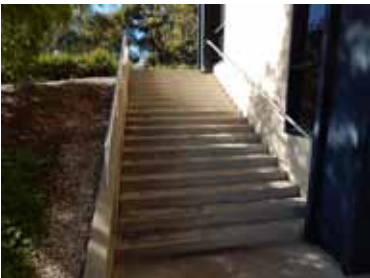
<p>Reconstruct this portion of the paving so that no change in level exceeds 1/4".</p>	P1
C90	<p>This stairway is not compliant as follows:</p> <ol style="list-style-type: none"> 1. The handrails are not configured correctly. 2. Contrasting color warning stripes are not provided.

<ol style="list-style-type: none"> 1. Reconstruct or replace the existing handrails to meet the configuration requirements indicated in Appendix C.4. 2. Provide contrasting color warnings stripes at each nosing according to the requirements indicated in Appendix C.4 	P1

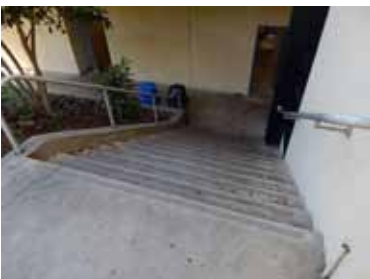
C91	<p>This stairway is not compliant as follows:</p> <ol style="list-style-type: none"> 1. The handrails are not configured correctly. 2. Contrasting color warning stripes are not provided.

<ol style="list-style-type: none"> 1. Reconstruct or replace the existing handrails to meet the configuration requirements indicated in Appendix C.4. 2. Provide contrasting color warnings stripes at each nosing according to the requirements indicated in Appendix C.4 	P1

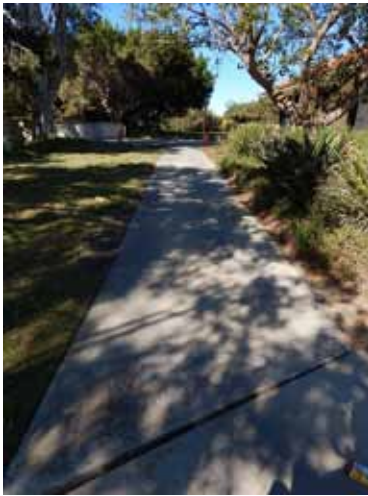
#	ITEM	PHOTO or DIAGRAM	MITIGATION MEASURE	SCHEDULE
C92	This portion of the wheelchair POT to the lower level of the gymnasium is compliant.

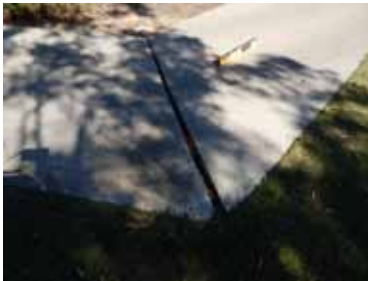
None required.	N/A
C93	This portion of the walkway has a large gap in the paving.

Reconstruct this portion of the paving so that no change in level exceeds 1/4".	P1
C94	This portion of the walkway which is the wheelchair POT is too steep at 6.1%

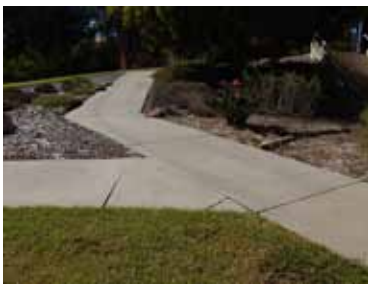
#	ITEM	PHOTO or DIAGRAM	MITIGATION MEASURE	SCHEDULE
C95	There is no level landing at the intersection of these two walkways

Reconstruct these walkways so that the intersection provides a level landing that does not exceed 2% in any direction.	P1
C96	This portion of the walkway on the east side of the gymnasium is not compliant. The cross slope is too steep at 4.8%-6.4%

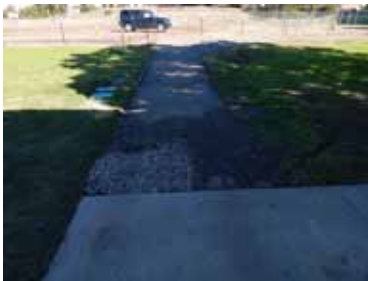
Reconstruct any portion of this walkway with the cross slope that exceeds 2% so that the new paving is level and does not exceed 2% cross slope.	P1
C97	This portion of the POT from the locker room to the sports field area is not compliant.

Provide a solid paving area 48" wide minimum with a 2% maximum cross slope and a 5% maximum slope in the direction of travel.	P1
C98	This portion of the POT from the locker room to the sports field area is not compliant.

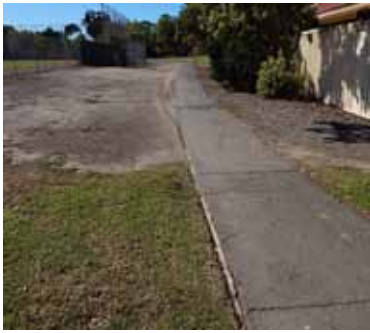
#	ITEM	PHOTO or DIAGRAM	MITIGATION MEASURE	SCHEDULE
C99	This portion of the POT from the locker room to the sports field area is not compliant.

Provide a solid paving area 48" wide minimum with a 2% maximum cross slope and a 5% maximum slope in the direction of travel.	P1
C100	This portion of the POT from the locker room to the sports field area is not compliant.

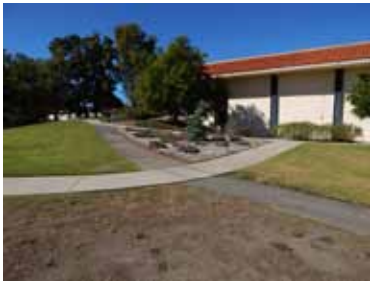
C102	The POT from the gymnasium to the tennis courts is not compliant in cross-slope and slope in the direction of travel.

Provide an accessible wheelchair POT from the gymnasium to the tennis courts.	P1

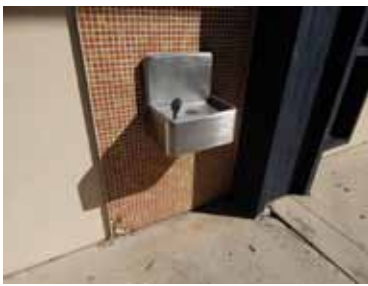
#	ITEM	PHOTO or DIAGRAM	MITIGATION MEASURE	SCHEDULE
C103	The single drinking fountain unit is not compliant.

Replace the single unit with a dual height unit that meets all of the accessibility requirements.	P1
C104	This wall-mounted air-conditioning unit is mounted to low and produces an overhanging hazard to the visually impaired.

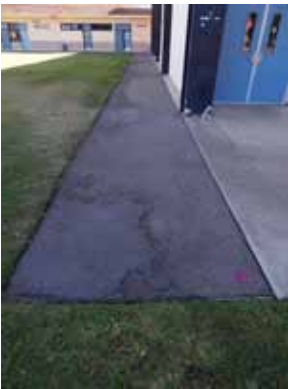
Provide a guard rail around the base of this unit mirroring the footprint of this unit with railings at 4" & 30" high.	P1
C105	The transition between the asphalt paving and the concrete walkway produces an abrupt change in level.

Grind down or build up this paving area so that there is no abrupt change in level that exceeds 1/4".	P1

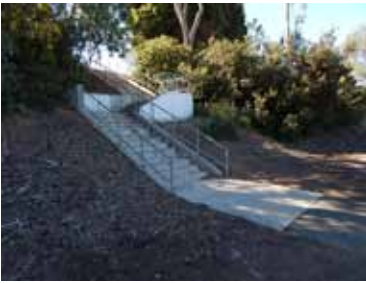
<ol style="list-style-type: none"> 1. Provide a clearly marked about the travel from the gymnasium to the top of the stairway separated from vehicular traffic as much as possible. 2. Provide a wheelchair compliant POT from the gymnasium to the football field. Equivalent facilitation could be achieved if compliant disabled parking was provided at the field level. 	P1
C107	<p>This exterior stairway is not compliant as follows:</p> <ol style="list-style-type: none"> 1. The handrails are not configured properly with the required horizontal extensions at the top and bottom. 1. Contrasting colored warning stripes are not provided on each nosing.

<ol style="list-style-type: none"> 1. Replace or modify the existing handrails so that they comply with the requirements as indicated in Appendix C.4 2. Provide contrasting color warning stripes at each nosing according to Appendix C.4 	P1

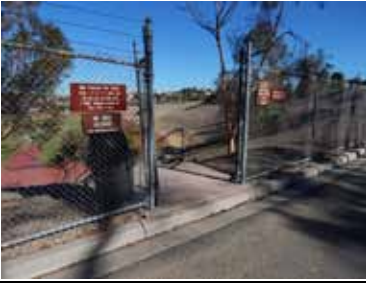
C108	<p>The pedestrian crossing at the vehicular way between the upper and lower stairway leading to the football field is not compliant. The pedestrian crossing is not clearly marked.</p>

Clearly mark the pedestrian crossing with white lines on either side 3" wide.	P1
C109	<p>This exterior stairway is not compliant as follows:</p> <ol style="list-style-type: none"> 1. The handrails are not configured properly with the required horizontal extensions at the top and bottom. 1. Contrasting colored warning stripes are not provided on each nosing.
