ADA Self Evaluation and Transition Plan

MiraCosta College, **Oceanside Campus**

Board Approved on 05-18-2017

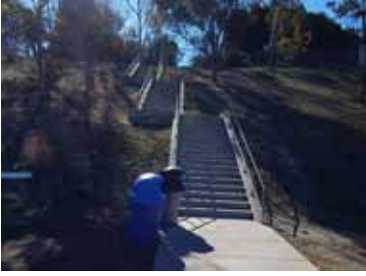
Clearly mark the pedestrian crossing with white lines on either side 3" wide.	P1
C109	<p>This exterior stairway is not compliant as follows:</p> <ol style="list-style-type: none"> 1. The handrails are not configured properly with the required horizontal extensions at the top and bottom. 1. Contrasting colored warning stripes are not provided on each nosing.

<ol style="list-style-type: none"> 1. Replace or modify the existing handrails so that they comply with the requirements as indicated in Appendix C.4 2. Provide contrasting color warning stripes at each nosing according to Appendix C.4 	P1

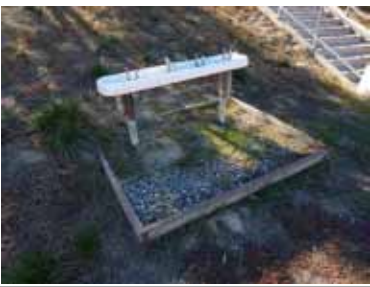
#	ITEM	PHOTO or DIAGRAM	MITIGATION MEASURE	SCHEDULE
C110	<p>The drinking fountain at the field level is not compliant as follows.</p> <ol style="list-style-type: none"> 1. There is no compliant POT to the drinking fountain. 2. The drinking fountain does not have a high and low unit.

<ol style="list-style-type: none"> 1. Provide a wheelchair compliant accessible POT to the drinking fountain area. 2. Provide a compliant high low drinking fountain at this location. 	P1
C111	There is no wheelchair designated seating at the teams seating area on the field

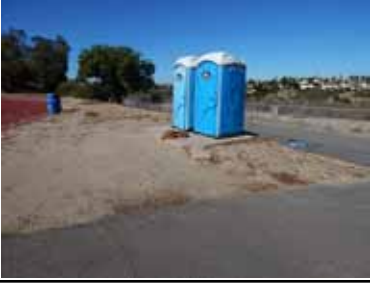
Provide a wheelchair designated space directly adjacent to the team seating bench 30" X 48" in size with a 48" minimum POT to the area.	P1
C112	<p>The portable toilets at the field level are not compliant as follows:</p> <ol style="list-style-type: none"> 1. There is no POT to the area. 2. None of the units area wheelchair accessible.

<ol style="list-style-type: none"> 1. Provide a compliant wheelchair POT to the area. 2. Provide one wheelchair accessible unit. 	P1

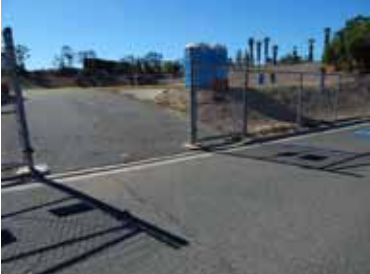
C113	<p>The POT from the disabled parking to the field level is not compliant as follows:</p> <ol style="list-style-type: none"> 1. The POT is not clearly designated. 2. The POT is too steep. 3. The POT is routed along a dangerous vehicular way.

<ol style="list-style-type: none"> 1. The disabled parking should be relocated up on the same level as the football field. 2. The disabled parking should be relocated up on the same level as the football field. 3. The disabled parking should be relocated up on the same level as the football field. 	P1

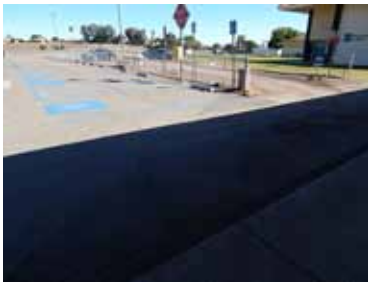
<ol style="list-style-type: none"> 1. The disabled parking should be relocated up on the same level as the football field. 2. The disabled parking should be relocated up on the same level as the football field. 	P1
C115	<p>There is no compliant accessible POT from the disabled parking in parking lot 5A to the walkway around Building 5100.</p>

<p>Provide a compliant accessible POT along the front of each of the disabled parking spaces directly to the walkway around building 5100. This compliant POT must be a minimum of 48" wide with a maximum cross slope of 2%.</p>	P1

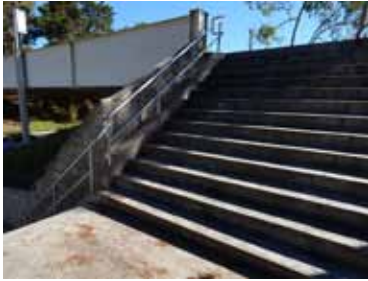
C116	<p>This exterior stairway is not compliant as follows:</p> <ol style="list-style-type: none"> 1. Contrasting colored warning stripes are not provided.

<ol style="list-style-type: none"> 1. Provide contrasting color warning stripes at each nosing according to Appendix C.4 	P1
C117	<p>This exterior stairway is not compliant as follows:</p> <ol style="list-style-type: none"> 1. Contrasting colored warning stripes are not provided.

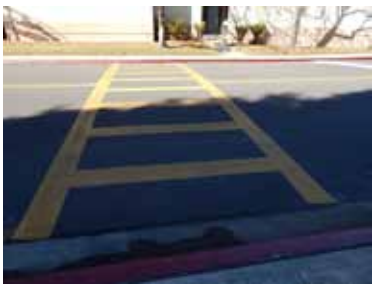
#	ITEM	PHOTO or DIAGRAM	MITIGATION MEASURE	SCHEDULE
C118	The pedestrian crossing at this location is not compliant. There are no curb ramps.

Provide compliant curb ramps at each end of this pedestrian crossing according to Appendix A.5.	P2
C119	The stairway is not compliant as follows: 1. There are no handrails provided. 2. There are no contrasting colored warning stripes on the nosing.

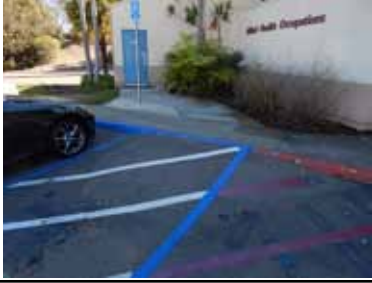
1. Provide compliant handrails on both sides of the stairs according to Appendix C.4 2. Provide contrasting colored warnings stripes on each nosing according to Appendix C.4	P2
C120	The curb ramp at the disabled parking space projects into the access aisle and is noncompliant.

Replace the built-up curb ramp in the access aisle with a compliant curb ramp according to Appendix A.4 - A.6	P2
C121	The angular section of walkway surrounding the sign pole is too steep for a compliant POT.

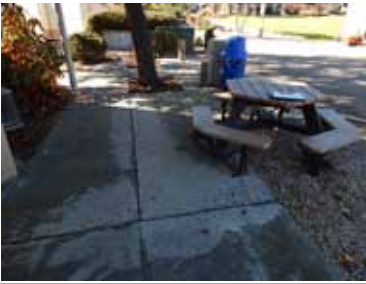
#	ITEM	PHOTO or DIAGRAM	MITIGATION MEASURE	SCHEDULE
C122	The picnic table does not have wheelchair accessible seating.

Modify or replace the table so that one seating space is wheelchair accessible and provides compliant knee clearance according to Appendix B.1	P2
C123	There is a flush condition between the pedestrian walkway and the vehicular drop-off.

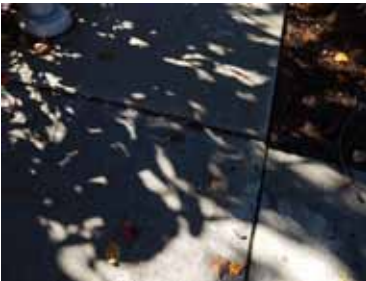
Provide a 36" deep band of DWD at the edge of the flush condition between the walkway and the vehicular way.	P2
C124	There is a 1" high abrupt change in walkway the paving adjacent to the tree well that is noncompliant

Modify or replace this section of paving so that there is no abrupt change in level that exceeds 1/4".	P2

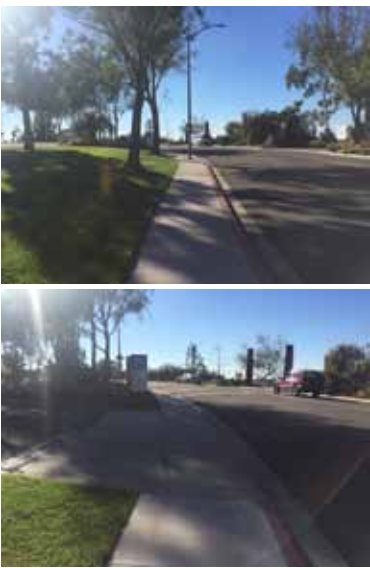
#	ITEM	PHOTO or DIAGRAM	MITIGATION MEASURE	SCHEDULE
C125	<p>The POT along the northern drive, leading from the accessible route adjacent to the Bio tech facility, to the POT serving building 17 is not compliant.</p> <ol style="list-style-type: none"> The cross slope exceeds 2% (2.8 - 3.7%) The crossing at the drive at parking lot 3E has: <ol style="list-style-type: none"> A flush transition at the drive that does not have DWDs The cross slope crossing the drive exceeds 2%

<ol style="list-style-type: none"> Repair any portion of the POT so that the running slope does not exceed 5% and the cross slope does not exceed 2%. <i>Reference the site diagram for the non compliant portions of the POT.</i> Crossing <ol style="list-style-type: none"> Install a 36" deep band of DWD at the flush transition, extending the full width. (<i>Appendix A.13 & 14</i>) Construct an apron at the drive, maintaining a 48" width with a cross slope less than 2% 	P3

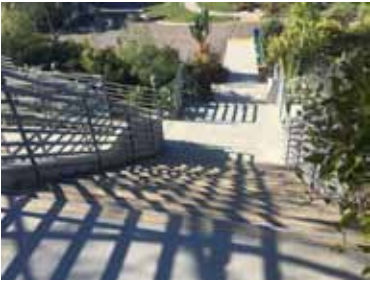
C126	<p>These stairs are compliant in configuration except as follows:</p> <ol style="list-style-type: none"> Contrasting colored warning stripes are not provided.

<ol style="list-style-type: none"> Provide contrasting colored warning stripes on each nosing of the stairs according to Appendix C .4 	P3
C127	<p>The ramp leading from the upper POT to the horticulture building is not compliant.</p> <ol style="list-style-type: none"> The handrails are too narrow at 46" and do not provide the required width of 48" min. There are no wheel guides provided

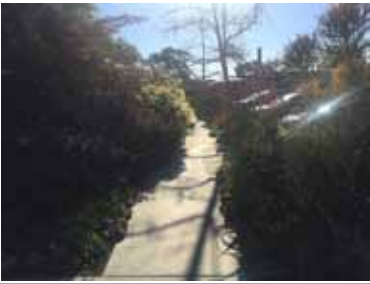
#	ITEM	PHOTO or DIAGRAM	MITIGATION MEASURE	SCHEDULE
C128	The POT serving the horticulture building's upper parking area is not compliant. The landscaping has not been maintained.

Maintain the landscaping so the 48" width min is maintained.	P3
C129	The flush transition at the horticulture building's upper parking area is not compliant there are no DWDs provided

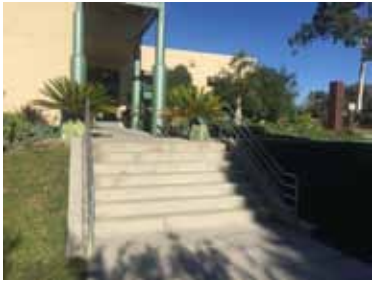
None required	N/A
C132	These stairs are compliant in configuration except as follows: 1. Contrasting colored warning stripes are not provided.

1. Provide contrasting colored warning stripes on each nosing of the stairs according to Appendix C .4	P3
C133	The outdoor dining area is not compliant. There is no wheelchair accessible POT provided

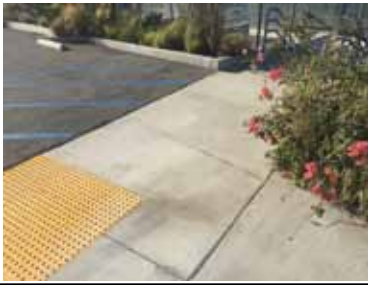
None required	N/A
C135	The DWDs provided at the lower parking area of the horticulture building are not compliant. The DWDs do not extend the full width of the flush transition.

Install a 36" deep band of DWD at the flush transition, extending the full width. (Appendix A.13 & 14)	P3
C136	These stairs are compliant in configuration except as follows: 1. Contrasting colored warning stripes are not provided.

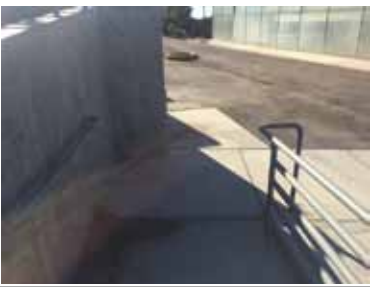
#	ITEM	PHOTO or DIAGRAM	MITIGATION MEASURE	SCHEDULE
C138	The flush transition into the vehicular way at the base of this curb ramp is not compliant. There are no DWDs provided

Install a 36" deep band of DWD at the flush transition, extending the full width. (Appendix A.13 & 14)	P3
C139	There is no wheel chair accessible POT leading from the upper green house to the lower.

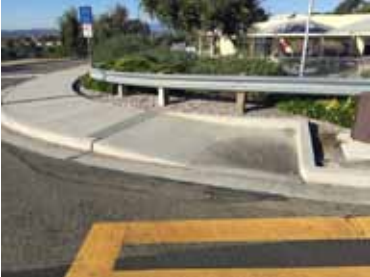
Provide a wheel chair accessible POT leading to the lower greenhouse.	P3
C140	This curb ramp is not compliant as follows: 1. The curb ramp does not have DWD.

Provide a 36" deep band of DWD at the bottom of the curb ramp.	P3

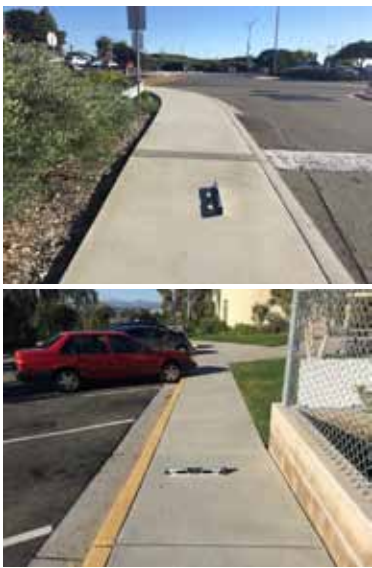
#	ITEM	PHOTO or DIAGRAM	MITIGATION MEASURE	SCHEDULE
C141	This portion of the walkway in front of the Child Development Center is too steep at 8% and has a cross slope exceeding 2%

Reconstruct this portion of the walkway into a wheelchair ramp meeting the requirements of Appendix C.2 and C.3 or reduce the overall slope to 5% maximum with a cross slope less than 2%.	P3
C142	The POT leading to the front entrance of the Child Development Center is compliant

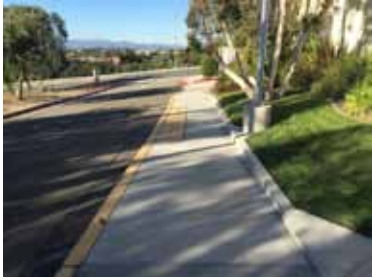
None required.	N/A
C143	This loading zone at the Child Development Center is not compliant. There is a flush transition between the walkway and the vehicular way and the DWDs provided do not have the correct dimensions.

Provide a 36" deep band of DWD the full length of the flush condition according to Appendix A.13, A.14	P3

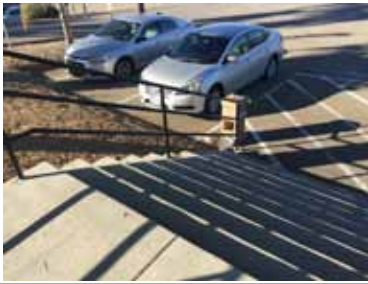
#	ITEM	PHOTO or DIAGRAM	MITIGATION MEASURE	SCHEDULE
C144	<p>This stairway at Lot 4C is not compliant as follows:</p> <ol style="list-style-type: none"> 1. The handrails are not configured correctly. 2. The nosing do not have contrasting colored warning stripes.

<ol style="list-style-type: none"> 1. Replace the existing handrails with compliant handrails that meet the requirements of Appendix C.4 2. Provide contrasting color warning stripes at each nosing according to Appendix C.4 	P3
C145	<p>The upper POT leading from the athletic department to the tennis courts is not compliant as follows:</p> <ol style="list-style-type: none"> 1. The required handrails are not Provided at the stairs 2. The nosing of the stairs do not have contrasting colored warning stripes. 3. There is no wheelchair accessible POT

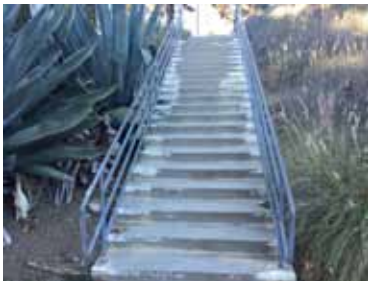
C146	<p>The lower stairway at the tennis court is not compliant as follows:</p> <ol style="list-style-type: none"> 1. The handrails are not configured correctly. 2. The nosing/nosing do not have contrasting colored warning stripes.

<ol style="list-style-type: none"> 1. Replace the existing handrails with compliant handrails that meet the requirements of Appendix C.4 2. Provide contrasting color warning stripes at each nosing according to Appendix C.4 	P3

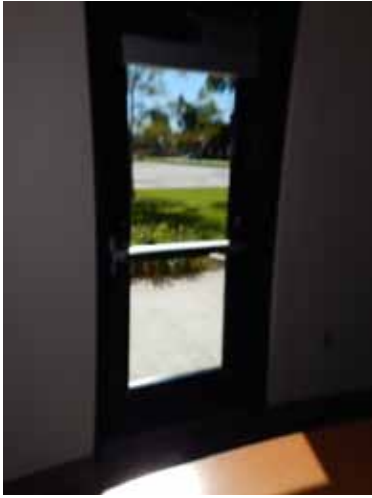
None required.	N/A
D1.2	The exit doors in this facility are not compliant. They do not have the required tactile exit signage.

Provide tactile exit signage at each exit door in this facility mounted on the latch side of the door at 60" AFF according to the requirements of Appendix D.8	P1
D1.3	The transaction counter at the reception desk is compliant.

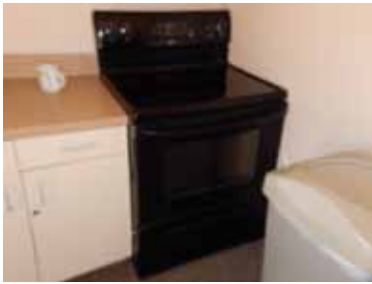
#	ITEM	PHOTO or DIAGRAM	MITIGATION MEASURE	SCHEDULE
D1.4	<p>The open range in the break room/lounge adjacent to the Board Room is not compliant as follows:</p> <ol style="list-style-type: none"> 1. It is mounted too close to the sidewall. 2. The controls require reaching over a hot surface and the controls are out of the compliant reach range

<ol style="list-style-type: none"> 1. Relocate the oven/range so that the centerline is at least 24" from the sidewall. 2. Replace the oven/range with a type that has front controls. 	P1
D1.5	<p>The Board Room is compliant except as follows:</p> <ol style="list-style-type: none"> 1. There is no indication that assistive listening devices are provided in this room.

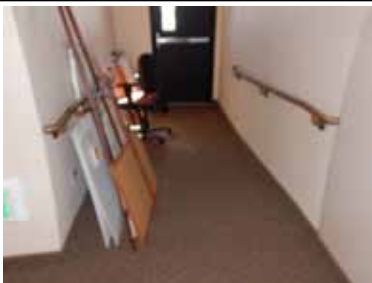
D1.6	<p>The wheelchair ramp down to the exit door from the dais platform is compliant except as follows:</p> <ol style="list-style-type: none"> 1. Furniture and other items are being stored on the ramp obscuring one handrail and reducing the minimum clear width required.

<ol style="list-style-type: none"> 1. Remove all items stored on this ramp and keep it clear in the future. 	P1
D1.7	<p>The tactile room number signage in this facility is compliant.</p>

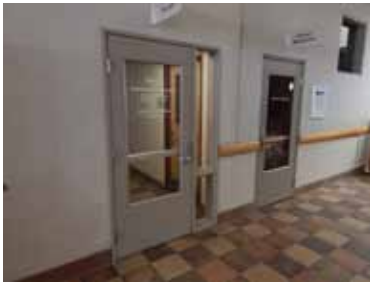
#	ITEM	PHOTO or DIAGRAM	MITIGATION MEASURE	SCHEDULE
D1.8	The wall-mounted signage mounted high on the wall above several doors in this facility are not compliant. They do not have corresponding tactile/braille signage mounted next to the door.

Provide tactile wall signage mounted at 60" AFF on the latch side of the door.	P1
D1.9	The exit doors in this facility are not compliant. They do not have the required tactile exit signage.

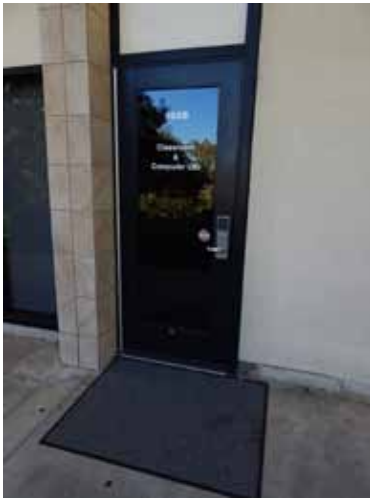
#	ITEM	PHOTO or DIAGRAM	MITIGATION MEASURE	SCHEDULE
D1.11	The side entry door to this facility is not compliant. The bottom of the threshold is not flush with the adjacent exterior paving.

Raise the exterior paving to provide a level landing, sloped no more than 2% in any direction, that is flush with the bottom of the threshold and produces a profile as indicated in Appendix A.15	P1
Men				
D1.12	The entry door to this restroom is not compliant as follows; 1. The door operating pressure exceeds 5 pounds maximum. 2. Door symbol is not contrasting in color from the finish of the door 3. The wall signage provided on the latch side of the door does not meet the minimum requirements.

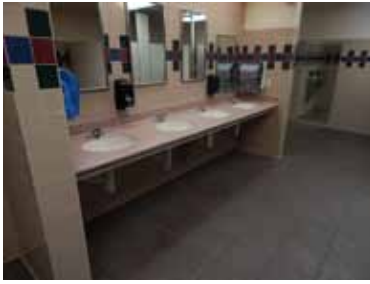
D1.13	The accessible lavatory is not compliant as follows; 1. The automatic faucet run time is programed at 3 seconds 2. The hot water and drain pipes and sharp objects under the sink have not been insulated or covered adequately

1. Reprogram the auto closing mechanism so that it has a runtime of 10 seconds 2. Provide adequate insulation and covering of all exposed pipes and sharp objects under the sink.	P1

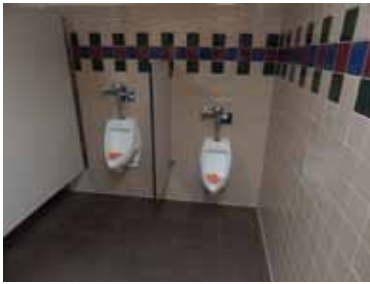
#	ITEM	PHOTO or DIAGRAM	MITIGATION MEASURE	SCHEDULE
D1.14	The urinal is compliant

None required	N/A
D1.15	The accessible toilet and stall are not compliant as follows; 1. The rear grab bar does not extend 24" minimum beyond the centerline of the fixture on the wide side. (21") 2. The stall door is not self closing. 3. U-shaped handles are not provided on both sides of the door.

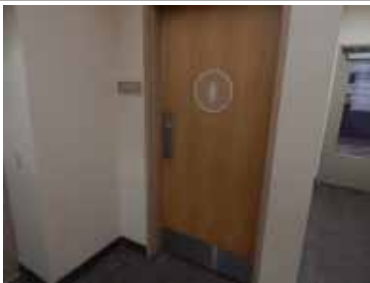
<ol style="list-style-type: none"> 1. Relocate the grab bars so they are at 33" -36" AFF to the top of the bar. 2. Adjust the stall door so that it is self-closing. 3. Provide U-shaped handles on both sides of the door. 	P1
Women				
D1.16	The entry door to this restroom is not compliant as follows; 1. The door operating pressure exceeds 5 pounds maximum. 2. Door symbol is not contrasting in color from the finish of the door 3. The wall signage provided on the latch side of the door does not meet the minimum requirements.

<ol style="list-style-type: none"> 1. Adjust the automatic closer on this door so that the pressure to operate does not exceed 5 pounds. 2. Replace the door symbol with a symbol that is 70% contrast in color from the finish of the door. OR Provide a white border 1" wide around the symbol. 3. Provide a compliant wall sign on the latch side of the door mounted at 60" AFF to the TOP of the sign and 4" from the jamb. (Refer to Appendix B.14- B.17) 	P1

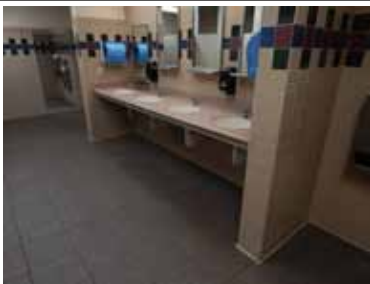
D1.17	The accessible lavatory is not compliant as follows; 1. The automatic faucet run time is programed at 3 seconds 2. The hot water and drain pipes and sharp objects under the sink have not been insulated or covered adequately

<ol style="list-style-type: none"> 1. Reprogram the auto closing mechanism so that it has a runtime of 10 seconds 2. Provide adequate insulation and covering of all exposed pipes and sharp objects under the sink. 	P1

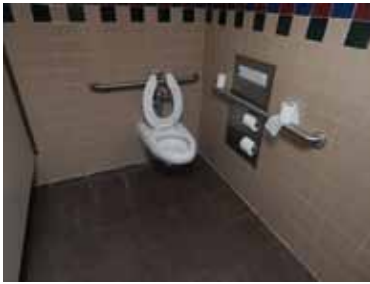
#	ITEM	PHOTO or DIAGRAM	MITIGATION MEASURE	SCHEDULE
D1.18	<p>The accessible toilet and stall are not compliant as follows;</p> <ol style="list-style-type: none"> 1. The rear grab bar does not extend 24" minimum beyond the centerline of the fixture on the wide side. (21") 2. The stall door is not self closing. 3. U-shaped handles are not provided on both sides of the door.

<ol style="list-style-type: none"> 1. Relocate the grab bars so they are at 33" -36" AFF to the top of the bar. 2. Adjust the stall door so that it is self-closing. 3. Provide U-shaped handles on both sides of the door. 	P1
Men				
D1.19	<p>The entry door to this restroom is not compliant as follows;</p> <ol style="list-style-type: none"> 1. The door operating pressure exceeds 5 pounds maximum. 2. The wall signage provided on the latch side of the door does not meet the minimum requirements.

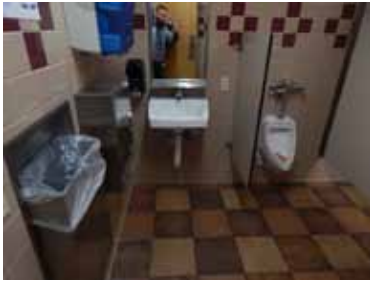
D1.20	<p>The accessible lavatory is not compliant as follows;</p> <ol style="list-style-type: none"> 1. The automatic faucet run time is programed at 3 seconds 2. The hot water and drain pipes and sharp objects under the sink have not been insulated or covered adequately

<ol style="list-style-type: none"> 1. Reprogram the auto closing mechanism so that it has a runtime of 10 seconds 2. Provide adequate insulation and covering of all exposed pipes and sharp objects under the sink. 	P1
D1.21	<p>The accessible toilet and stall are not compliant as follows;</p> <ol style="list-style-type: none"> 1. The centerline of the toilet is located too far or too close to the sidewall. 2. The rear grab bar does not extend 24" minimum beyond the centerline of the fixture on the wide side. (21")

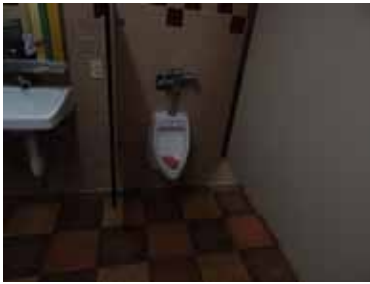
#	ITEM	PHOTO or DIAGRAM	MITIGATION MEASURE	SCHEDULE
D1.22	The urinal is compliant

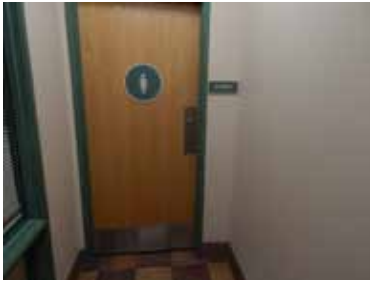
None required	N/A
Women				
D1.23	The entry door to this restroom is not compliant as follows; 1. The door operating pressure exceeds 5 pounds maximum. 2. The wall signage provided on the latch side of the door does not meet the minimum requirements.

1. Adjust the automatic closer on this door so that the pressure to operate does not exceed 5 pounds. 2. Provide a compliant wall sign on the latch side of the door mounted at 60" AFF to the TOP of the sign and 4" from the jamb. (Refer to Appendix B.14- B.17)	P1
D1.24	The overhead cabinets are not compliant. They pose an overhead hazard.

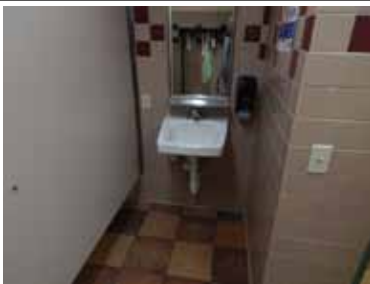
Remount the cabinets so that the bottom of the fixture is greater than 80" AFF	P1
D1.25	The accessible lavatory is not compliant as follows; 1. The automatic faucet run time is programed at 3 seconds 2. The hot water and drain pipes and sharp objects under the sink have not been insulated or covered adequately

1. Reprogram the auto closing mechanism so that it has a runtime of 10 seconds 2. Provide adequate insulation and covering of all exposed pipes and sharp objects under the sink.	P1

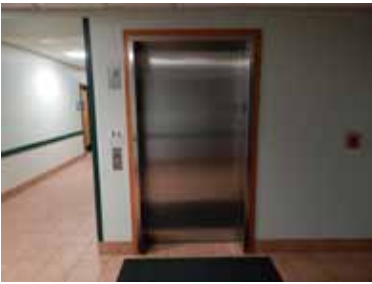
#	ITEM	PHOTO or DIAGRAM	MITIGATION MEASURE	SCHEDULE
D3.3	The secondary elevator in the staff only area of the library is compliant.

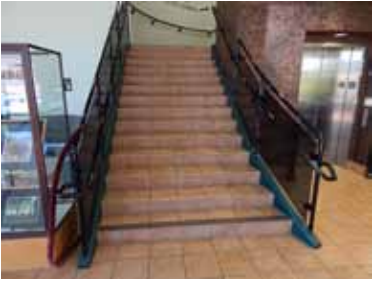
None required.	N/A
D3.4	The main stairway at the entry of the library is compliant.

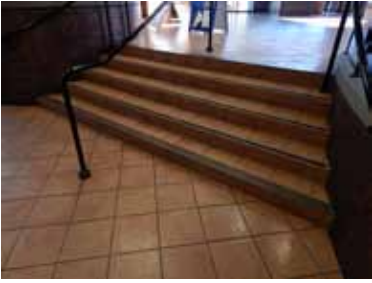
None required.	N/A
D3.5	The stairway leading down from the entry-level to the lower level of the library is compliant.

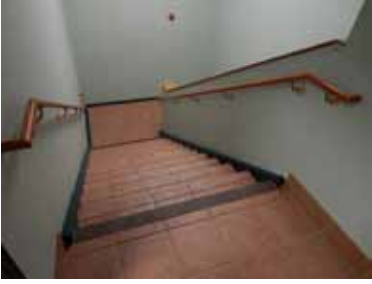
None required.	N/A
D3.6	The secondary stairway between the lower and upper level in the staff only area of the library is compliant.

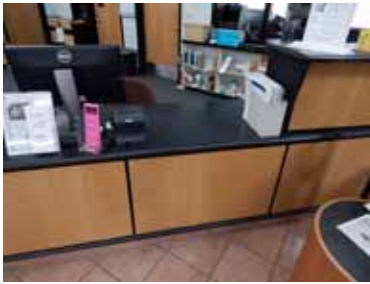
#	ITEM	PHOTO or DIAGRAM	MITIGATION MEASURE	SCHEDULE
D3.7	All of the transaction areas in the library are compliant.

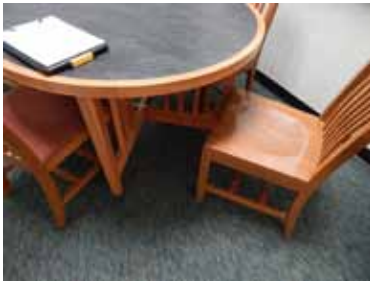
None required.	N/A
D3.8	The circular tables in the study rooms are not compliant. They do not have adequate knee clearance for wheelchair seating.

Replace the tables with the type that has 30" wide x 19" deep knee clearance as indicated in Appendix B.1	P2
D3.9	The square tables in the library are not compliant. They do not have adequate knee clearance for wheelchair seating.

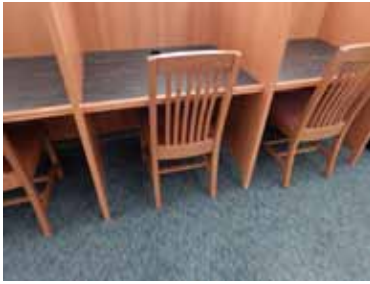
Replace enough tables with the type that has 30" wide x 19" deep knee clearance as indicated in Appendix B.1 to provide 5% accessible seating of the total table seating. The accessible tables should be equally distributed throughout the library.	P2
D3.10	The study corrals are accessible.

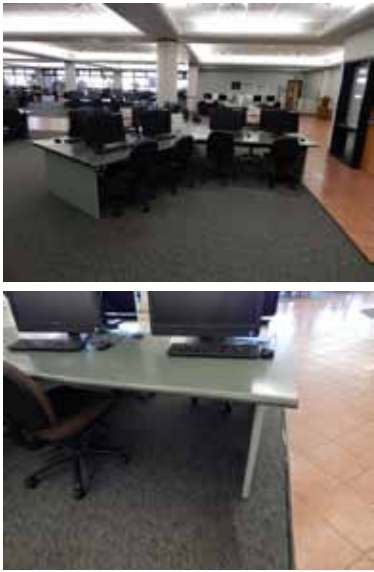
#	ITEM	PHOTO or DIAGRAM	MITIGATION MEASURE	SCHEDULE
D3.11	<p>The computer workstations are accessible. (The operation of the computers was not part of this review. The computers should have programs that allow the visually impaired and hearing impaired to operate them.)</p>

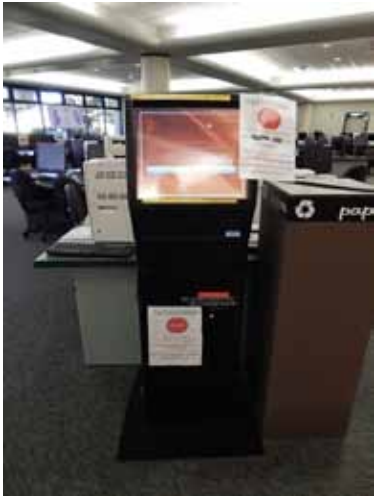
None required.	N/A
D3.12	<p>This electronic kiosk does not meet the needs of the visually impaired and is not compliant. (The actual function of the machine during transactions was not part of this review.)</p>

Provide an electronic kiosk that meets the needs of the visually impaired or provide equivalent facilitation through functions of the library staff.	P2

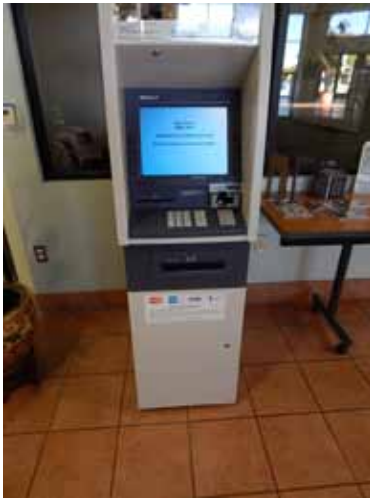
#	ITEM	PHOTO or DIAGRAM	MITIGATION MEASURE	SCHEDULE
D3.13	This ATM machine in the lobby is compliant. (The actual function of the machine during transactions was not part of this review.)

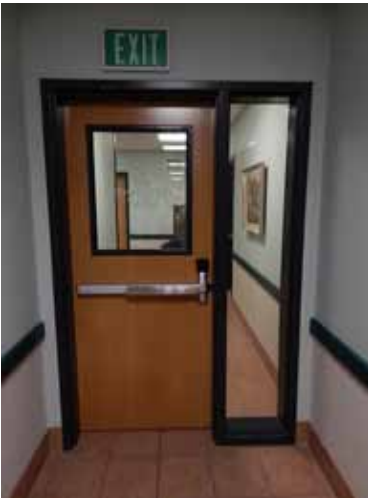
#	ITEM	PHOTO or DIAGRAM	MITIGATION MEASURE	SCHEDULE
D3.15	This exit doors throughout the library are not compliant. Tactile exit signage is not provided.

Provide a tactile exit sign mounted on the wall adjacent to the door at 60" AFF according to Appendix D.8	P2
D3.16	The POT throughout the library on both levels is compliant.

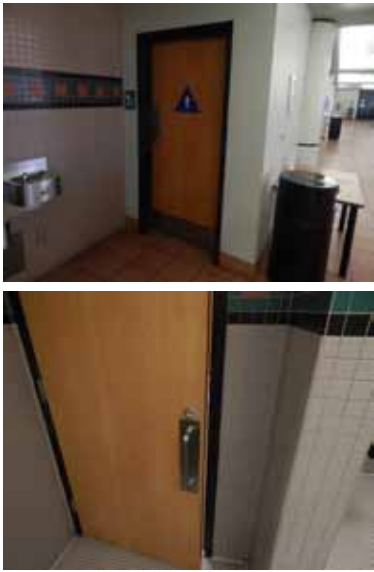
#	ITEM	PHOTO or DIAGRAM	MITIGATION MEASURE	SCHEDULE
D3.17	<p>The entry door to this restroom is not compliant as follows;</p> <ol style="list-style-type: none"> 1. The door operating pressure exceeds 5 pounds maximum. 2. The wall signage provided on the latch side of the door is mounted incorrectly. 3. The required 18" pull side clearance is not provided

<ol style="list-style-type: none"> 1. Adjust the automatic closer on this door so that the pressure to operate does not exceed 5 pounds. 2. Provide a compliant wall sign on the latch side of the door mounted at 60" AFF to the TOP of the sign and 4" from the jamb. (Refer to Appendix B.14- B.17) 3. Reverse the door swing, and the hinge side of the door. 	P2
D3.18	<p>The accessible lavatory is not compliant as follows;</p> <p>The hot water and drain pipes and sharp objects under the sink have not been insulated or covered adequately.</p>

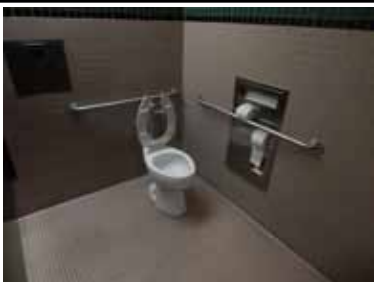
D3.19	<p>The accessible toilet and stall are not compliant as follows;</p> <ol style="list-style-type: none"> 1. The rear grab bar does not extend 24" minimum beyond the centerline of the fixture on the wide side. (22") 2. The stall door is not self closing. 3. U-shaped handles are not provided on both sides of the door. 4. The required pull side clearance is not provided

<ol style="list-style-type: none"> 1. Relocate the grab bars so they are at 33" -36" AFF to the top of the bar. 2. Adjust the stall door so that it is self-closing. 3. Provide U-shaped handles on both sides of the door. 4. Reconfigure the partition so that it has a 18" x 60" pull side clearance. 	P2

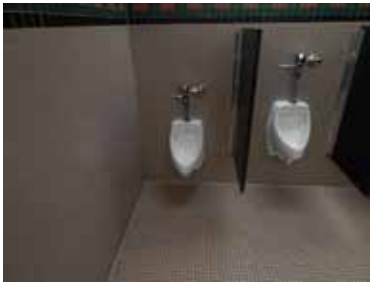
#	ITEM	PHOTO or DIAGRAM	MITIGATION MEASURE	SCHEDULE
D3.20	The urinal is compliant

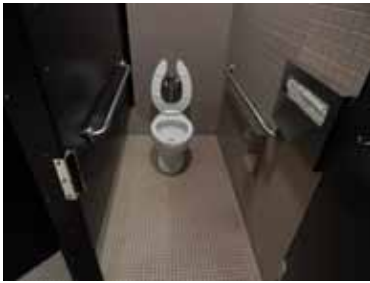
None required	N/A
D3.21	The semi ambulatory stall is not compliant. 1. The centerline of the toilet is 16" from the partition 2. The top of toilet seat is at 16" 3. The stall door does not provide a clear opening of 32" (30")

1. Reconfigure the partition so that the toilet has a centerline of 18" to the partition. 2. Replace the toilet with one that has a seat height of 17" - 19" AFF 3. Reconfigure the stall door so that it has a clear opening of no less than 32"	P2
Women First Floor				
D3.22	The entry door to this restroom is not compliant as follows; 1. The door operating pressure exceeds 5 pounds maximum. 2. The wall signage provided on the latch side of the door is mounted incorrectly. 3. The required 18" pull side clearance is not provided

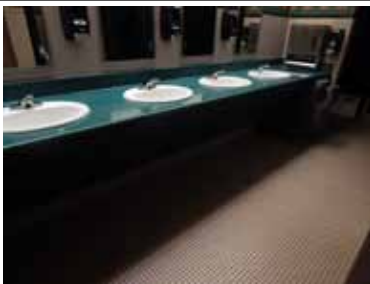
D3.23	The accessible lavatory is not compliant as follows; The knee clearance does not meet the requirements.

Modify the sink counter so that the required knee clearance is provided. (See Appendix B.1 for clearance profile)	P2

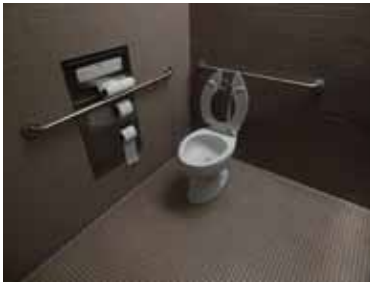
#	ITEM	PHOTO or DIAGRAM	MITIGATION MEASURE	SCHEDULE
D3.24	<p>The accessible toilet and stall are not compliant as follows;</p> <ol style="list-style-type: none"> 1. The rear grab bar does not extend 24" minimum beyond the centerline of the fixture on the wide side. (22") 2. The stall door is not self closing. 3. U-shaped handles are not provided on both sides of the door. 4. The required pull side clearance is not provided

<ol style="list-style-type: none"> 1. Relocate the grab bars so they are at 33" -36" AFF to the top of the bar. 2. Adjust the stall door so that it is self-closing. 3. Provide U-shaped handles on both sides of the door. 4. Reconfigure the partition so that it has a 18" x 60" pull side clearance. 	P2
D3.25	<p>The semi ambulatory stall is not compliant.</p> <ol style="list-style-type: none"> 1. The centerline of the toilet is 16" from the partition 2. The top of toilet seat is at 16" 3. The stall door does not provide a clear opening of 32" (30") 	[No photo provided]	<ol style="list-style-type: none"> 1. Reconfigure the partition so that the toilet has a centerline of 18" to the partition. 2. Replace the toilet with one that has a seat height of 17" - 19" AFF 3. Reconfigure the stall door so that it has a clear opening of no less than 32" 	P2

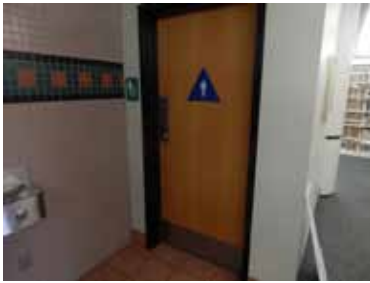
Men Second Floor				
D3.26	<p>The entry door to this restroom is not compliant as follows;</p> <ol style="list-style-type: none"> 1. The door operating pressure exceeds 5 pounds maximum. 2. The wall signage provided on the latch side of the door is mounted incorrectly. 3. The required 18" pull side clearance is not provided

<ol style="list-style-type: none"> 1. Adjust the automatic closer on this door so that the pressure to operate does not exceed 5 pounds. 2. Provide a compliant wall sign on the latch side of the door mounted at 60" AFF to the TOP of the sign and 4" from the jamb. (Refer to Appendix B.14- B.17) 3. Reverse the door swing, and the hinge side of the door. 	P2
D3.27	<p>The accessible lavatory is not compliant as follows;</p> <p>The knee clearance does not meet the requirements.</p>

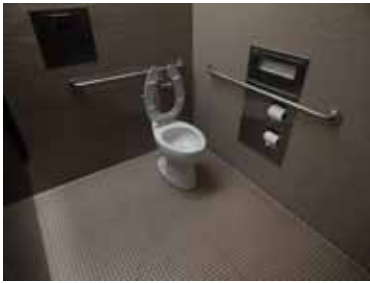
None required	N/A
D3.29	The accessible toilet and stall are not compliant as follows; 1. The side grab bar does not extend 54" minimum beyond the centerline of the fixture on the wide side. (52") 2. The stall door is not self closing. 3. The required pull side clearance is not provided

<ol style="list-style-type: none"> 1. Relocate the grab bars so they are at 33" -36" AFF to the top of the bar. 2. Adjust the stall door so that it is self-closing. 3. Reconfigure the partition so that it has a 18" x 60" pull side clearance. 	P2
Women Second Floor				
D3.30	The entry door to this restroom is not compliant as follows; 1. The door operating pressure exceeds 5 pounds maximum. 2. The wall signage provided on the latch side of the door is mounted incorrectly. 3. The required 18" pull side clearance is not provided

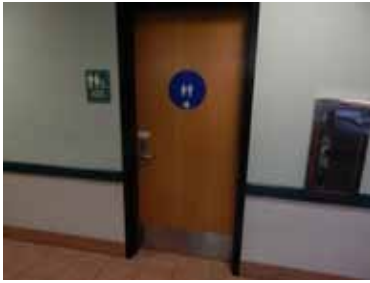
<ol style="list-style-type: none"> 1. Relocate the grab bars so they are at 33" -36" AFF to the top of the bar. 2. Adjust the stall door so that it is self-closing. 3. Reconfigure the partition so that it has a 18" x 60" pull side clearance. 	P2
Staff Unisex 1				
D3.33	<p>The entry door to this restroom is not compliant as follows;</p> <ol style="list-style-type: none"> 1. The door operating pressure exceeds 5 pounds maximum. 2. The wall signage provided on the latch side of the door is mounted incorrectly. 3. Door symbol is not contrasting in color from the finish of the door

<ol style="list-style-type: none"> 1. Adjust the automatic closer on this door so that the pressure to operate does not exceed 5 pounds. 2. Provide a compliant wall sign on the latch side of the door mounted at 60" AFF to the TOP of the sign and 4" from the jamb. (Refer to Appendix B.14- B.17) 3. Replace the door symbol with a symbol that is 70% contrast in color from the finish of the door. OR Provide a white border 1" wide around the symbol. 	P2

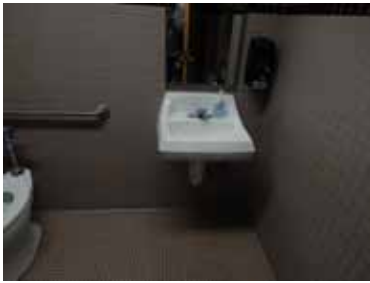
D3.34	<p>The accessible lavatory is not compliant as follows;</p> <p>The automatic faucet run time is programed at 3 seconds</p>

Reprogram the auto closing mechanism so that it has a runtime of 10 seconds	P2
D3.35	<p>The accessible toilet and stall are not compliant as follows;</p> <ol style="list-style-type: none"> 1. The rear grab bar does not extend 24" minimum beyond the centerline of the fixture on the wide side. (22") 2. The side grab bar does not extend 54" minimum beyond the front edge of the fixture. (52") 3. The toilet tissue dispenser is not located correctly.

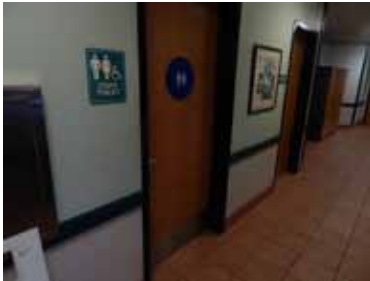
Staff Unisex 2				
D3.36	<p>The entry door to this restroom is not compliant as follows;</p> <ol style="list-style-type: none"> 1. The door operating pressure exceeds 5 pounds maximum. 2. The wall signage provided on the latch side of the door is mounted incorrectly. 3. Door symbol is not contrasting in color from the finish of the door

<ol style="list-style-type: none"> 1. Adjust the automatic closer on this door so that the pressure to operate does not exceed 5 pounds. 2. Provide a compliant wall sign on the latch side of the door mounted at 60" AFF to the TOP of the sign and 4" from the jamb. (Refer to Appendix B.14- B.17) 3. Replace the door symbol with a symbol that is 70% contrast in color from the finish of the door. OR Provide a white border 1" wide around the symbol. 	P2
D3.37	<p>The accessible lavatory is not compliant as follows;</p> <p>The automatic faucet run time is programed at 3 seconds</p>

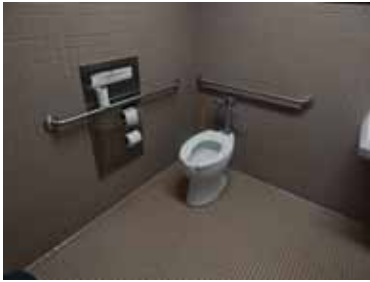
D3.38	<p>The accessible toilet and stall are not compliant as follows;</p> <ol style="list-style-type: none"> 1. The rear grab bar does not extend 24" minimum beyond the centerline of the fixture on the wide side. (22") 2. The side grab bar does not extend 54" minimum beyond the front edge of the fixture. (52") 3. The toilet tissue dispenser is not located correctly.

<ol style="list-style-type: none"> 1. Replace the rear grab bar or relocate the rear grab bar so that it extends 24" beyond the centerline of the toilet to the wide side. 2. Replace the side grab bar or relocate the side grab bar so that it extends 54" beyond the front edge of the fixture. 3. Relocate the toilet tissue dispenser so that it is located 7"- 9" on the front of the toilet and 19" AFF. (Locate to the centerline of the dispenser) 	P2

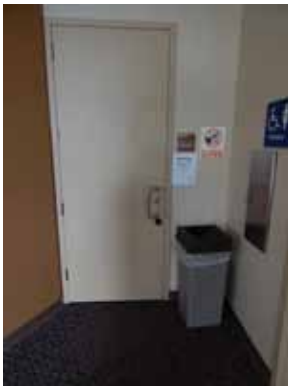
#	ITEM	PHOTO or DIAGRAM	MITIGATION MEASURE	SCHEDULE
D4.3	Lobby, 2005; The main entry doors into the theater on each side of the foyer are not compliant because 12" pull side clearance is obscured by a trashcan.

Relocate this trashcan to some other place in the foyer.	P3
D4.4	Control Room, 2004; The wheelchair lift accessing the control booth is not compliant because it is being used for storage.

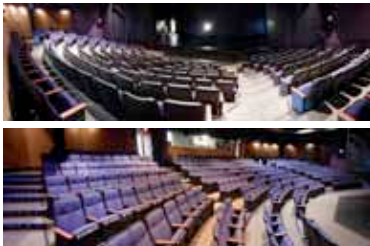
#	ITEM	PHOTO or DIAGRAM	MITIGATION MEASURE	SCHEDULE
D4.5	Classroom Seating, 2001A; The theater seating in this facility is not compliant as follows: 1. Adequate wheelchair seating is not provided or designated. 2. Adequate companion seating is not provided or designated. 3. Adequate semi ambulatory seating is not provided or designated. 4. Adequate aisle seating is not provided or designated. 5. There is no accessible route from the disabled seating at the upper level on to the platform.

1. Provide six wheelchair accessible 30"x48" spaces at the upper level of the seating area. Designate the seating areas an ISA symbol. 2. Provide six companion seats directly adjacent to the six wheelchair spaces. 3. Provide 3 minimum semi-ambulatory seats with 24" leg clearance at the front. These seats must be designated with an ISA symbol. 4. Replace a minimum of 5% of all aisle seats with accessible seats that have either lifting armrests or hinged panels on the side. These seats must be designated with an ISA symbol. 5. Provide an accessible POT from the disabled seating to the platform without requiring the individual to go outside and through the Reception, Room 2008.	P3

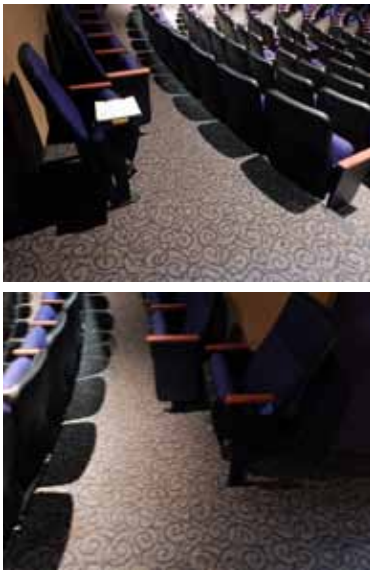
D4.6	Classroom Seating, 2001A; There are two existing accessible seats designated at the top level of the seating in this theater. It is unclear if they are semi-ambulatory seats or companion seats. There is not sufficient room adjacent to them for wheelchair seating.

Refer to mitigation for accessible seating in the Item above.	P3

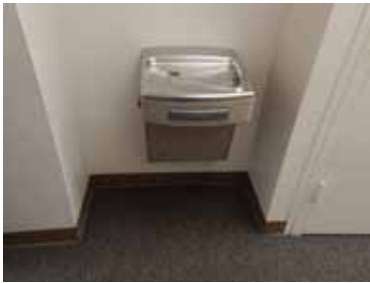
#	ITEM	PHOTO or DIAGRAM	MITIGATION MEASURE	SCHEDULE
D4.7	It was not apparent that an assistive listening system and devices were available.	[No photo provided]	Provide a permanent assistive listening system for the theater seating area and provide the following requirements have been met in regards to the assistive listening devices that are available: 1. A total of 10 receivers must be available. 2. Of the 3 receivers a minimum of 5 must be hearing aid compatible.	P3
D4.8	The single height drinking fountain in the core door is not compliant. It is required to be a dual height unit.

Replace this drinking fountain with a compliant tool height unit.	P3
D4.9	Reception, Room 2008; The transaction area is not compliant at 44" AFF.

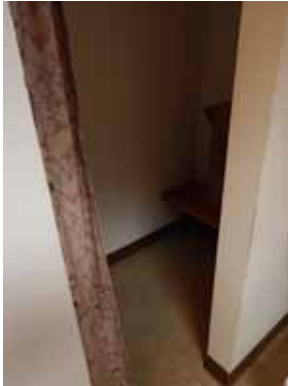
None required.	N/A
D4.13	Changing Room, Room 2018B; This changing room is not wheelchair accessible.

Reconfigure this room so that there is a 60" dia. turning space and a wheelchair accessible bench for changing.	P3
D4.14	Laundry Room, Room 2018B; This Laundry Room is not compliant as follows: 1. There is not enough space for a wheelchair to access the appliances. 2. The controls on the appliances are not accessible within the allowable reach range

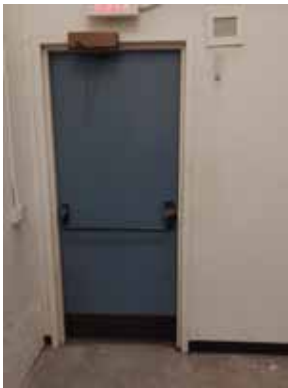
#	ITEM	PHOTO or DIAGRAM	MITIGATION MEASURE	SCHEDULE
D4.15	<p>This exit doors throughout this building are not compliant. Tactile exit signage is not provided.</p>

<p>Provide a tactile exit sign mounted on the wall adjacent to each exit door at 60" AFF according to Appendix D.8</p>	P3
D4.16	<p>Men's Shower, Room 2016; This wheelchair accessible shower is not compliant as follows:</p> <ol style="list-style-type: none"> 1. The adjustable shower head has been removed and the existing one is too high.

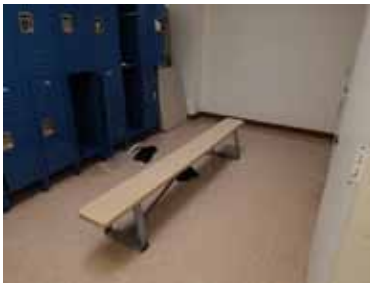
<ol style="list-style-type: none"> 1. Replace the fixed head with a movable shower head that can be used in a fixed position or handheld with a hose 59" long minimum. The spray unit shall have an on-off control with the non-positive shut-off. The spray unit shall have a device so that the water delivered through it is 120°F maximum. 	P3
D4.17	<p>Men's Locker, Room 2016; The locker room is not compliant as follows:</p> <ol style="list-style-type: none"> 1. The lockers are not within the allowable reach range. 2. The changing bench is not accessible.

<ol style="list-style-type: none"> 1. Provide one locker minimum that meets the reach range requirements in Appendix D.2 2. Provide an accessible changing bench 20" deep x 48" wide with a vertical back or against the wall adjacent to an accessible POT and a transfer area 30"x48" clear. 	P3

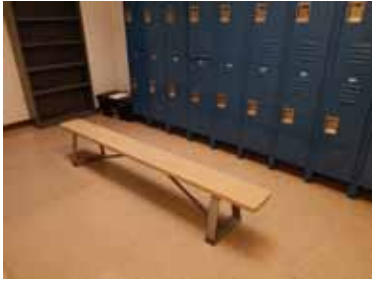
None required	N/A
D4.19	Women's Locker, Room 2014; The locker room is not compliant as follows: 1. The lockers are not within the allowable reach range. 2. The changing bench is not accessible.

1. Provide one locker minimum that meets the reach range requirements in Appendix D.2 2. Provide an accessible changing bench 20" deep x 48" wide with a vertical back or against the wall adjacent to an accessible POT and a transfer area 30"x48" clear.	P3
Men				
D4.20	The entry into this restroom is compliant.

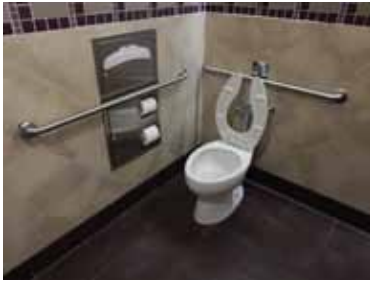
None required	N/A
D4.23	<p>The accessible toilet and stall are not compliant as follows;</p> <ol style="list-style-type: none"> 1. The rear grab bar does not extend 24" minimum beyond the centerline of the fixture on the wide side. (20") 2. The side grab bar does not extend 54" minimum beyond the rear wall. (51") 3. The toilet tissue dispenser is located too high or too far from the front of the toilet. 4. The toilet seat tissue dispenser is not located on an accessible route. 5. The stall door is not self closing. 6. U-shaped handles are not provided on both sides of the door.

<ol style="list-style-type: none"> 1. Replace the rear grab bar or relocate the rear grab bar so that it extends 24" beyond the centerline of the toilet to the wide side. 2. Replace the side grab bar or relocate the side grab bar so that it extends 54" beyond the rear wall. 3. Relocate the toilet tissue dispenser so that it is located 7" - 9" on the front of the toilet and 19" AFF. (Locate to the centerline of the dispenser) 4. Relocate the toilet seat tissue dispenser so that it is located on an accessible route. (Locations above the grab bars are not accessible.) 5. Adjust the stall door so that it is self-closing. 6. Provide U-shaped handles on both sides of the door. 	P3

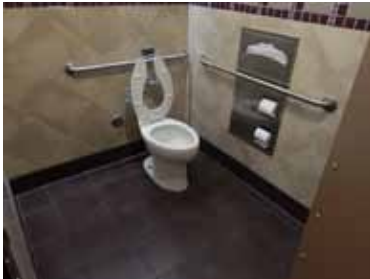
None required	N/A
D4.26	<p>The accessible toilet and stall are not compliant as follows;</p> <ol style="list-style-type: none"> 1. The rear grab bar does not extend 24" minimum beyond the centerline of the fixture on the wide side. (20") 2. The side grab bar does not extend 54" minimum beyond the rear wall. (51") 3. The toilet tissue dispenser is located too high or too far from the front of the toilet. 4. The toilet seat tissue dispenser is not located on an accessible route. 5. The stall door is not self closing. 6. U-shaped handles are not provided on both sides of the door.

<ol style="list-style-type: none"> 1. Replace the rear grab bar or relocate the rear grab bar so that it extends 24" beyond the centerline of the toilet to the wide side. 2. Replace the side grab bar or relocate the side grab bar so that it extends 54" beyond the rear wall. 3. Relocate the toilet tissue dispenser so that it is located 7"- 9" on the front of the toilet and 19" AFF. (Locate to the centerline of the dispenser) 4. Relocate the toilet seat tissue dispenser so that it is located on an accessible route. (Locations above the grab bars are not accessible.) 5. Adjust the stall door so that it is self-closing. 6. Provide U-shaped handles on both sides of the door. 	P3

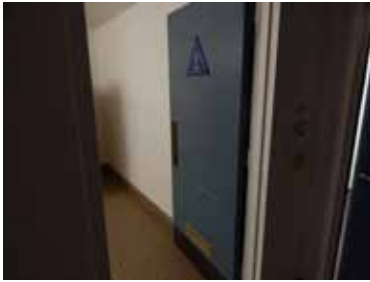
None required	N/A
Men Back Stage				
D4.28	<p>The entry door to this restroom is not compliant as follows;</p> <ol style="list-style-type: none"> 1. The door operating pressure exceeds 5 pounds maximum. 2. The door symbol is mounted incorrectly and the sign finish is not non-glare. 3. Door symbol is not contrasting in color from the finish of the door 4. The wall signage provided on the latch side of the door is not provided at 60" AFF.

<ol style="list-style-type: none"> 1. Adjust the automatic closer on this door so that the pressure to operate does not exceed 5 pounds. 2. Replace the door symbol with a non-glare contrasting finish and mount at 60" AFF. 3. Replace the door symbol with a symbol that is 70% contrast in color from the finish of the door. OR Provide a white border 1" wide around the symbol. 4. Provide a compliant wall sign on the latch side of the door mounted at 60" AFF to the TOP of the sign and 4" from the jamb. (Refer to Appendix B.14- B.17) 	P3

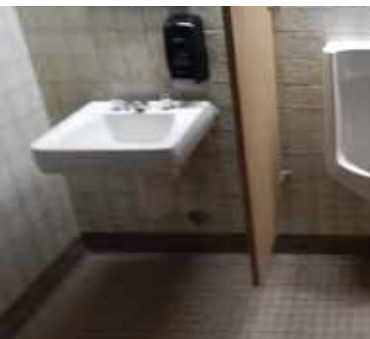
D4.29	<p>The accessible lavatory is not compliant as follows;</p> <ol style="list-style-type: none"> 1. The knee clearance does not meet the requirements. 2. The hot water and drain pipes and sharp objects under the sink have not been insulated or covered adequately.

<ol style="list-style-type: none"> 1. Modify the sink counter so that the required knee clearance is provided. (See Appendix B.1 for clearance profile) 2. Provide adequate insulation and covering of all exposed pipes and sharp objects under the sink. 	P3

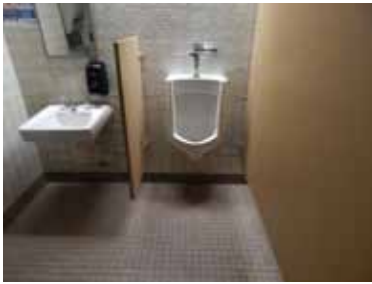
#	ITEM	PHOTO or DIAGRAM	MITIGATION MEASURE	SCHEDULE
D4.30	The urinal is compliant.

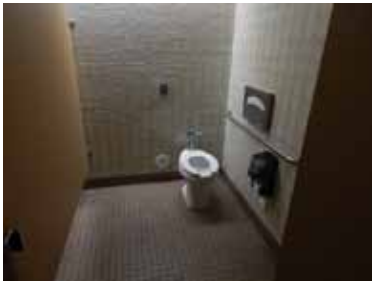
None required	N/A
D4.31	<p>The accessible toilet and stall are not compliant as follows;</p> <ol style="list-style-type: none"> 1. The rear grab bar is not provided 2. The side grab bar does not extend 54" minimum beyond the rear wall. (20") 3. The toilet tissue dispenser is located too high or too far from the front of the toilet. 4. The stall door is not self closing. 5. U-shaped handles are not provided on both sides of the door.

<ol style="list-style-type: none"> 1. Install a rear grab bar so that it extends 24" beyond the centerline of the toilet to the wide side. 2. Replace the side grab bar or relocate the side grab bar so that it extends 24" beyond the rear wall. 3. Relocate the toilet tissue dispenser so that it is located 7" - 9" on the front of the toilet and 19" AFF. (Locate to the centerline of the dispenser) 4. Adjust the stall door so that it is self-closing. 5. Provide U-shaped handles on both sides of the door. 	P3

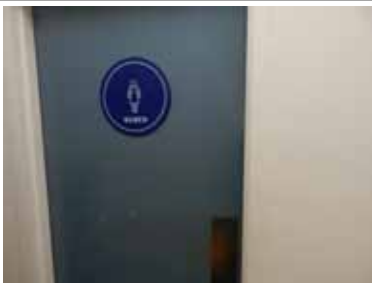
Women Back Stage				
D4.32	<p>The entry door to this restroom is not compliant as follows;</p> <ol style="list-style-type: none"> 1. The door operating pressure exceeds 5 pounds maximum. 2. The door symbol is mounted incorrectly and the sign finish is not non-glare. 3. Door symbol is not contrasting in color from the finish of the door 4. The wall signage provided on the latch side of the door is not provided at 60" AFF.

<ol style="list-style-type: none"> 1. Adjust the automatic closer on this door so that the pressure to operate does not exceed 5 pounds. 2. Replace the door symbol with a non-glare contrasting finish and mount at 60" AFF. 3. Replace the door symbol with a symbol that is 70% contrast in color from the finish of the door. OR Provide a white border 1" wide around the symbol. 4. Provide a compliant wall sign on the latch side of the door mounted at 60" AFF to the TOP of the sign and 4" from the jamb. (Refer to Appendix B.14- B.17) 	P3

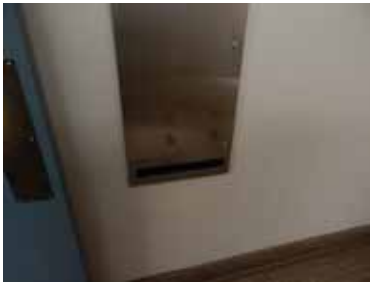
#	ITEM	PHOTO or DIAGRAM	MITIGATION MEASURE	SCHEDULE
D4.33	The feminine hygiene dispenser is not compliant. It required pinching a grasping to operate.

1. Replace the feminine hygiene dispenser with one that does not require pinching and grasping	P3
D4.34	The accessible lavatory is not compliant as follows; 1. The knee clearance does not meet the requirements. 2. The hot water and drain pipes and sharp objects under the sink have not been insulated or covered adequately.

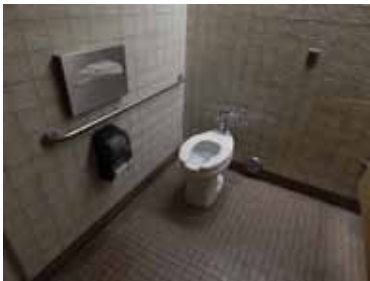
1. Modify the sink counter so that the required knee clearance is provided. (See Appendix B.1 for clearance profile) 2. Provide adequate insulation and covering of all exposed pipes and sharp objects under the sink.	P3
D4.35	The accessible toilet and stall are not compliant as follows; 1. The grab bar is mounted at the wrong height. 2. The rear grab bar is not provided 3. The side grab bar does not extend 54" minimum beyond the rear wall. (20") 4. The toilet tissue dispenser is located too high or too far from the front of the toilet. 5. The stall door is not self closing. 6. U-shaped handles are not provided on both sides of the door.

1. Relocate the grab bars so they are at 33" -36" AFF to the top of the bar. 2. Install a rear grab bar so that it extends 24" beyond the centerline of the toilet to the wide side. 3. Replace the side grab bar or relocate the side grab bar so that it extends 24" beyond the rear wall. 4. Relocate the toilet tissue dispenser so that it is located 7" - 9" on the front of the toilet and 19" AFF. (Locate to the centerline of the dispenser) 5. Adjust the stall door so that it is self-closing. 6. Provide U-shaped handles on both sides of the door.	P3

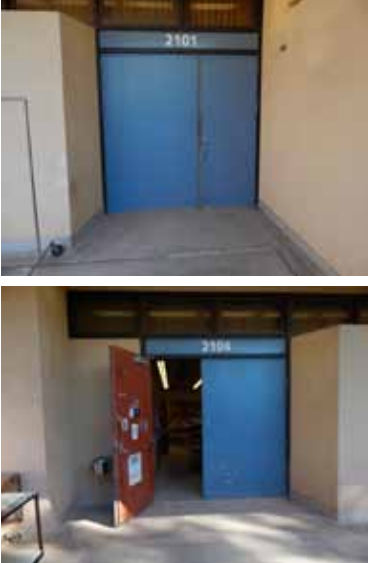
D5.1	<p>The main entry doors at this building are not compliant as follows:</p> <ol style="list-style-type: none"> 1. They do not have the tactile room number and name mounted adjacent to the door on the exterior.

<ol style="list-style-type: none"> 1. Provide tactile room number and name signage mounted adjacent to the door on the exterior according to the requirements of Appendix B.16 	P3
D5.2	<p>This exterior entry door at this building is compliant.</p>

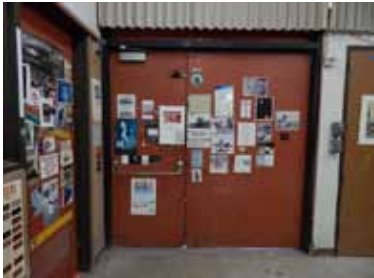
None required.	N/A
D5.5	All of the emergency exit doors in this building are not compliant as follows: 1. The exit doors do not have the required tactile exit signage mounted on the wall adjacent to the door.

1. Provide tactile exit signs mounted adjacent to the door according to the requirements of Appendix B.16 and D.8	P3
D5.6	Photo Finish and Darkroom, Room 2107 The student workstations in this room are compliant.

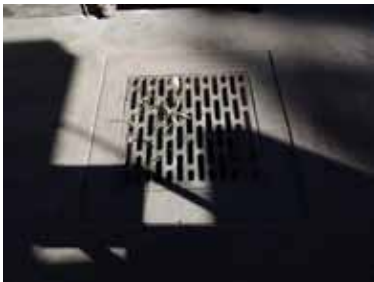
None required.	N/A
D5.7	The grate on the area drain at the patio outside of Room 2104 is not compliant. The openings in the grate are too large at 1" wide.

Replace the cover over this area drain with one that does not have openings larger than 1/2".	P3

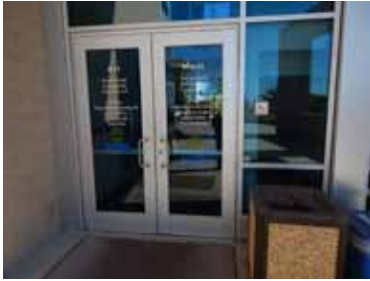
D6.1	The exterior entry doors into this building are compliant.

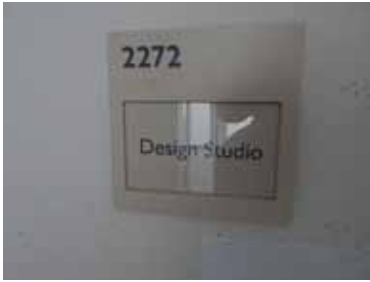
None required.	N/A
D6.2	The exit doors in this building are compliant.	[No photo provided]	None required.	N/A
D6.3	The room and door signage in this building is compliant.

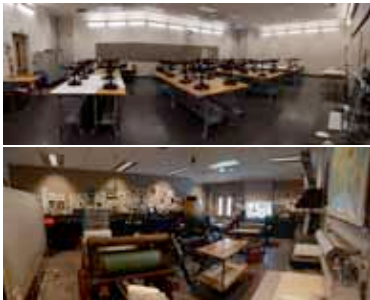
None required.	N/A
D6.4	The student work areas and workstations in this building are compliant.

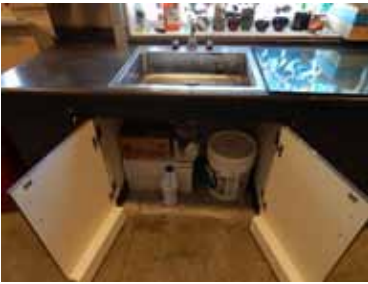
#	ITEM	PHOTO or DIAGRAM	MITIGATION MEASURE	SCHEDULE
D6.5	<p>All of the sinks in the student classrooms and work areas are compliant except as follows:</p> <ol style="list-style-type: none"> Even though the knee clearance below the sink is compliant, it is up obstructed by storage items.

<ol style="list-style-type: none"> Remove any items that are being stored under the sinks that obstruct the knee clearance for a wheelchair user. Refer to Appendix B.14 for clearance profile. 	P3
D6.6	The reception area and transaction counter on the first floor of this building is compliant.
