ADA Self Evaluation and Transition Plan

MiraCosta College, **Oceanside Campus**

Board Approved on 05-18-2017

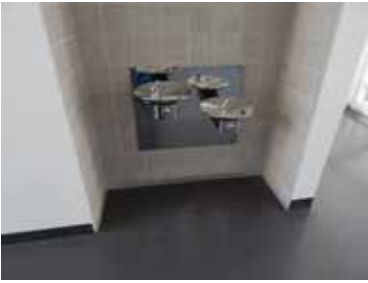
None required.	N/A
D6.7	The drinking fountains in this building are compliant.

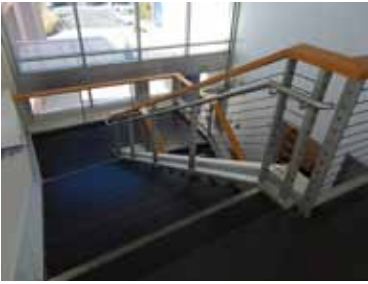
None required.	N/A
D6.8	The stairways in this building are compliant.

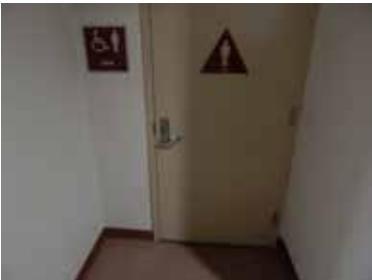
None required.	N/A
Men				
D6.10	The entry door to this restroom is not compliant as follows; 1. The door operating pressure exceeds 5 pounds maximum. 2. The wall signage provided on the latch side of the door is not provided at 60" AFF.

1. Adjust the automatic closer on this door so that the pressure to operate does not exceed 5 pounds. 2. Provide a compliant wall sign on the latch side of the door mounted at 60" AFF to the TOP of the sign and 4" from the jamb. (Refer to Appendix B.14- B.17)	P3
D6.11	The lavatory is compliant

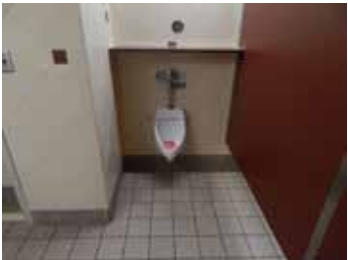
None required	N/A
D6.12	The urinal is compliant

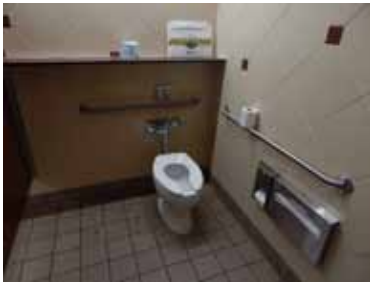
#	ITEM	PHOTO or DIAGRAM	MITIGATION MEASURE	SCHEDULE
D6.13	<p>The accessible toilet and stall are not compliant as follows;</p> <ol style="list-style-type: none"> 1. The side grab bar does not extend 54" minimum beyond the rear wall. (52") 2. The toilet tissue dispenser is located too high or too far from the front of the toilet. 3. U-shaped handles are not provided on both sides of the door.

<ol style="list-style-type: none"> 1. Replace the side grab bar or relocate the side grab bar so that it extends 54" beyond the rear wall. 2. Relocate the toilet tissue dispenser so that it is located 7"- 9" on the front of the toilet and 19" AFF. (Locate to the centerline of the dispenser) 3. Provide U-shaped handles on both sides of the door. 	P3
Women				
D6.14	<p>The entry door to this restroom is not compliant as follows;</p> <ol style="list-style-type: none"> 1. The door operating pressure exceeds 5 pounds maximum. 2. The wall signage provided on the latch side of the door is not provided at 60" AFF. 	[No photo provided]	<ol style="list-style-type: none"> 1. Adjust the automatic closer on this door so that the pressure to operate does not exceed 5 pounds. 2. Provide a compliant wall sign on the latch side of the door mounted at 60" AFF to the TOP of the sign and 4" from the jamb. (Refer to Appendix B.14- B.17) 	P3

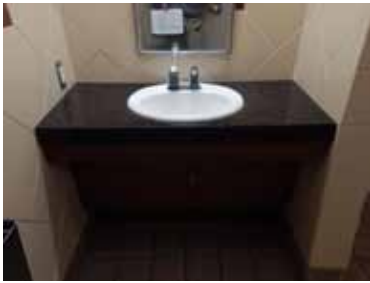
D6.15	The lavatory is compliant

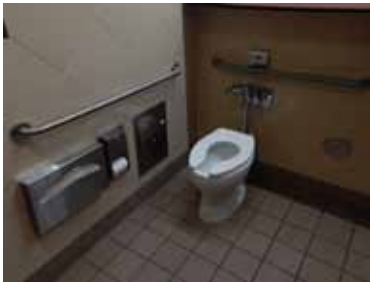
None required	N/A
D6.16	<p>The accessible toilet and stall are not compliant as follows;</p> <ol style="list-style-type: none"> 1. The side grab bar does not extend 54" minimum beyond the rear wall. (52") 2. The toilet tissue dispenser is located too high or too far from the front of the toilet. 3. U-shaped handles are not provided on both sides of the door.

<ol style="list-style-type: none"> 1. Replace the side grab bar or relocate the side grab bar so that it extends 54" beyond the rear wall. 2. Relocate the toilet tissue dispenser so that it is located 7"- 9" on the front of the toilet and 19" AFF. (Locate to the centerline of the dispenser) 3. Provide U-shaped handles on both sides of the door. 	P3

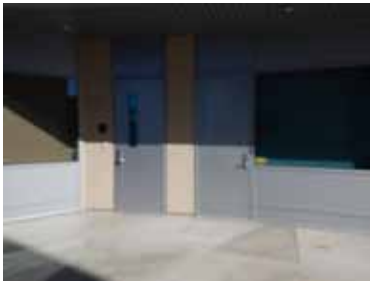
D7.1	This exterior entry door at this building is compliant.

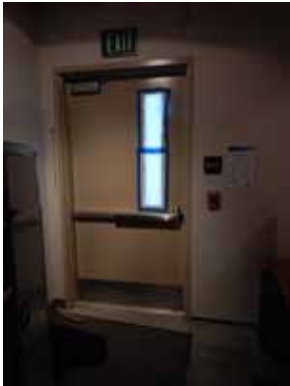
None required.	N/A
D7.3	All of the emergency exit doors in this building are compliant.

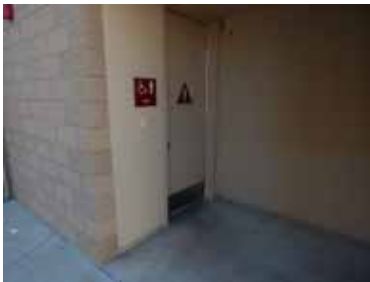
None required,	N/A
Men				
D7.4	<p>The entry door to this restroom is not compliant as follows;</p> <ol style="list-style-type: none"> 1. The door operating pressure exceeds 5 pounds maximum. 2. The wall signage provided on the latch side of the door is not provided at 60" AFF.

<ol style="list-style-type: none"> 1. Adjust the automatic closer on this door so that the pressure to operate does not exceed 5 pounds. 2. Provide a compliant wall sign on the latch side of the door mounted at 60" AFF to the TOP of the sign and 4" from the jamb. (Refer to Appendix B.14- B.17) 	P3

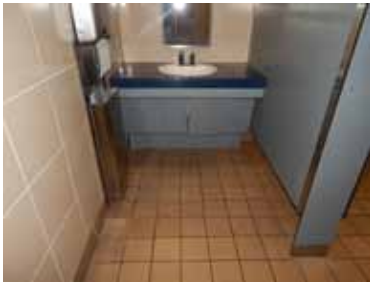
#	ITEM	PHOTO or DIAGRAM	MITIGATION MEASURE	SCHEDULE
D7.5	The lavatory is compliant

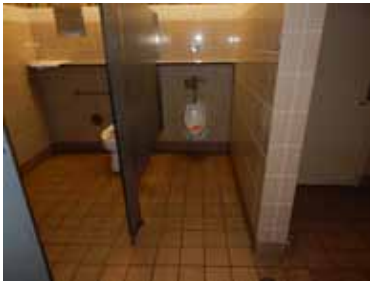
None required	N/A
D7.6	The urinal is compliant

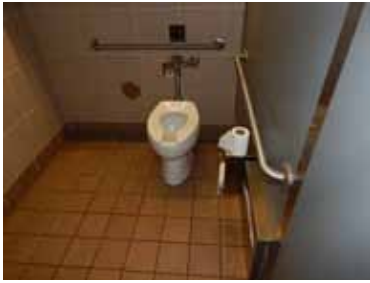
None required	N/A
D7.7	<p>The accessible toilet and stall are not compliant as follows;</p> <ol style="list-style-type: none"> 1. The toilet tissue dispenser is located too high or too far from the front of the toilet. 2. The stall door is not self closing. 3. The latching hardware is not compliant. 4. U-shaped handles are not provided on both sides of the door.

<ol style="list-style-type: none"> 1. Relocate the toilet tissue dispenser so that it is located 7"- 9" on the front of the toilet and 19" AFF. (Locate to the centerline of the dispenser) 2. Adjust the stall door so that it is self-closing. 3. Provide new latching hardware that does not require pinching, twisting or grasping. 4. Provide U-shaped handles on both sides of the door. 	P3
Women

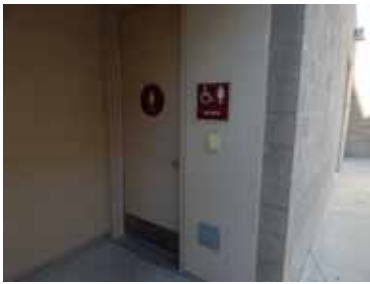
D7.8	<p>The entry door to this restroom is not compliant as follows;</p> <ol style="list-style-type: none"> 1. The door operating pressure exceeds 5 pounds maximum. 2. The wall signage provided on the latch side of the door is not provided at 60" AFF.

<ol style="list-style-type: none"> 1. Adjust the automatic closer on this door so that the pressure to operate does not exceed 5 pounds. 2. Provide a compliant wall sign on the latch side of the door mounted at 60" AFF to the TOP of the sign and 4" from the jamb. (Refer to Appendix B.14- B.17) 	P3

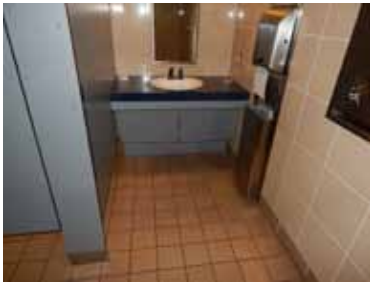
#	ITEM	PHOTO or DIAGRAM	MITIGATION MEASURE	SCHEDULE
D7.9	The lavatory is compliant

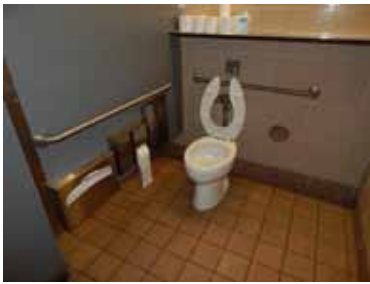
None required	N/A
D7.10	<p>The accessible toilet and stall are not compliant as follows;</p> <ol style="list-style-type: none"> 1. The toilet tissue dispenser is located too high or too far from the front of the toilet. 2. The stall door is not self closing. 3. The latching hardware is not compliant. 4. U-shaped handles are not provided on both sides of the door.

<ol style="list-style-type: none"> 1. Relocate the toilet tissue dispenser so that it is located 7" - 9" on the front of the toilet and 19" AFF. (Locate to the centerline of the dispenser) 2. Adjust the stall door so that it is self-closing. 3. Provide new latching hardware that does not require pinching, twisting or grasping. 4. Provide U-shaped handles on both sides of the door. 	P3

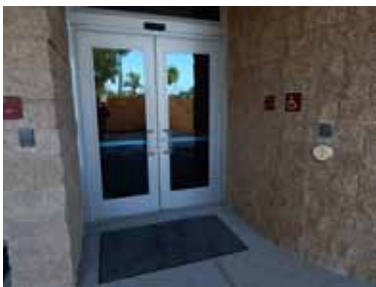
#	ITEM	PHOTO or DIAGRAM	MITIGATION MEASURE	SCHEDULE
D8.2	This main entry door to this facility is not compliant. The auto door operator is not functioning.

Repair the door operator to functioning condition.	P3
D8.3	The transaction area at the ticket booth is compliant.

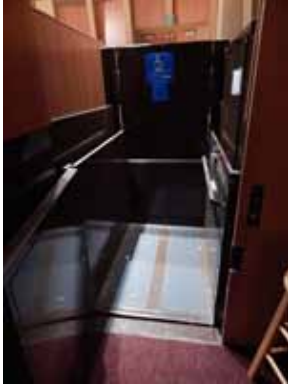
#	ITEM	PHOTO or DIAGRAM	MITIGATION MEASURE	SCHEDULE
D8.5	Concert Hall, 2405; The wheelchair lift serving the stage is not compliant. It does not function without the use of a key.

Service and maintain the lift so that it is in operating condition all of the time. Remove any locking devices so that it can be operated without a key.	P3
D8.6	Concert Hall, 2405; The portable stairway serving the right side of the stage is blocking wheelchair access to the lift.

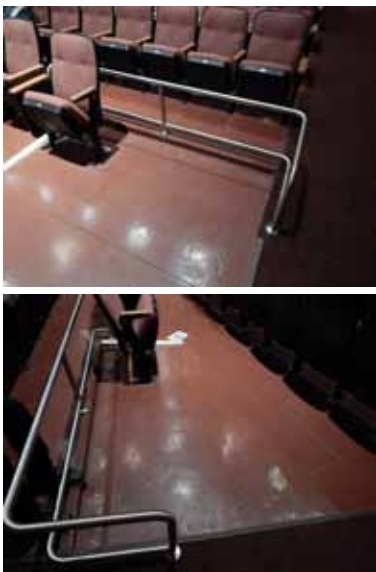
#	ITEM	PHOTO or DIAGRAM	MITIGATION MEASURE	SCHEDULE
D8.11	<p>Concert Hall, 2405;</p> <p>The 2 wheelchair seating positions on both sides of the middle section are not compliant as follows:</p> <ol style="list-style-type: none"> 1. The wheelchair spaces are not clearly designated. 2. The companion seating is not clearly designated. 3. The fixed companion seating is not located properly.

<ol style="list-style-type: none"> 1. Clearly designate the wheelchair seating spaces with an ISA symbol according to Appendix D.1 2. Clearly designate the companion seating spaces with an ISA symbol according to Appendix D.1 3. Relocate the companion seats so that the shoulder alignment point of the companion seat is 36" from the front of the wheelchair space or 12" from the back of the wheelchair space. 	P3
D8.12	<p>Concert Hall, 2405;</p> <p>The 2 wheelchair seating positions on both sides of the top row are not compliant as follows:</p> <ol style="list-style-type: none"> 1. The wheelchair spaces are not clearly designated. 2. The companion seating is not clearly designated. 3. The fixed companion seating is not located properly. 4. The POT from the aisle to the wheelchair space is too narrow at 28" clear.

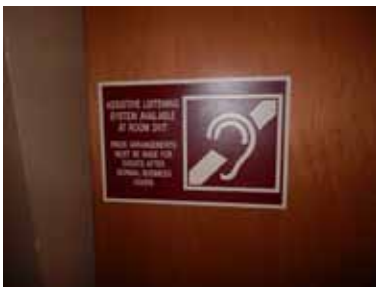
#	ITEM	PHOTO or DIAGRAM	MITIGATION MEASURE	SCHEDULE
D8.13	The existing assistive listening system devices were not available to check for compliance.

Verify that the following requirements have been met in regards to the assistive listening devices that are available: 1. A total of 20 receivers must be available. 2. Of the 20 receivers a minimum of 5 must be hearing aid compatible.	P3
Men				
D8.14	The entry door to this restroom is not compliant as follows; 1. The door operating pressure exceeds 5 pounds maximum. 2. The wall signage provided on the latch side of the door is not provided at 60" AFF.

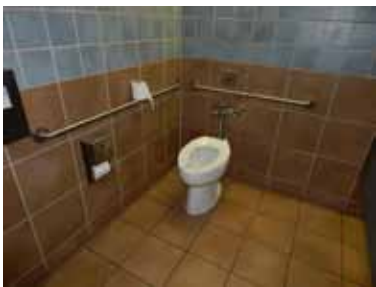
#	ITEM	PHOTO or DIAGRAM	MITIGATION MEASURE	SCHEDULE
D8.17	<p>The accessible toilet and stall are not compliant as follows;</p> <ol style="list-style-type: none"> 1. The toilet tissue dispenser is located too high or too far from the front of the toilet. 2. The stall door is not self closing. 3. The latching hardware is not compliant. 4. U-shaped handles are not provided on both sides of the door.

<ol style="list-style-type: none"> 1. Relocate the toilet tissue dispenser so that it is located 7"- 9" on the front of the toilet and 19" AFF. (Locate to the centerline of the dispenser) 2. Adjust the stall door so that it is self-closing. 3. Provide new latching hardware that does not require pinching, twisting or grasping. 4. Provide U-shaped handles on both sides of the door. 	P3
Women				
D8.18	<p>The entry door to this restroom is not compliant as follows;</p> <ol style="list-style-type: none"> 1. The door operating pressure exceeds 5 pounds maximum. 2. The wall signage provided on the latch side of the door is not provided at 60" AFF.

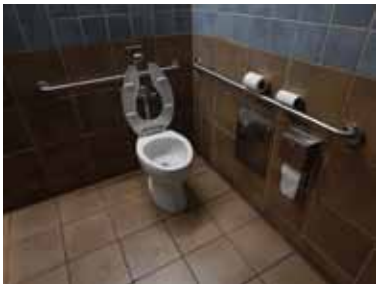
None required	N/A
D8.20	<p>The accessible toilet and stall are not compliant as follows;</p> <ol style="list-style-type: none"> 1. The toilet tissue dispenser is located too high or too far from the front of the toilet. 2. The stall door is not self closing. 3. The latching hardware is not compliant. 4. U-shaped handles are not provided on both sides of the door.

<ol style="list-style-type: none"> 1. Relocate the toilet tissue dispenser so that it is located 7"- 9" on the front of the toilet and 19" AFF. (Locate to the centerline of the dispenser) 2. Adjust the stall door so that it is self-closing. 3. Provide new latching hardware that does not require pinching, twisting or grasping. 4. Provide U-shaped handles on both sides of the door. 	P3

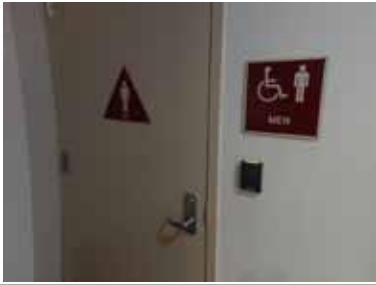
None required	N/A
Men				
D8.22	The entry door to this restroom is not compliant as follows; 1. The door operating pressure exceeds 5 pounds maximum. 2. The wall signage provided on the latch side of the door is not provided at 60" AFF.

1. Adjust the automatic closer on this door so that the pressure to operate does not exceed 5 pounds. 2. Provide a compliant wall sign on the latch side of the door mounted at 60" AFF to the TOP of the sign and 4" from the jamb. (Refer to Appendix B.14- B.17)	
D8.23	The lavatory is compliant

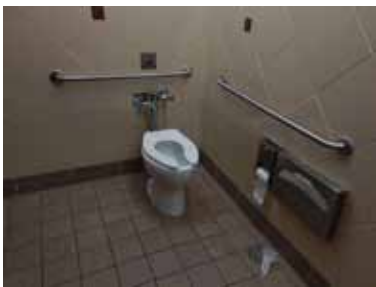
#	ITEM	PHOTO or DIAGRAM	MITIGATION MEASURE	SCHEDULE
D8.25	<p>The accessible toilet and stall are not compliant as follows;</p> <ol style="list-style-type: none"> 1. The side grab bar does not extend 54" minimum beyond the rear wall. (52") 2. The toilet tissue dispenser is located too high or too far from the front of the toilet. 3. U-shaped handles are not provided on both sides of the door.

<ol style="list-style-type: none"> 1. Replace the side grab bar or relocate the side grab bar so that it extends 54" beyond the rear wall. 2. Relocate the toilet tissue dispenser so that it is located 7"- 9" on the front of the toilet and 19" AFF. (Locate to the centerline of the dispenser) 3. Provide U-shaped handles on both sides of the door. 	P3
Women				
D8.26	<p>The entry door to this restroom is not compliant as follows;</p> <ol style="list-style-type: none"> 1. The door operating pressure exceeds 5 pounds maximum. 2. The wall signage provided on the latch side of the door is not provided at 60" AFF.

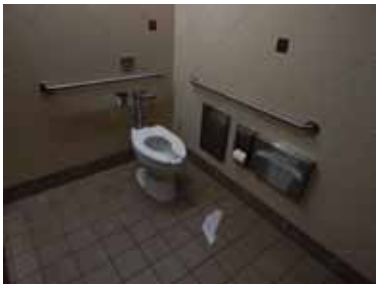
None required	N/A
D8.28	<p>The accessible toilet and stall are not compliant as follows;</p> <ol style="list-style-type: none"> 1. The stall door is not self closing. 2. The latching hardware is not compliant. 3. U-shaped handles are not provided on both sides of the door.

<ol style="list-style-type: none"> 1. Adjust the stall door so that it is self-closing. 2. Provide new latching hardware that does not require pinching, twisting or grasping. 3. Provide U-shaped handles on both sides of the door. 	P3

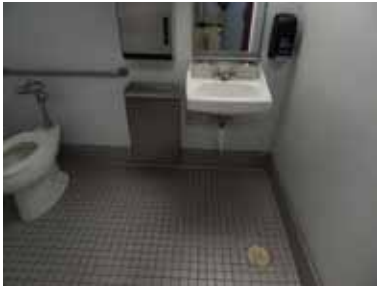
Unisex 1				
D9.5	<p>The entry door to this restroom is not compliant as follows;</p> <ol style="list-style-type: none"> 1. The door operating pressure exceeds 5 pounds maximum. 2. The door symbol is mounted incorrectly and the sign finish is not non-glare. 3. The wall signage provided on the latch side of the door is not provided at 60" AFF. 	None Provided	<ol style="list-style-type: none"> 1. Adjust the automatic closer on this door so that the pressure to operate does not exceed 5 pounds. 2. Replace the door symbol with a non-glare contrasting finish and mount at 60" AFF. 3. Provide a compliant wall sign on the latch side of the door mounted at 60" AFF to the TOP of the sign and 4" from the jamb. (Refer to Appendix B.14- B.17) 	P3
D9.6	<p>The accessible lavatory is not compliant as follows;</p> <ol style="list-style-type: none"> 1. The hot water and drain pipes and sharp objects under the sink have not been insulated or covered adequately.

<ol style="list-style-type: none"> 1. Provide adequate insulation and covering of all exposed pipes and sharp objects under the sink. 	P3

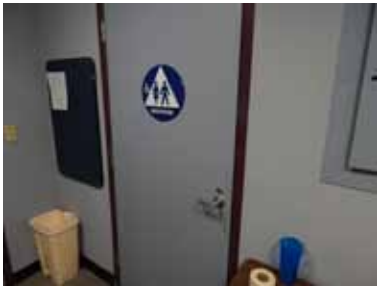
None required	N/A
Unisex 2				
D9.8	<p>The entry door to this restroom is not compliant as follows;</p> <ol style="list-style-type: none"> 1. The door operating pressure exceeds 5 pounds maximum. 2. The door symbol is mounted incorrectly and the sign finish is not non-glare. 3. The wall signage provided on the latch side of the door is not provided at 60" AFF.

<ol style="list-style-type: none"> 1. Adjust the automatic closer on this door so that the pressure to operate does not exceed 5 pounds. 2. Replace the door symbol with a non-glare contrasting finish and mount at 60" AFF. 3. Provide a compliant wall sign on the latch side of the door mounted at 60" AFF to the TOP of the sign and 4" from the jamb. (Refer to Appendix B.14- B.17) 	P3

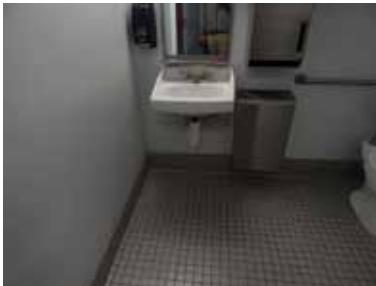
#	ITEM	PHOTO or DIAGRAM	MITIGATION MEASURE	SCHEDULE
D9.9	<p>The accessible lavatory is not compliant as follows;</p> <p>1. The hot water and drain pipes and sharp objects under the sink have not been insulated or covered adequately.</p>

<p>1. Provide adequate insulation and covering of all exposed pipes and sharp objects under the sink.</p>	P3
D9.10	<p>The toilet is compliant</p>

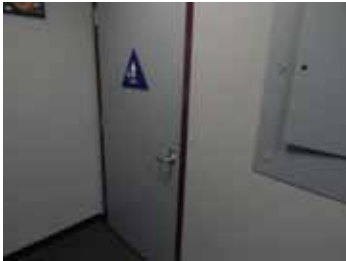
Men				
D10.2	<p>The entry door to this restroom is not compliant as follows;</p> <ol style="list-style-type: none"> 1. The door operating pressure exceeds 5 pounds maximum. 2. The wall signage provided on the latch side of the door is not provided at 60" AFF.

<ol style="list-style-type: none"> 1. Adjust the automatic closer on this door so that the pressure to operate does not exceed 5 pounds. 2. Provide a compliant wall sign on the latch side of the door mounted at 60" AFF to the TOP of the sign and 4" from the jamb. (Refer to Appendix B.14- B.17) 	P2
D10.3	<p>The accessible lavatory is not compliant as follows;</p> <ol style="list-style-type: none"> 1. The hot water and drain pipes and sharp objects under the sink have not been insulated or covered adequately.

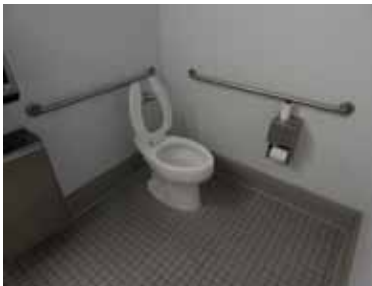
D10.4	<p>The accessible toilet and stall are not compliant as follows;</p> <ol style="list-style-type: none"> 1. The toilet tissue dispenser is located too high or too far from the front of the toilet. 2. The toilet seat tissue dispenser is not located on an accessible route.

<ol style="list-style-type: none"> 1. Relocate the toilet tissue dispenser so that it is located 7"- 9" on the front of the toilet and 19" AFF. (Locate to the centerline of the dispenser) 2. Relocate the toilet seat tissue dispenser so that it is located on an accessible route. (Locations above the grab bars are not accessible.) 	P2
Women				
D10.5	<p>The entry door to this restroom is not compliant as follows;</p> <ol style="list-style-type: none"> 1. The door operating pressure exceeds 5 pounds maximum. 2. The wall signage provided on the latch side of the door is not provided at 60" AFF.

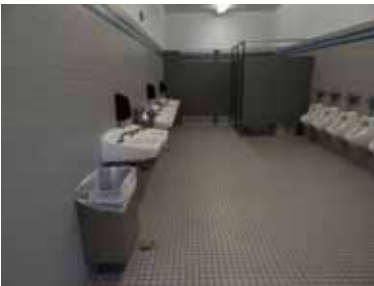
D11.5	<p>The accessible lavatory is not compliant as follows;</p> <ol style="list-style-type: none"> 1. The knee clearance does not meet the requirements. 2. The hot water and drain pipes and sharp objects under the sink have not been insulated or covered adequately.

<ol style="list-style-type: none"> 1. Modify the sink counter so that the required knee clearance is provided. (See Appendix B.1 for clearance profile) 2. Provide adequate insulation and covering of all exposed pipes and sharp objects under the sink. 	P2
D11.6	The urinal is compliant

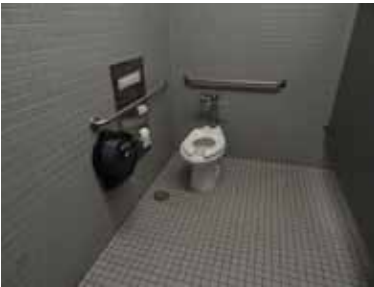
None required.	N/A
D11.7	<p>The accessible toilet and stall are not compliant as follows;</p> <ol style="list-style-type: none"> 1. The side grab bar does not extend 54" minimum beyond the rear wall. (52") 2. The toilet tissue dispenser is located too high or too far from the front of the toilet.

<ol style="list-style-type: none"> 1. Replace the side grab bar or relocate the side grab bar so that it extends 54" beyond the rear wall. 2. Relocate the toilet tissue dispenser so that it is located 7"- 9" on the front of the toilet and 19" AFF. (Locate to the centerline of the dispenser) 	P2

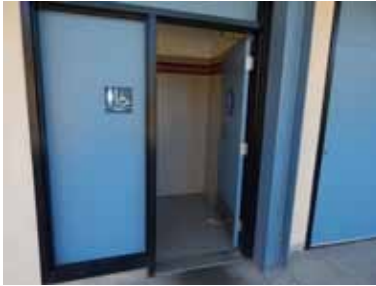
Women, 3204				
D11.8	<p>The entry door to this restroom is not compliant as follows;</p> <ol style="list-style-type: none"> 1. The door operating pressure exceeds 5 pounds maximum. 2. The door symbol is mounted incorrectly and the sign finish is not non-glare. 3. Door symbol is not contrasting in color from the finish of the door 4. The wall signage on the latch side of the door is not provided at 60" AFF.

<ol style="list-style-type: none"> 1. Adjust the automatic closer on this door so that the pressure to operate does not exceed 5 pounds. 2. Replace the door symbol with a non-glare contrasting finish and mount at 60" AFF. 3. Replace the door symbol with a symbol that is 70% contrast in color from the finish of the door. OR Provide a white border 1" wide around the symbol. 4. Provide a compliant wall sign on the latch side of the door mounted at 60" AFF to the TOP of the sign and 4" from the jamb. (Refer to Appendix B.14- B.17) 	P2

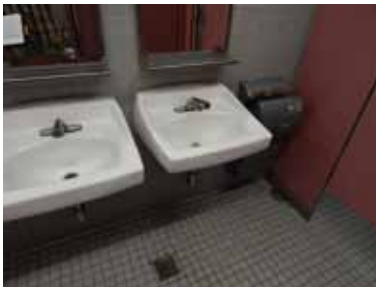
D11.9	<p>The accessible lavatory is not compliant as follows;</p> <ol style="list-style-type: none"> 1. The knee clearance does not meet the requirements. 2. The hot water and drain pipes and sharp objects under the sink have not been insulated or covered adequately.

<ol style="list-style-type: none"> 1. Modify the sink counter so that the required knee clearance is provided. (See Appendix B.1 for clearance profile) 2. Provide adequate insulation and covering of all exposed pipes and sharp objects under the sink. 	P2
D11.10	<p>The accessible toilet and stall are not compliant as follows;</p> <ol style="list-style-type: none"> 1. The side grab bar does not extend 54" minimum beyond the rear wall. (52") 2. The toilet tissue dispenser is located too high or too far from the front of the toilet.

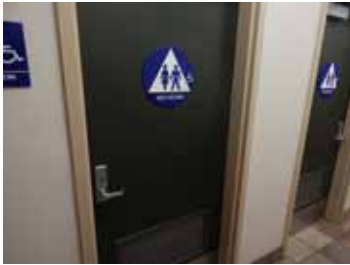
#	ITEM	PHOTO or DIAGRAM	MITIGATION MEASURE	SCHEDULE
Unisex 1				
D12.5	<p>The entry door to this restroom is not compliant as follows;</p> <ol style="list-style-type: none"> 1. The door operating pressure exceeds 5 pounds maximum. 2. The wall signage provided on the latch side of the door is not provided at 60" AFF.

<ol style="list-style-type: none"> 1. Adjust the automatic closer on this door so that the pressure to operate does not exceed 5 pounds. 2. Provide a compliant wall sign on the latch side of the door mounted at 60" AFF to the TOP of the sign and 4" from the jamb. (Refer to Appendix B.14- B.17) 	P2
D12.6	<p>The accessible lavatory is not compliant as follows;</p> <ol style="list-style-type: none"> 1. The hot water and drain pipes and sharp objects under the sink have not been insulated or covered adequately.

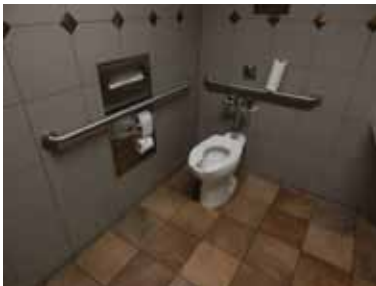
D12.7	<p>The accessible toilet and stall are not compliant as follows;</p> <ol style="list-style-type: none"> 1. The rear grab bar does not extend 24" minimum beyond the centerline of the fixture on the wide side. (22") 2. The toilet tissue dispenser is located too high or too far from the front of the toilet.

<ol style="list-style-type: none"> 1. Replace the rear grab bar or relocate the rear grab bar so that it extends 24" beyond the centerline of the toilet to the wide side. 2. Relocate the toilet tissue dispenser so that it is located 7"- 9" on the front of the toilet and 19" AFF. (Locate to the centerline of the dispenser) 	P2
Unisex 2				
D12.8	<p>The entry door to this restroom is not compliant as follows;</p> <ol style="list-style-type: none"> 1. The door operating pressure exceeds 5 pounds maximum. 2. The wall signage provided on the latch side of the door is not provided at 60" AFF.

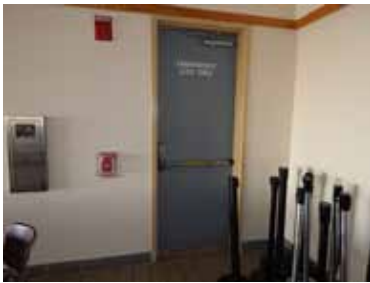
Upper Level / Cafeteria and Offices				
D13.1	The exit doors throughout this upper level are not compliant. Tactile exit signage is not provided.

Provide a tactile exit sign mounted on the wall adjacent to the door at 60" AFF according to Appendix D.8	P3
D13.2	The seating in the cafeteria is not compliant. There are no designated wheelchair seating areas. However, the tables do comply with knee clearance requirements for wheelchairs.

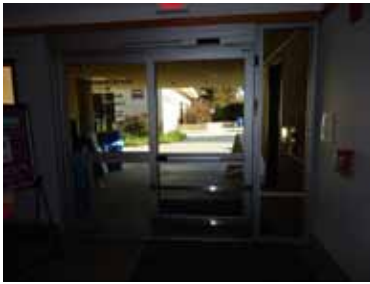
#	ITEM	PHOTO or DIAGRAM	MITIGATION MEASURE	SCHEDULE
D13.6	This exit door is not compliant. Tactile exit signage is not provided.

Provide a tactile exit sign mounted on the wall adjacent to the door at 60" AFF according to Appendix D.8	P3
D13.7	This exit door is not compliant. Tactile exit signage is not provided.

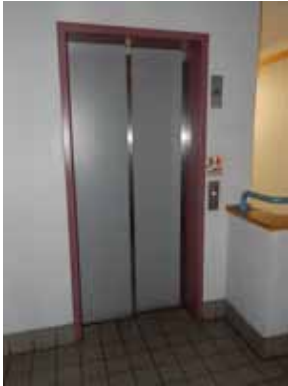
Provide a tactile exit sign mounted on the wall adjacent to the door at 60" AFF according to Appendix D.8	P3
D13.8	The elevator lobby is not compliant as follows: 1. Both elevator jams do not have raised numbers designating the floor.

1. Provide raised, 2" tall numbers designating the floor, mounted at 60" AFF, with white numbers on black background with appropriate braille beneath. Provide a five pointed star on the Jim markings at the lower level.	P3

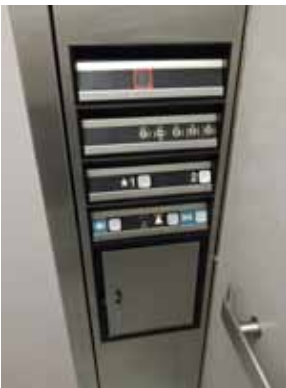
None required.	N/A
D13.10	The cab controls of this elevator are not compliant as follows: 1. There is no visible car position indicator above the control panel.

1. Provide a visible car position indicator above the control panel or over the doorway.	P3
Lower Level / Bookstore				
D13.11	The entry door into the bookstore is compliant.

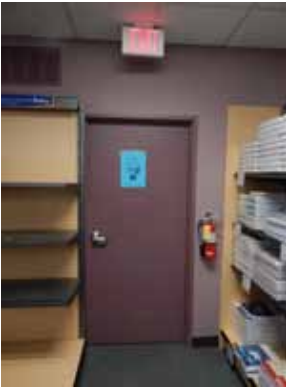
None required.	N/A
D13.14	This exit doors throughout this level are not compliant. Tactile exit signage is not provided.

Provide a tactile exit sign mounted on the wall adjacent to the door at 60" AFF according to Appendix D.8	P3

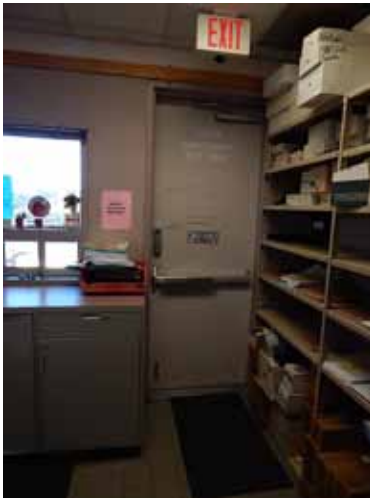
#	ITEM	PHOTO or DIAGRAM	MITIGATION MEASURE	SCHEDULE
D13.15	<p>The copy center on the north side of the bookstore is not compliant as follows:</p> <ol style="list-style-type: none"> 1. The exit door is not compliant. Tactile exit signage is not provided. 2. The transaction counter on the inside and the outside is too high at 39" AFF.

<ol style="list-style-type: none"> 1. Provide a tactile exit sign mounted on the wall adjacent to the door at 60" AFF according to Appendix D.8 2. Provide a transaction counter at 34" AFF max. on both the inside and outside of this room. 	P3
D13.16	<p>This exit doors throughout this level are not compliant. Tactile exit signage is not provided.</p>

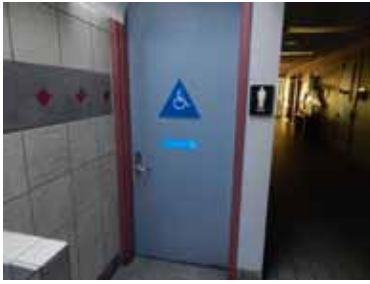
None required.	N/A
Men				
D13.19	<p>The entry door to this restroom is not compliant as follows;</p> <ol style="list-style-type: none"> 1. The door operating pressure exceeds 5 pounds maximum. 2. The wall signage provided on the latch side of the door is mounted incorrectly. 3. Door symbol is not contrasting in color from the finish of the door

<ol style="list-style-type: none"> 1. Adjust the automatic closer on this door so that the pressure to operate does not exceed 5 pounds. 2. Provide a compliant wall sign on the latch side of the door mounted at 60" AFF to the TOP of the sign and 4" from the jamb. (Refer to Appendix B.14- B.17) 3. Replace the door symbol with a symbol that is 70% contrast in color from the finish of the door. OR Provide a white border 1" wide around the symbol. 	P3

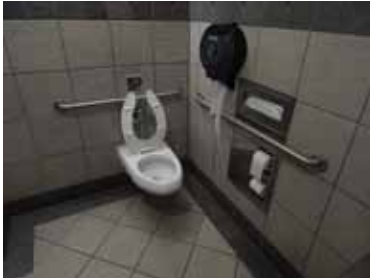
None required	N/A
D13.22	<p>The accessible toilet and stall are not compliant as follows;</p> <ol style="list-style-type: none"> 1. The rear grab bar does not extend 24" minimum beyond the centerline of the fixture on the wide side. (22") 2. The side grab bar does not extend 54" minimum beyond the front edge of the fixture. (52") 3. The toilet tissue dispenser is not located correctly.

<ol style="list-style-type: none"> 1. Replace the rear grab bar or relocate the rear grab bar so that it extends 24" beyond the centerline of the toilet to the wide side. 2. Replace the side grab bar or relocate the side grab bar so that it extends 54" beyond the front edge of the fixture. 3. Relocate the toilet tissue dispenser so that it is located 7"- 9" on the front of the toilet and 19" AFF. (Locate to the centerline of the dispenser) 	P3

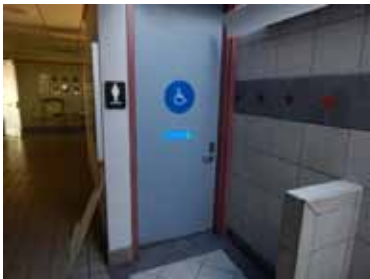
Women				
D13.23	<p>The entry door to this restroom is not compliant as follows;</p> <ol style="list-style-type: none"> 1. The door operating pressure exceeds 5 pounds maximum. 2. The wall signage provided on the latch side of the door is mounted incorrectly. 3. Door symbol is not contrasting in color from the finish of the door

<ol style="list-style-type: none"> 1. Adjust the automatic closer on this door so that the pressure to operate does not exceed 5 pounds. 2. Provide a compliant wall sign on the latch side of the door mounted at 60" AFF to the TOP of the sign and 4" from the jamb. (Refer to Appendix B.14- B.17) 3. Replace the door symbol with a symbol that is 70% contrast in color from the finish of the door. OR Provide a white border 1" wide around the symbol. 	P3

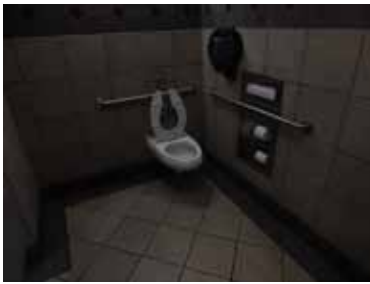
None required	N/A
D13.25	The accessible toilet and stall are not compliant as follows; 1. The side grab bar does not extend 54" minimum beyond the front edge of the fixture. (52") 2. The toilet tissue dispenser is not located correctly.

<ol style="list-style-type: none"> 1. Replace the side grab bar or relocate the side grab bar so that it extends 54" beyond the front edge of the fixture. 2. Relocate the toilet tissue dispenser so that it is located 7"- 9" on the front of the toilet and 19" AFF. (Locate to the centerline of the dispenser) 	P3

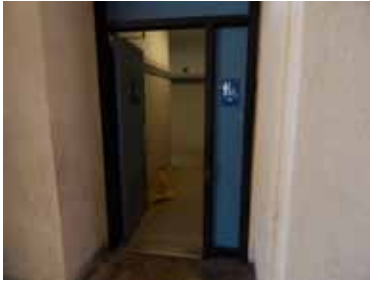
Unisex 1				
D14.4	<p>The entry door to this restroom is not compliant as follows;</p> <ol style="list-style-type: none"> 1. The wall signage provided on the latch side of the door is mounted incorrectly. 2. Door symbol is not contrasting in color from the finish of the door

<ol style="list-style-type: none"> 1. Provide a compliant wall sign on the latch side of the door mounted at 60" AFF to the TOP of the sign and 4" from the jamb. (Refer to Appendix B.14- B.17) 2. Replace the door symbol with a symbol that is 70% contrast in color from the finish of the door. OR Provide a white border 1" wide around the symbol. 	P3
D14.5	<p>The accessible lavatory is not compliant as follows;</p> <ol style="list-style-type: none"> 1. The knee clearance does not meet the requirements. 2. The hot water and drain pipes and sharp objects under the sink have not been insulated or covered adequately.

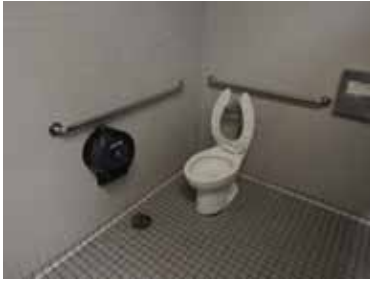
None required	N/A
D14.7	<p>The accessible toilet and stall are not compliant as follows;</p> <ol style="list-style-type: none"> 1. The rear grab bar does not extend 24" minimum beyond the centerline of the fixture on the wide side. 2. The toilet tissue dispenser is located too high or too far from the front of the toilet.

<ol style="list-style-type: none"> 1. Replace the rear grab bar or relocate the rear grab bar so that it extends 24" beyond the centerline of the toilet to the wide side. 2. Relocate the toilet tissue dispenser so that it is located 7"- 9" on the front of the toilet and 19" AFF so that it does not protrude more than 3" into the clear floor space.. (Locate to the centerline of the dispenser) 	P3

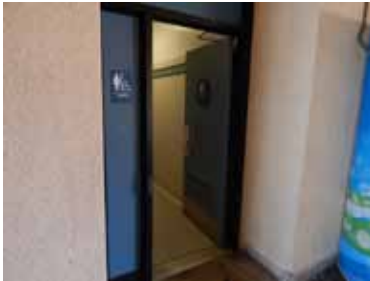
Unisex 2				
D14.8	<p>The entry door to this restroom is not compliant as follows;</p> <ol style="list-style-type: none"> 1. The wall signage provided on the latch side of the door is mounted incorrectly. 2. Door symbol is not contrasting in color from the finish of the door

<ol style="list-style-type: none"> 1. Provide a compliant wall sign on the latch side of the door mounted at 60" AFF to the TOP of the sign and 4" from the jamb. (Refer to Appendix B.14- B.17) 2. Replace the door symbol with a symbol that is 70% contrast in color from the finish of the door. OR Provide a white border 1" wide around the symbol. 	P3
D14.9	<p>The accessible lavatory is not compliant as follows;</p> <ol style="list-style-type: none"> 1. The knee clearance does not meet the requirements. 2. The hot water and drain pipes and sharp objects under the sink have not been insulated or covered adequately.

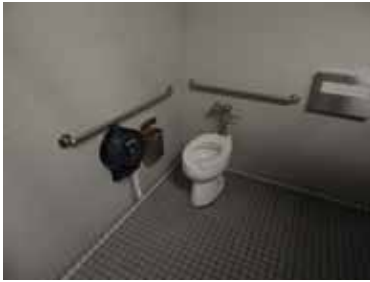
D14.10	<p>The accessible toilet and stall are not compliant as follows;</p> <ol style="list-style-type: none"> 1. The rear grab bar does not extend 24" minimum beyond the centerline of the fixture on the wide side. 2. The toilet tissue dispenser is located too high or too far from the front of the toilet.

<ol style="list-style-type: none"> 1. Replace the rear grab bar or relocate the rear grab bar so that it extends 24" beyond the centerline of the toilet to the wide side. 2. Relocate the toilet tissue dispenser so that it is located 7"- 9" on the front of the toilet and 19" AFF so that it does not protrude more than 3" into the clear floor space.. (Locate to the centerline of the dispenser) 	P3

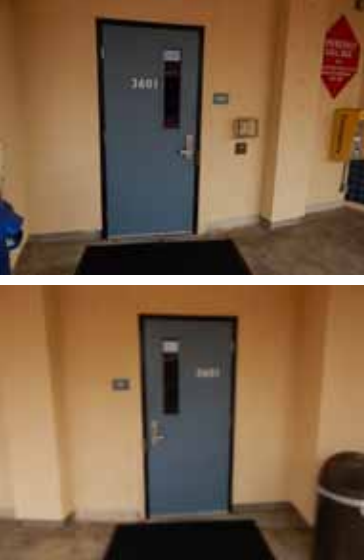
<p>D15.1</p>	<p>Lecture Hall, Room 3601; The two entry doors to this room are not compliant as follows:</p> <ol style="list-style-type: none"> 1. The door operating pressure exceeds 5 pounds maximum. 2. The entry doors are not indicated as an accessible entrance.

<ol style="list-style-type: none"> 1. Adjust the automatic closer on the doors so that the operating pressure does not exceed 5 pounds. 2. Provide an ISA sign on the front door according to Appendix D.1 	<p>P3</p>
<p>D15.2</p>	<p>Lecture Hall, Room 3601; The exterior stairways on both sides of the Lecture Hall are not compliant as follows:</p> <ol style="list-style-type: none"> 1. The nosing do not have contrasting color warning stripes.

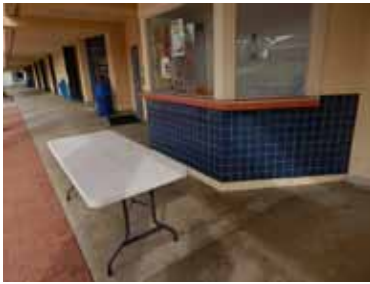
#	ITEM	PHOTO or DIAGRAM	MITIGATION MEASURE	SCHEDULE
D15.3	Lecture Hall, Room 3601; The transaction area at the ticket booth is too high and not compliant.

Provide a transaction area at the ticket booth that is 34" AFF maximum.	P3
D15.4	Lecture Hall, Room 3601; The ramps down on both sides of the seating area are not compliant. The slope in the direction of travel is too steep at 9.6%-10.1%

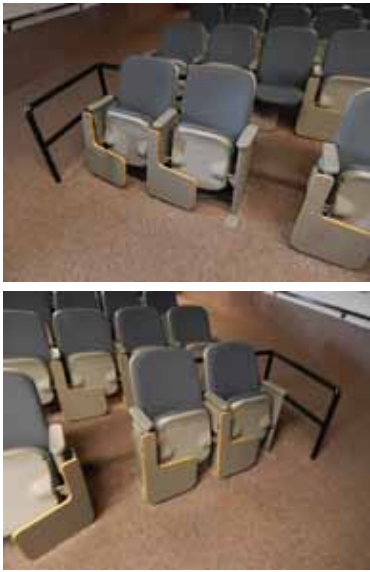
#	ITEM	PHOTO or DIAGRAM	MITIGATION MEASURE	SCHEDULE
D15.6	Lecture Hall, Room 3601; The wheelchair seating on the lower level has been in filled my temporary seating that is not easily removable. This is not compliant.

This wheelchair seating can be moved to the upper level as indicated in the two items above.	P3
D15.7	Lecture Hall, Room 3601; There is no evidence that in this lecture hall that assistive listening devices are provided for the hearing impaired and therefore it is not compliant.	[No photo provided]	1. Provide a permanently installed assistive listening system. 2. Provide 4% of the total number of seats, but no less than two, assistive listening device receivers for this lecture hall. No fewer than two, shall be hearing-aid compatible in accordance with CBC Section 1B-706.3 3. Provide compliant signage indicating that the devices are available and where they are to be picked up. Refer to Appendix B.18 for the appropriate symbol.	P3

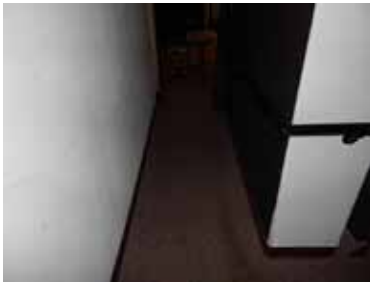
D15.8	Lecture Hall, Room 3601; The ramp access up to the stage level is not compliant. It is too narrow and too steep at 36" wide and 10.0% slope.

Widen this ramp to 48" and reduce the slope to 8.3% and install compliant grab bars on both sides. OR Provide an alternate means of access to the stage by the addition of a wheelchair lift.	P3

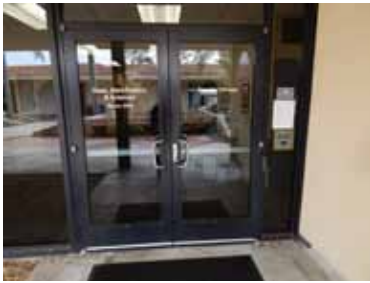
None required.	N/A
D15.10	Lobby, Room 3610C; The two entry doors to this room are not compliant as follows: 1. The door operating pressure exceeds 5 pounds The door operating pressure exceeds 5 pounds maximum. 2. The entry doors are not indicated as an accessible entrance.

1. Adjust the automatic closer on the doors so that the operating pressure does not exceed 5 pounds. 2. Provide an ISA sign on the front door according to Appendix D.1	P3
D15.11	All of the exit doors in this building are not compliant. They do not have the required tactile exit signs installed.	[No photo provided]	Install appropriate tactile exit and exit route signs according to Appendix D.8 at every door in this building designated as an exit.	P3
D15.12	In this building; the classroom seating, POT and designated wheelchair seating is compliant.

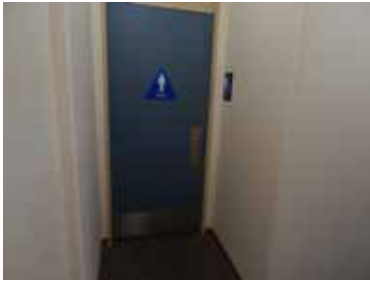
Men				
D15.13	The entry door to this restroom is not compliant as follows; 1. The door operating pressure exceeds 5 pounds maximum. 2. Door symbol is not contrasting in color from the finish of the door 3. The wall signage provided on the latch side of the door is not provided at 60" AFF.

1. Adjust the automatic closer on this door so that the pressure to operate does not exceed 5 pounds. 2. Replace the door symbol with a symbol that is 70% contrast in color from the finish of the door. OR Provide a white border 1" wide around the symbol. 3. Provide a compliant wall sign on the latch side of the door mounted at 60" AFF to the TOP of the sign and 4" from the jamb. (Refer to Appendix B.14- B.17)	P3

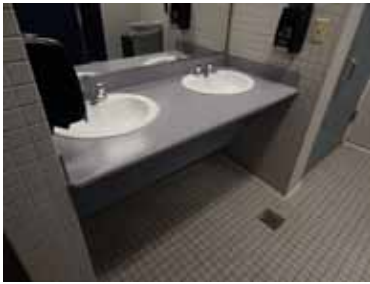
#	ITEM	PHOTO or DIAGRAM	MITIGATION MEASURE	SCHEDULE
D15.14	<p>The accessible lavatory is not compliant as follows;</p> <ol style="list-style-type: none"> 1. The knee clearance does not meet the requirements. 2. The hot water and drain pipes and sharp objects under the sink have not been insulated or covered adequately. 3. The required clear floor space is not provided

<ol style="list-style-type: none"> 1. Modify the sink counter so that the required knee clearance is provided. (See Appendix B.1 for clearance profile) 2. Provide adequate insulation and covering of all exposed pipes and sharp objects under the sink. 3. Reconfigure this lavatory so that a 30" x 48" clear floor space is provided on the front approach 	P3
D15.15	The urinal is compliant

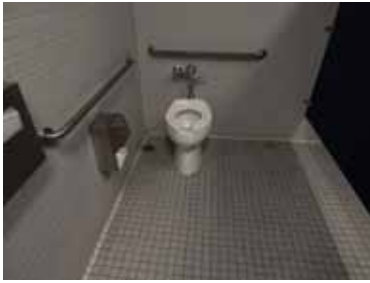
None required	N/A
D15.16	<p>The accessible toilet and stall are not compliant as follows;</p> <ol style="list-style-type: none"> 1. The toilet tissue dispenser is located too high or too far from the front of the toilet. 2. The toilet seat tissue dispenser is not located on an accessible route. 3. U-shaped handles are not provided on both sides of the door.

<ol style="list-style-type: none"> 1. Relocate the toilet tissue dispenser so that it is located 7"- 9" on the front of the toilet and 19" AFF. (Locate to the centerline of the dispenser) 2. Relocate the toilet seat tissue dispenser so that it is located on an accessible route. (Locations above the grab bars are not accessible.) 3. Provide U-shaped handles on both sides of the door. 	P3

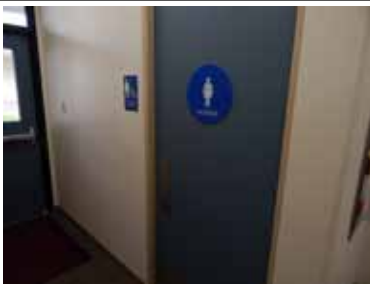
Women				
D15.17	<p>The entry door to this restroom is not compliant as follows;</p> <ol style="list-style-type: none"> 1. The door operating pressure exceeds 5 pounds maximum. 2. Door symbol is not contrasting in color from the finish of the door 3. The wall signage provided on the latch side of the door is not provided at 60" AFF.

<ol style="list-style-type: none"> 1. Adjust the automatic closer on this door so that the pressure to operate does not exceed 5 pounds. 2. Replace the door symbol with a symbol that is 70% contrast in color from the finish of the door. OR Provide a white border 1" wide around the symbol. 3. Provide a compliant wall sign on the latch side of the door mounted at 60" AFF to the TOP of the sign and 4" from the jamb. (Refer to Appendix B.14- B.17) 	P3

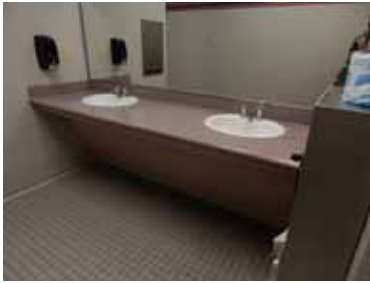
#	ITEM	PHOTO or DIAGRAM	MITIGATION MEASURE	SCHEDULE
D15.18	<p>The accessible lavatory is not compliant as follows;</p> <ol style="list-style-type: none"> 1. The knee clearance does not meet the requirements.

<ol style="list-style-type: none"> 1. Modify the sink counter so that the required knee clearance is provided. (See Appendix B.1 for clearance profile) 	P3
D15.19	<p>The accessible toilet and stall are not compliant as follows;</p> <ol style="list-style-type: none"> 1. The centerline of the toilet is located too far or too close to the sidewall. 2. The rear grab bar does not extend 24" minimum beyond the centerline of the fixture on the wide side. (21") 3. The toilet tissue dispenser is located too high or too far from the front of the toilet. 4. U-shaped handles are not provided on both sides of the door.

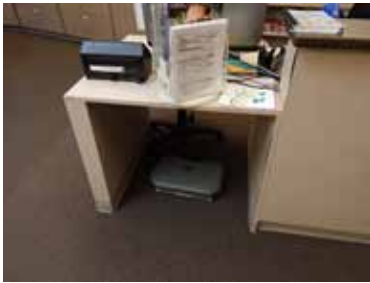
None required.	N/A
D16.2	Office, 3727B; This transaction area is not compliant. There are various items obscuring the surface of the transaction surface.

Remove objects of securing the transaction surface and keep this area free and clear for the use by individuals in wheelchairs.	P2
D16.3	Office, 3727B; This transaction area is not compliant. There are various items obscuring the surface of the transaction surface.

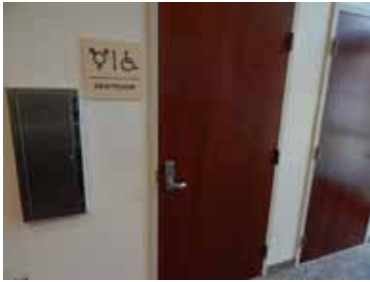
None required.	N/A
Unisex 1				
D16.5	<p>The entry door to this restroom is not compliant as follows;</p> <ol style="list-style-type: none"> 1. The door operating pressure exceeds 5 pounds maximum. 2. The door symbol is not provided. 3. The wall signage provided on the latch side of the door is not provided at 60" AFF.

<ol style="list-style-type: none"> 1. Adjust the automatic closer on this door so that the pressure to operate does not exceed 5 pounds. 2. Install a door symbol with a non-glare contrasting finish and mount at 60" AFF with a symbol that is 70% contrast in color from the finish of the door. OR Provide a white border 1" wide around the symbol. 3. Provide a compliant wall sign on the latch side of the door mounted at 60" AFF to the TOP of the sign and 4" from the jamb. (Refer to Appendix B.14- B.17) 	P2

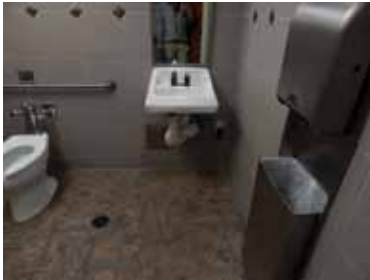
D16.6	<p>The accessible lavatory is not compliant as follows;</p> <ol style="list-style-type: none"> 1. The hot water and drain pipes and sharp objects under the sink have not been insulated or covered adequately.

<ol style="list-style-type: none"> 1. Provide adequate insulation and covering of all exposed pipes and sharp objects under the sink. 	P2
D16.7	This toilet is compliant

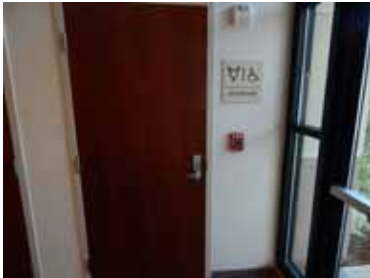
Unisex 2				
D16.8	<p>The entry door to this restroom is not compliant as follows;</p> <ol style="list-style-type: none"> 1. The door operating pressure exceeds 5 pounds maximum. 2. The door symbol is not provided. 3. The wall signage provided on the latch side of the door is not provided at 60" AFF.

<ol style="list-style-type: none"> 1. Adjust the automatic closer on this door so that the pressure to operate does not exceed 5 pounds. 2. Install a door symbol with a non-glare contrasting finish and mount at 60" AFF with a symbol that is 70% contrast in color from the finish of the door. OR Provide a white border 1" wide around the symbol. 3. Provide a compliant wall sign on the latch side of the door mounted at 60" AFF to the TOP of the sign and 4" from the jamb. (Refer to Appendix B.14- B.17) 	P2
D16.9	<p>The accessible lavatory is not compliant as follows;</p> <ol style="list-style-type: none"> 1. The hot water and drain pipes and sharp objects under the sink have not been insulated or covered adequately.

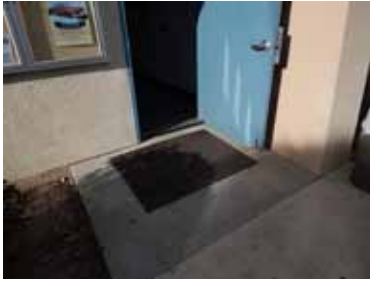
D17.1	The landing at the exterior entry door on the upper level is not compliant. It is not level and sloped at 6%.

Reconstruct the exterior landing at this door so that it is level at no more than 2% slope and is flush with the bottom of the threshold. This landing should extend 60" minimum out from the face of the door and 24" beyond the latch side of the door. Reconstruct the existing concrete walkway so that it meets the new threshold and does not exceed 5% slope in the direction of travel.	P3
D17.2	This drinking fountain is not compliant. It is not a dual height unit and does not meet clearance and height requirements.

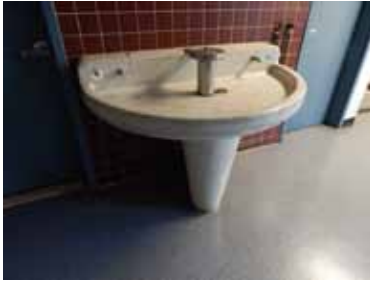
Replace this drinking fountain unit with a wall-mounted hydration station for filling water bottles.	P3
D17.3	This hand wash station is not compliant. it does not meet the new clearance and reach requirements for wheelchair use.

Replace the sink with a compliant hand wash sink. OR Provide a separate hand wash sink that is wheelchair accessible in the immediate area.	P3

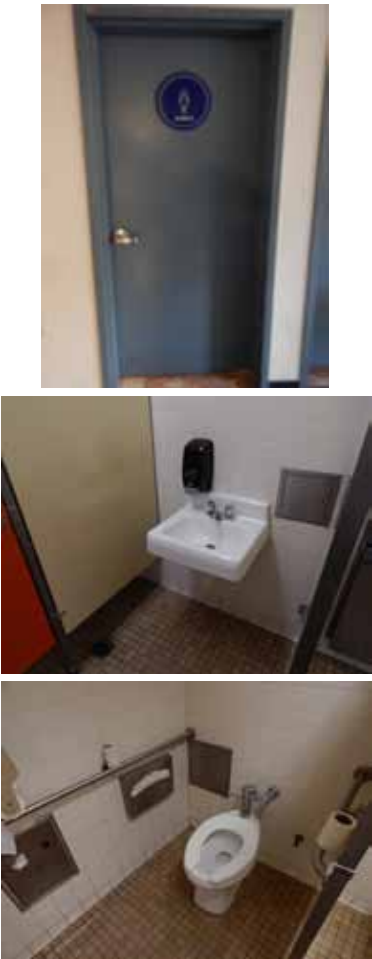
#	ITEM	PHOTO or DIAGRAM	MITIGATION MEASURE	SCHEDULE
D17.5	The women's toilet room is not compliant in size, configuration and clearances.

This toilet room should be reconfigured to meet all of the size, configuration and clearance requirements as indicated in Appendix B.5 - B.17	P3
D17.6	All doors in this building that are designated exit doors are not compliant. They do not have the required tactile exit signage.	[No photo provided]	Provide tactile exit signage at every interior door designated as an exit according to Appendix D.8	P3
D17.7	All doors in this building are not compliant. They do not have the required tactile room number signage.	[No photo provided]	Provide tactile room number signage at every interior door located according to Appendix D.8	P3

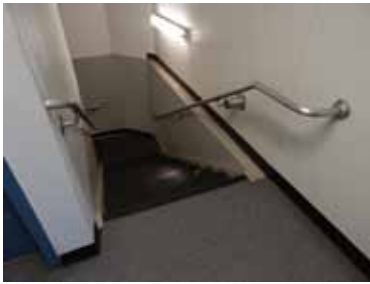
#	ITEM	PHOTO or DIAGRAM	MITIGATION MEASURE	SCHEDULE
D17.8	The existing POT from the upper-level classroom to the lower level vehicle repair area is not wheelchair compliant.

Provide some means of vertical lift for wheelchair users from the lower level to the upper level.	P3
D17.9	The existing stairway from the upper level to the lower level is not compliant as follows: 1. It lacks 70% contrasting color warning stripes at the top and bottom nosing of each run. 2. The nosings have an abrupt edge.

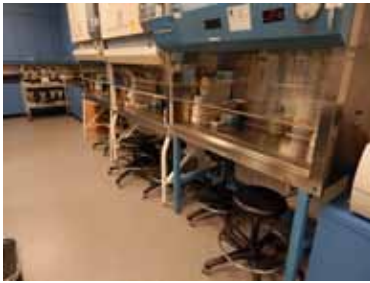
None required.	N/A
D17.14	Lab, Room 4051; The fume hoods provide wheelchair access to the working surface. However, the controls on these units are mounted too high at 64" to 70" AFF.

Provide one fume hood with controls that are mounted no higher than 48" AFF.	P3
D17.15	Biotech; All doors in this area that are designated exit doors are not compliant. They do not have the required tactile exit signage.

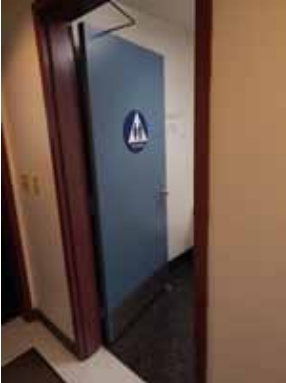
Arrange the exercise equipment so that a POT 36" wide minimum is provided to one of each type of equipment. Provide a 30"x48" clear transfer area at one of each type of equipment.	P2
Unisex				
D18.3	1. Compliant tactile signage is not provided on the wall next to the jamb. 2. The force to operate this door is too much.

1. Provide compliant wall signage on the left side of the door mounted according to Appendix B.16 2. Adjust the auto closer on the door so that the force to operate the door does not exceed 5#.	P2
D18.4	1. The toilet is mounted too far from the wall at 20" 2. Toilet tissue dispenser is too close to the front of the toilet at 2" 3. The grab bar on the side wall is mounted too far from the rear wall at 17" 4. The bottom of the mirror is too high at 41" AFF

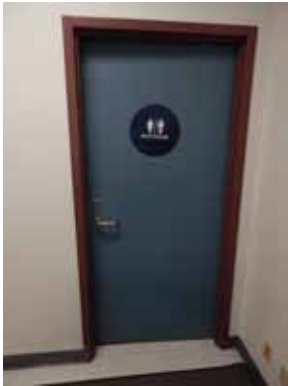
#	ITEM	PHOTO or DIAGRAM	MITIGATION MEASURE	SCHEDULE
D18.5	<ol style="list-style-type: none"> 1. Compliant tactile signage is not provided on the wall next to the jamb. 2. The force to operate this door is too much.

<ol style="list-style-type: none"> 1. Provide compliant wall signage on the left side of the door mounted according to Appendix B.16 2. Adjust the auto closer on the door so that the force to operate the door does not exceed 5#. 	P2
D18.6	<ol style="list-style-type: none"> 1. Toilet tissue dispenser is mounted too high. 2. The bottom of the mirror is too high at 49" AFF

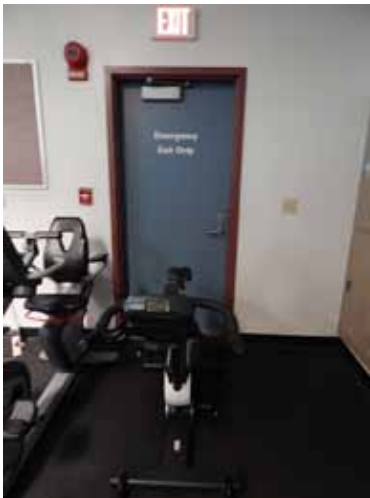
<ol style="list-style-type: none"> 1. Relocate the toilet tissue dispenser so that it is 7" to 9" from the front of the toilet and 19" AFF. 2. Relocate the mirror so that the bottom is 40" AFF max. 	P2
D18.7	<p>Weight Room, 4108 and Lobby, 4102;</p> <p>All doors in this area that are designated exit doors are not compliant. They do not have the required tactile exit signage.</p>

Provide tactile exit signage at every interior door designated as an exit according to Appendix D.8	P2

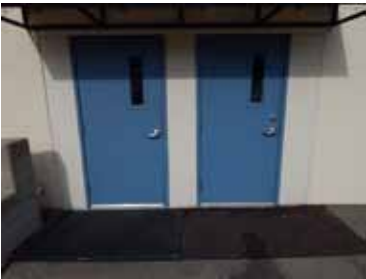
D19.1	The two entry doors into this building are not compliant as follows: 1. The bottom of the threshold has an abrupt level change to the exterior landing of 1" - 1.5"

1. Provide a level landing at the exterior of these doors that is flush with the bottom of the threshold.	P3
D19.2	The transaction area in this office is compliant.

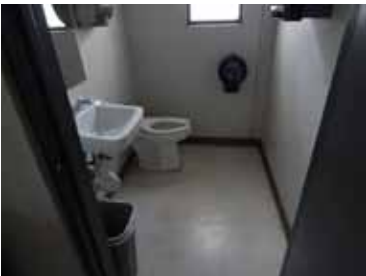
None required.	N/A
Unisex Toilet				
D19.4	The restroom serving this facility is not compliant and lacks the required dimensions to make it accessible.

1. Remodel this restroom so that dimension in appendix	P3

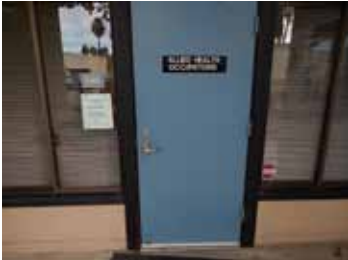
D21.1	The entrances to the nursing classroom facility are not compliant. The force to operate exceeds 5 pounds.

1. Adjust the closer so that the force to operate is less than 5 pounds.	P2
D21.2	The interior POT is not compliant. 1. The required signage is not provided 2. The door clearances are not maintained and are obstructed by interior furniture

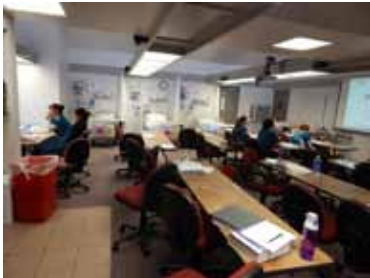
None required	P2
D21.4	The interior POT is not compliant. The required 36" POT is not maintained throughout the classroom and laboratory areas.

1. Maintain a 36" POT in the classrooms and laboratory areas.	P2
D21.5	Not used.			
D21.6	The interior POT is not compliant. The required 36" POT is not maintained throughout the classroom and laboratory areas.

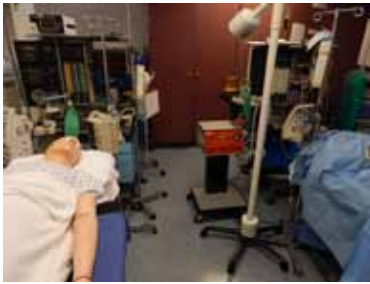
#	ITEM	PHOTO or DIAGRAM	MITIGATION MEASURE	SCHEDULE
D21.7	The interior POT is not compliant. The required 36" POT is not maintained throughout the classroom and laboratory areas.

Maintain a 36" POT in the classrooms and laboratory areas.	
D21.8	This classroom is compliant.

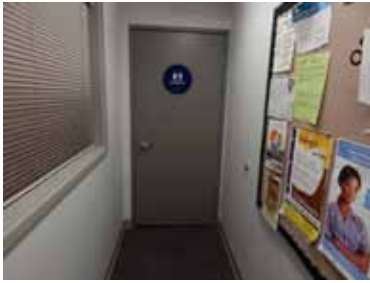
None required	N/A
Unisex				
D21.9	The entry door to this restroom is not compliant as follows; 1. The door operating pressure exceeds 5 pounds maximum. 2. The door symbol is mounted incorrectly and the sign finish is not non-glare. 3. The wall signage provided on the latch side of the door is not provided at 60" AFF. 4. The required 12" push side clearance is not provided

1. Adjust the automatic closer on this door so that the pressure to operate does not exceed 5 pounds. 2. Replace the door symbol with a non-glare contrasting finish and mount at 60" AFF. 3. Provide a compliant wall sign on the latch side of the door mounted at 60" AFF to the TOP of the sign and 4" from the jamb. (Refer to Appendix B.14- B.17) 4. Remove the closer and the latch on this door	P2
