ADA Self Evaluation and Transition Plan

MiraCosta College, **Oceanside Campus**

Board Approved on 05-18-2017

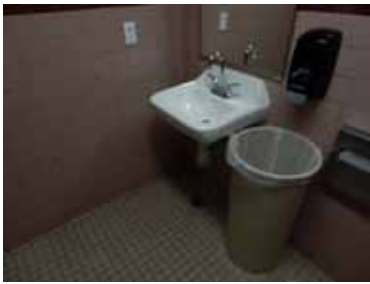
D21.10	The accessible lavatory is not compliant as follows; 1. The hot water and drain pipes and sharp objects under the sink have not been insulated or covered adequately.

1. Provide adequate insulation and covering of all exposed pipes and sharp objects under the sink.	P2

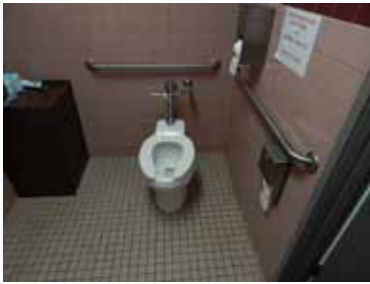
#	ITEM	PHOTO or DIAGRAM	MITIGATION MEASURE	SCHEDULE
D21.11	<p>The accessible toilet and stall are not compliant as follows;</p> <ol style="list-style-type: none"> 1. The centerline of the toilet is located too far or too close to the sidewall. 2. The side grab bar does not extend 54" minimum beyond the front edge of the fixture. (45") 3. The toilet tissue dispenser is located too high or too far from the front of the toilet.

<ol style="list-style-type: none"> 1. Relocate the toilet so the centerline is 17"-18" from the finished surface of the sidewall. 2. Replace the side grab bar or relocate the side grab bar so that it extends 54" beyond the front edge of the fixture. 3. Relocate the toilet tissue dispenser so that it is located 7"- 9" on the front of the toilet and 19" AFF. (Locate to the centerline of the dispenser) 	P2
D22. Bldg. 4500 - Science Building				
D22.1	<p>The two entry doors to this building are not compliant as follows:</p> <ol style="list-style-type: none"> 1. The door operating pressure exceeds 5 pounds The door operating pressure exceeds 5 pounds maximum. 2. The entry doors are not indicated as an accessible entrance.

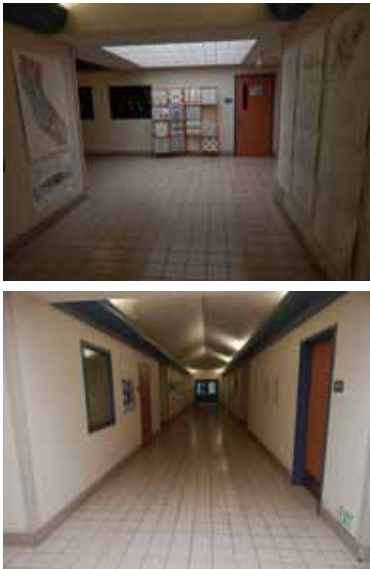
D22.2	<p>The interior hallways in this building is compliant. The door clearances and signage are compliant.</p>

None required.	N/A

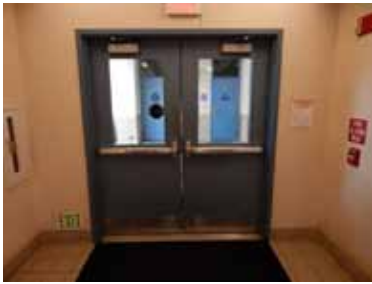
#	ITEM	PHOTO or DIAGRAM	MITIGATION MEASURE	SCHEDULE
D22.3	All of the doors in this building that are designated exit doors are not compliant. They lack the require tactile exit signs.

Install appropriate tactile exit and exit route signs according to Appendix D .8 at every door in this building designated as an exit.	P3
D22.4	There are no accessible workstations in Room 4508, Lab Service.

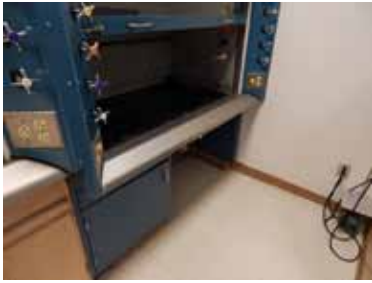
Provide an accessible workstation in this room with a worktop height not to exceed 34" AFF and knee clearance according to Appendix B.1	P3
D22.5	Chemistry Lab, Room 4501; There is one wheelchair accessible fume hood in this room that is compliant.

None required.	N/A
D22.6	Chemistry Lab, Room 4501; There is one wheelchair accessible workstation in this room that is compliant but not accessible due to equipment obscuring the top of the workstation.

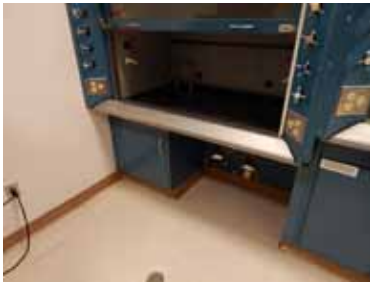
#	ITEM	PHOTO or DIAGRAM	MITIGATION MEASURE	SCHEDULE
D22.7	Chemistry Lab, Room 4505; There is one wheelchair accessible fume hood in this room that is compliant.

None required.	N/A
D22.8	Chemistry Lab, Room 4505; There is one wheelchair accessible workstation in this room that is compliant but not accessible due to equipment obscuring the top of the workstation.

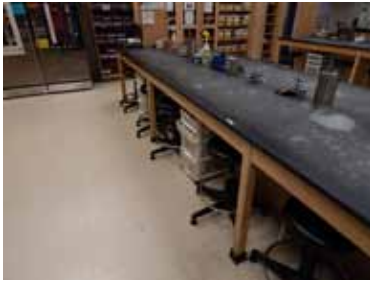
Remove any equipment or other items obscuring the top of the accessible workstation in this room.	P3
D22.9	Biology Lab, Room 4514; There is no wheelchair accessible workstation in this room.

Provide an accessible workstation in this room with a worktop height not to exceed 34" AFF and knee clearance according to Appendix B.1	P3
D22.10	Lab Service, Room 4521; There is no wheelchair accessible workstation in this room.

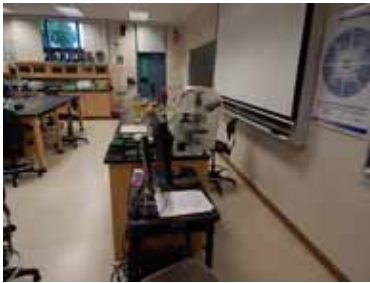
#	ITEM	PHOTO or DIAGRAM	MITIGATION MEASURE	SCHEDULE
D22.11	Biology Lab, Room 4522; There is no wheelchair accessible workstation in this room.

Provide an accessible workstation in this room with a worktop height not to exceed 34" AFF and knee clearance according to Appendix B.1	P3
D22.12	Biology Lab, Room 4523; There is no wheelchair accessible workstation in this room.

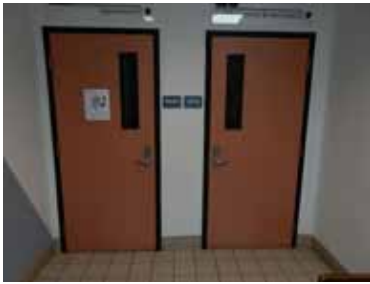
#	ITEM	PHOTO or DIAGRAM	MITIGATION MEASURE	SCHEDULE
D23.4	The interior POT of this facility is not compliant. The required signage is not provided

Install compliant signage according to appendix D.8	P3
D23.5	The interior of this classroom is compliant

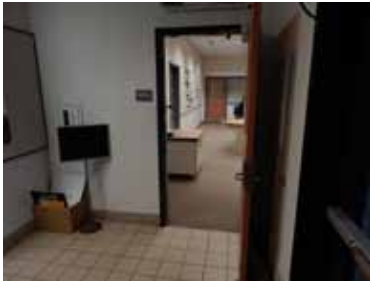
None required	N/A
D23.11	The interior POT of this facility is not compliant. The required signage is not provided

Install compliant signage according to appendix D.8	P3

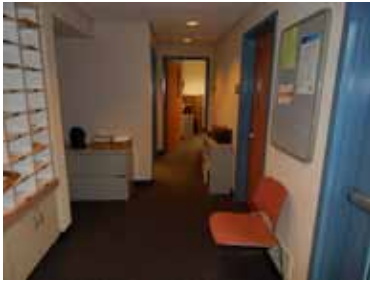
None required	N/A
D23.14	The interior POT of this facility is not compliant. The required signage is not provided

Install compliant signage according to appendix D.8	P3
D23.15	The interior of the conference room is compliant.

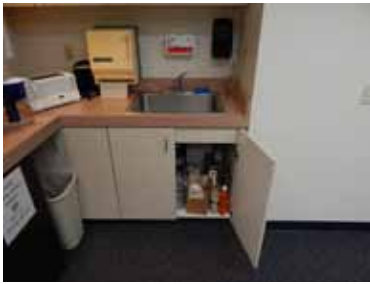
#	ITEM	PHOTO or DIAGRAM	MITIGATION MEASURE	SCHEDULE
D23.16	The sink in the conference room is not compliant. The required knee and toe clearance is not provided.

Reconfigure this sink according to appendix B.1	P3
D23.17	The interior POT of this facility is not compliant. The required signage is not provided

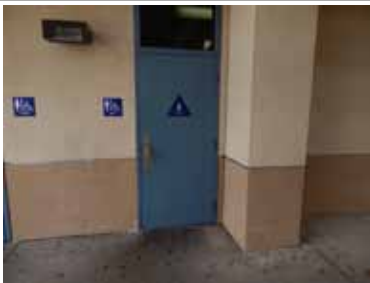
Install compliant signage according to appendix D.8	P3
Men				
D23.18	The entry door to this restroom is not compliant as follows; 1. The door operating pressure exceeds 5 pounds maximum. 2. There is not level landing at this entrance. 3. Door symbol is not contrasting in color from the finish of the door 4. The wall signage provided on the latch side of the door is not provided at 60" AFF.

1. Adjust the automatic closer on this door so that the pressure to operate does not exceed 5 pounds. 2. Reconstruct the landing so that it is less than 2% in any direction for up to 60" from the threshold. 3. Replace the door symbol with a symbol that is 70% contrast in color from the finish of the door. OR Provide a white border 1" wide around the symbol. 4. Provide a compliant wall sign on the latch side of the door mounted at 60" AFF to the TOP of the sign and 4" from the jamb. (Refer to Appendix B.14- B.17)	P3

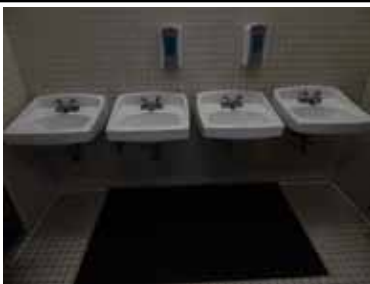
D23.19	The accessible lavatory is not compliant as follows; 1. The hot water and drain pipes and sharp objects under the sink have not been insulated or covered adequately.

1. Provide adequate insulation and covering of all exposed pipes and sharp objects under the sink.	P3

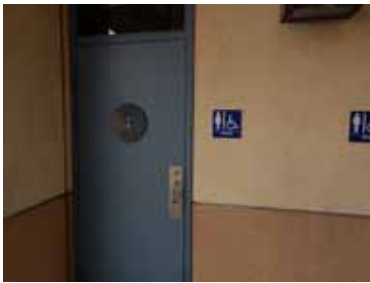
Women				
D23.22	<p>The entry door to this restroom is not compliant as follows;</p> <ol style="list-style-type: none"> 1. The door operating pressure exceeds 5 pounds maximum. 2. There is not level landing at this entrance. 3. Door symbol is not contrasting in color from the finish of the door 4. The wall signage provided on the latch side of the door is not provided at 60" AFF.

<ol style="list-style-type: none"> 1. Adjust the automatic closer on this door so that the pressure to operate does not exceed 5 pounds. 2. Reconstruct the landing so that it is less than 2% in any direction for up to 60" from the threshold. 3. Replace the door symbol with a symbol that is 70% contrast in color from the finish of the door. OR Provide a white border 1" wide around the symbol. 4. Provide a compliant wall sign on the latch side of the door mounted at 60" AFF to the TOP of the sign and 4" from the jamb. (Refer to Appendix B.14- B.17) 	P3

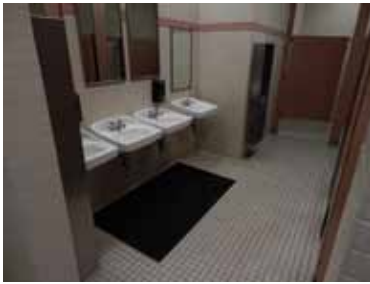
#	ITEM	PHOTO or DIAGRAM	MITIGATION MEASURE	SCHEDULE
D23.23	<p>The accessible lavatory is not compliant as follows;</p> <ol style="list-style-type: none"> 1. The hot water and drain pipes and sharp objects under the sink have not been insulated or covered adequately.

<ol style="list-style-type: none"> 1. Provide adequate insulation and covering of all exposed pipes and sharp objects under the sink. 	P3
D23.24	<p>The accessible toilet and stall are not compliant as follows;</p> <ol style="list-style-type: none"> 1. The rear grab bar does not extend 24" minimum beyond the centerline of the fixture on the wide side. (20") 2. The side grab bar does not extend 54" minimum beyond the rear wall. (50") 3. The stall door is not self closing. 4. The latching hardware is not compliant. 5. U-shaped handles are not provided on both sides of the door.

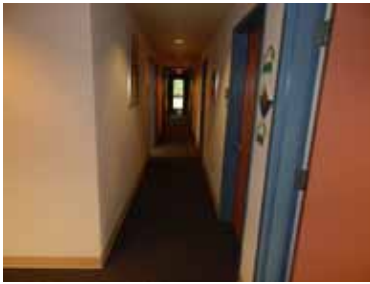
#	ITEM	PHOTO or DIAGRAM	MITIGATION MEASURE	SCHEDULE
D24.5	The interior POT of this facility is not compliant. The required signage is not provided

Install compliant signage according to appendix D.8	P2
D24.6	The interior of the conference room is compliant.

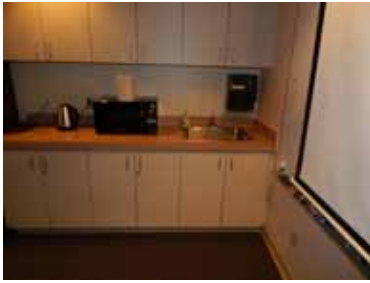
None required	N/A
D24.7	The sink in the meeting room is not compliant. The required knee and toe clearance is not provided.

Reconfigure this sink according to Appendix B.1	P2
D24.8	The interior of the employee work room is compliant.

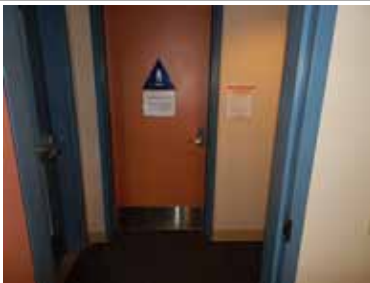
None required	N/A
Men				
D24.11	The entry door to this restroom is not compliant as follows; 1. The door operating pressure exceeds 5 pounds maximum. 2. The door symbol is mounted incorrectly and the sign finish is not non-glare. 3. The wall signage is not provided on the latch side of the door is not provided at 60" AFF.

1. Adjust the automatic closer on this door so that the pressure to operate does not exceed 5 pounds. 2. Replace the door symbol with a non-glare contrasting finish and mount at 60" AFF. 3. Provide a compliant wall sign on the latch side of the door mounted at 60" AFF to the TOP of the sign and 4" from the jamb. (Refer to Appendix B.14- B.17)	P2
D24.12	The accessible lavatory is not compliant as follows; 1. The knee clearance does not meet the requirements. 2. The hot water and drain pipes and sharp objects under the sink have not been insulated or covered adequately. 3. The bottom of the mirror exceeds 40" AFF

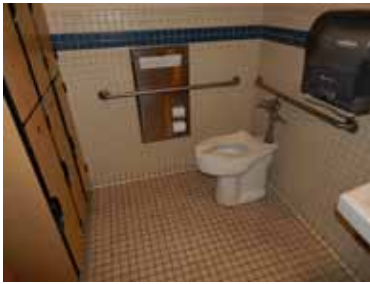
#	ITEM	PHOTO or DIAGRAM	MITIGATION MEASURE	SCHEDULE
D24.13	<p>The accessible toilet and stall are not compliant as follows;</p> <ol style="list-style-type: none"> 1. The rear grab bar does not extend 24" minimum beyond the centerline of the fixture on the wide side. (21") 2. The side grab bar does not extend 54" minimum beyond the rear wall. (50") 3. The toilet tissue dispenser is located too high or too far from the front of the toilet. 4. The required 30" x 48" clear floor space in front of the toilet is not provided

<ol style="list-style-type: none"> 1. Replace the rear grab bar or relocate the rear grab bar so that it extends 24" beyond the centerline of the toilet to the wide side. 2. Replace the side grab bar or relocate the side grab bar so that it extends 24" beyond the front edge of the fixture. 3. Relocate the toilet tissue dispenser so that it is located 7"- 9" on the front of the toilet and 19" AFF. (Locate to the centerline of the dispenser) 4. Remove any furniture obstructing the clear floor space. 	P2

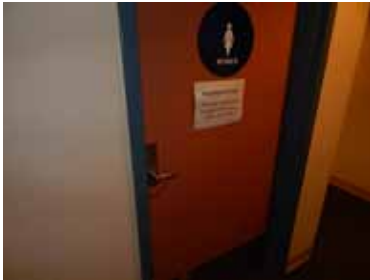
Women				
D24.14	<p>The entry door to this restroom is not compliant as follows;</p> <ol style="list-style-type: none"> 1. The door operating pressure exceeds 5 pounds maximum. 2. The door symbol is mounted incorrectly and the sign finish is not non-glare. 3. The wall signage is not provided on the latch side of the door is not provided at 60" AFF.

<ol style="list-style-type: none"> 1. Adjust the automatic closer on this door so that the pressure to operate does not exceed 5 pounds. 2. Replace the door symbol with a non-glare contrasting finish and mount at 60" AFF. 3. Provide a compliant wall sign on the latch side of the door mounted at 60" AFF to the TOP of the sign and 4" from the jamb. (Refer to Appendix B.14- B.17) 	P2
D24.15	<p>The accessible lavatory is not compliant as follows;</p> <ol style="list-style-type: none"> 1. The knee clearance does not meet the requirements. 2. The hot water and drain pipes and sharp objects under the sink have not been insulated or covered adequately. 3. The bottom of the mirror exceeds 40" AFF

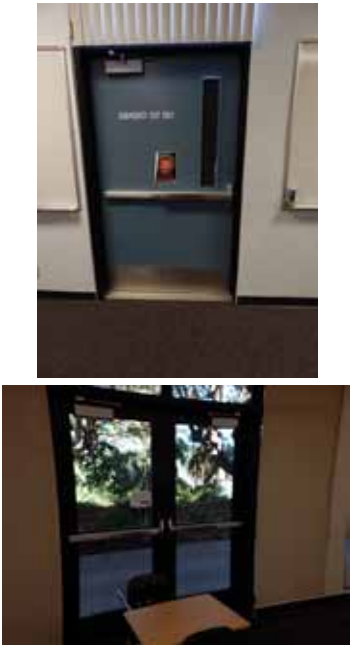
#	ITEM	PHOTO or DIAGRAM	MITIGATION MEASURE	SCHEDULE
D25.3	<p>All of the emergency exit doors in this facility are not compliant as follows:</p> <p>1. The exit doors do not have the required exit sign with braille.</p>

<p>1. Provide an exit sign mounted at 60" AFF on the wall adjacent to the latch side of the door according to Appendix D.8.</p>	P3
D25.4	<p>Various interior doorways do not have the required tactile signage.</p>

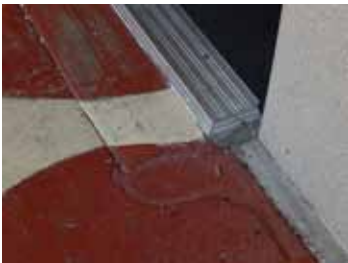
#	ITEM	PHOTO or DIAGRAM	MITIGATION MEASURE	SCHEDULE
D25.5	These exterior doors to not have compliant thresholds and level landings.

Reconstruct thresholds at the designated doorways to meet the requirements indicated in Appendix D .3 and A. 15.	P3
Men				
D25.6	The entry door to this restroom is not compliant as follows; 1. The door operating pressure exceeds 5 pounds maximum. 2. The wall signage provided on the latch side of the door is mounted incorrectly.

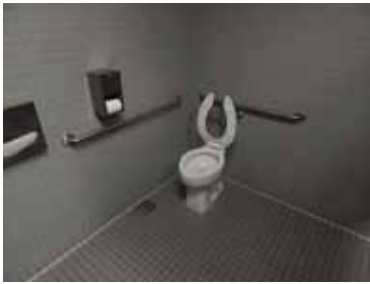
#	ITEM	PHOTO or DIAGRAM	MITIGATION MEASURE	SCHEDULE
D25.9	<p>The accessible toilet and stall are not compliant as follows;</p> <ol style="list-style-type: none"> 1. The flushing mechanism is not located on the wide side of the fixture . 2. The side grab bar does not extend 54" minimum beyond the rear wall. (51") 3. The toilet tissue dispenser is located too high or too far from the front of the toilet. 4. The stall door is not self closing. 5. U-shaped handles are not provided on both sides of the door.

<ol style="list-style-type: none"> 1. Replace the flush mechanism so that it is on the wide side of the fixture. 2. Replace the side grab bar or relocate the side grab bar so that it extends 54" beyond the rear wall. 3. Relocate the toilet tissue dispenser so that it is located 7"- 9" on the front of the toilet and 19" AFF. (Locate to the centerline of the dispenser) 4. Adjust the stall door so that it is self-closing. 5. Provide U-shaped handles on both sides of the door. 	P3

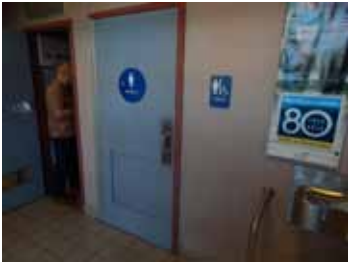
Women				
D25.10	<p>The entry door to this restroom is not compliant as follows;</p> <ol style="list-style-type: none"> 1. The door operating pressure exceeds 5 pounds maximum. 2. The wall signage provided on the latch side of the door is mounted incorrectly.

<ol style="list-style-type: none"> 1. Adjust the automatic closer on this door so that the pressure to operate does not exceed 5 pounds. 2. Provide a compliant wall sign on the latch side of the door mounted at 60" AFF to the TOP of the sign and 4" from the jamb. (Refer to Appendix B.14- B.17) 	P3
D25.11	<p>The accessible lavatory is not compliant as follows;</p> <ol style="list-style-type: none"> 1. The hot water and drain pipes and sharp objects under the sink have not been insulated or covered adequately. 2. The required accessible hardware is not provided 3. The knee clearance does not meet the requirements

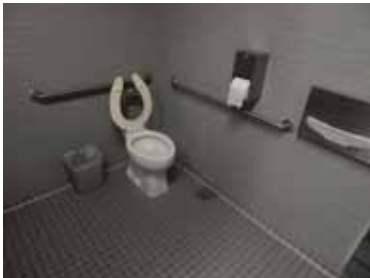
D25.12	<p>The accessible toilet and stall are not compliant as follows;</p> <ol style="list-style-type: none"> 1. The centerline of the toilet is located too far or too close to the sidewall. 2. The side grab bar does not extend 54" minimum beyond the rear wall. (52") 3. The toilet tissue dispenser is located too high or too far from the front of the toilet. 4. The toilet seat tissue dispenser is not located on an accessible route. 5. The stall door is not self closing. 6. U-shaped handles are not provided on both sides of the door.

<ol style="list-style-type: none"> 1. Relocate the toilet so the centerline is 17"-18" from the finished surface of the sidewall. 2. Replace the side grab bar or relocate the side grab bar so that it extends 54" beyond the rear wall 3. Relocate the toilet tissue dispenser so that it is located 7"- 9" on the front of the toilet and 19" AFF. (Locate to the centerline of the dispenser) 4. Relocate the toilet seat tissue dispenser so that it is located on an accessible route. (Locations above the grab bars are not accessible.) 5. Adjust the stall door so that it is self-closing. 6. Provide U-shaped handles on both sides of the door. 	P3

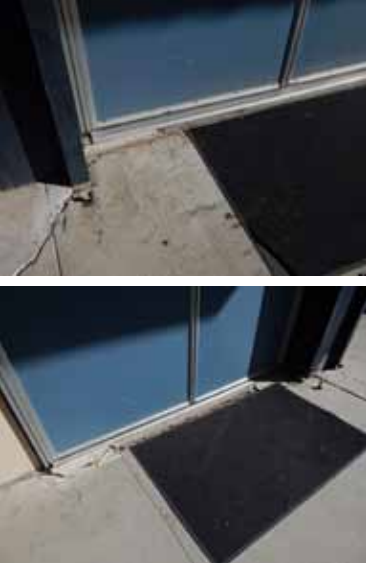
D27.1	<p>The entry doors on the upper level of this building are noncompliant as follows:</p> <ol style="list-style-type: none"> 1. The thresholds are raised above the adjacent exterior paving and there is a large gap between the paving and the threshold. 2. The operating force of the doors too much.

<ol style="list-style-type: none"> 1. Reconstruct the exterior paving in front of each door to mitigate the existing gap and achieving a threshold profile as indicated in Appendix A .15. 2. Adjust the automatic closer on the doors so that the operating pressure does not exceed 5 pounds of force. 	P1
D27.2	<p>The drinking fountains on the east side of the gymnasium floor are not compliant as follows:</p> <ol style="list-style-type: none"> 1. The wheelchair accessible drinking fountain is mounted to low at 26" clear.

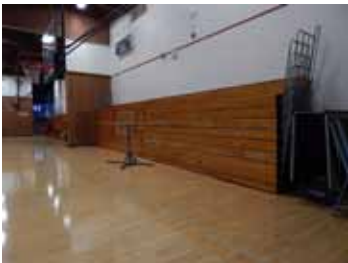
#	ITEM	PHOTO or DIAGRAM	MITIGATION MEASURE	SCHEDULE
D27.4	The existing retracting bleachers may not be compliant. Wheelchair access on to the bleachers is not required. However, wheelchair seating must be designated and marked at the court level when the bleachers are extended.

Provide designated and marked wheelchair spaces on the court level 30"x 48" with a total number distributed equally on each side of the court equal to 5% of the total seating.	P1
D27.5	This exit door is not compliant as follows: 1. Tactile exit signage is not provided. 2. The operating force of the doors is too much.

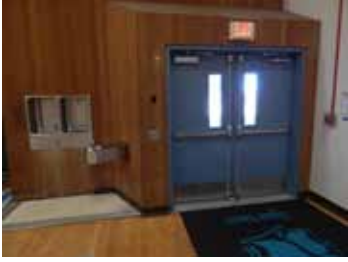
1. Provide a tactile exit sign mounted on the wall adjacent to the door according to Appendix D.8 2. Adjust the automatic closer on the doors so that the operating pressure does not exceed 5 pounds of force.	P1
D27.6	This exit door is not compliant as follows: 1. Tactile exit signage is not provided. 2. The operating force of the doors is too much.

1. Provide a tactile exit sign mounted on the wall adjacent to the door according to Appendix D.8 2. Adjust the automatic closer on the doors so that the operating pressure does not exceed 5 pounds of force.	P1

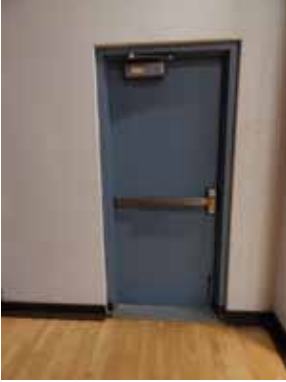
D27.7	This exit door is not compliant as follows: 1. Tactile exit signage is not provided. 2. The operating force of the doors is too much.

1. Provide a tactile exit sign mounted on the wall adjacent to the door according to Appendix D.8 2. Adjust the automatic closer on the doors so that the operating pressure does not exceed 5 pounds of force.	P1

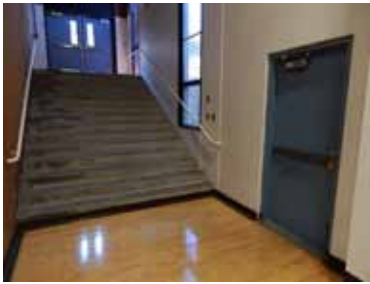
#	ITEM	PHOTO or DIAGRAM	MITIGATION MEASURE	SCHEDULE
D27.8	<p>This stairway is not compliant as follows:</p> <ol style="list-style-type: none"> 1. The handrails are not configured correctly. 2. Contrasting color warning stripes are not provided.

<ol style="list-style-type: none"> 1. Reconstruct or replace the existing handrails to meet the configuration requirements indicated in Appendix C.4. 2. Provide contrasting color warnings stripes at each nosing according to the requirements indicated in Appendix C.4 	P1
D27.9	<p>This stairway is not compliant as follows:</p> <ol style="list-style-type: none"> 1. The handrails are not configured correctly. 2. Contrasting color warning stripes are not provided.

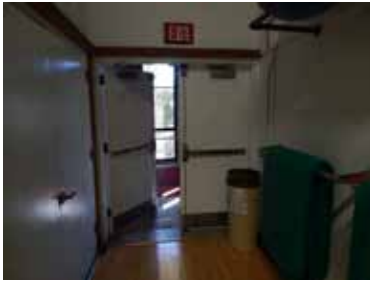
D27.10	<p>This exit door is not compliant as follows:</p> <ol style="list-style-type: none"> 1. Tactile exit signage is not provided. 2. The operating force of the doors is too much.

<ol style="list-style-type: none"> 1. Provide a tactile exit sign mounted on the wall adjacent to the door according to Appendix D.8 2. Adjust the automatic closer on the doors so that the operating pressure does not exceed 5 pounds of force. 	P1
D27.11	<p>This exit door is not compliant as follows:</p> <ol style="list-style-type: none"> 1. Tactile exit signage is not provided. 2. The operating force of the doors is too much.

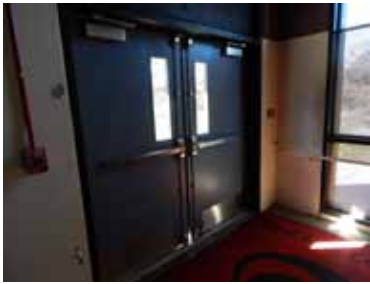
#	ITEM	PHOTO or DIAGRAM	MITIGATION MEASURE	SCHEDULE
D27.12	This exit door is not compliant as follows: 1. Tactile exit signage is not provided. 2. The operating force of the doors is too much.

1. Provide a tactile exit sign mounted on the wall adjacent to the door according to Appendix D.8 2. Adjust the automatic closer on the doors so that the operating pressure does not exceed 5 pounds of force.	P1
D27.13	Upper Gym, Rm. 5004: This exercise room is compliant.

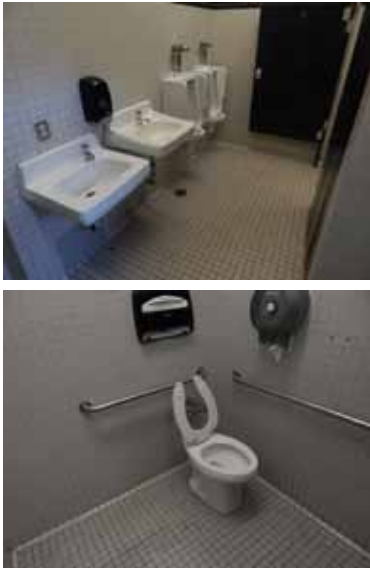
None required. However, a 36" wide POT minimum must be maintained inside this room to each piece of exercise equipment.	N/A
Men				
D27.14	This restroom does not have any of the space requirements in order for the accessible features to be accommodated.

Reconfigure this restroom to meet the size and clearance requirements according to Appendices B.5 - B.17	P1

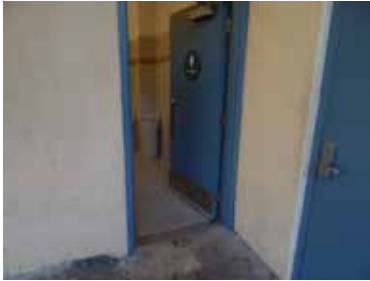
Women				
D27.15	<p>The entry door to this restroom is not compliant as follows;</p> <ol style="list-style-type: none"> 1. The door operating pressure exceeds 5 pounds maximum. 2. Door symbol is not contrasting in color from the finish of the door 3. The wall signage provided on the latch side of the door is not provided at 60" AFF.

<ol style="list-style-type: none"> 1. Adjust the automatic closer on this door so that the pressure to operate does not exceed 5 pounds. 2. Replace the door symbol with a symbol that is 70% contrast in color from the finish of the door. OR Provide a white border 1" wide around the symbol. 3. Provide a compliant wall sign on the latch side of the door mounted at 60" AFF to the TOP of the sign and 4" from the jamb. (Refer to Appendix B.14- B.17) 	P1
D27.16	<p>The accessible lavatory is not compliant as follows;</p> <ol style="list-style-type: none"> 1. The hot water and drain pipes and sharp objects under the sink have not been insulated or covered adequately. 2. The required accessible hardware is not provided 3. The knee clearance does not meet the requirements

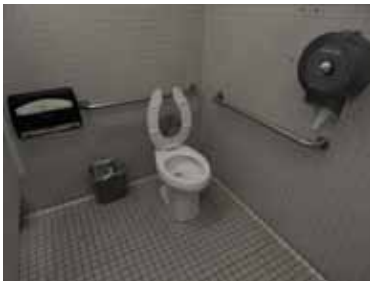
D27.17	<p>The accessible toilet and stall are not compliant as follows;</p> <ol style="list-style-type: none"> 1. The rear grab bar does not extend 24" minimum beyond the centerline of the fixture on the wide side. 2. The side grab bar does not extend 54" minimum beyond the front edge of the fixture. 3. The toilet tissue dispenser is located too high or too far from the front of the toilet. 4. The stall door is not self closing.

<ol style="list-style-type: none"> 1. Replace the rear grab bar or relocate the rear grab bar so that it extends 24" beyond the centerline of the toilet to the wide side. 2. Replace the side grab bar or relocate the side grab bar so that it extends 24" beyond the front edge of the fixture. 3. Relocate the toilet tissue dispenser so that it is located 7"- 9" on the front of the toilet and 19" AFF. (Locate to the centerline of the dispenser) 4. Adjust the stall door so that it is self-closing. 	P1

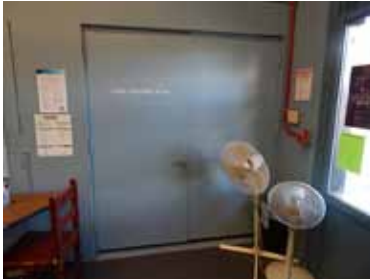
Install appropriate tactile exit and exit route signs according to Appendix D .8 at every door in this building designated as an exit.	P1
D28.2	Women's Dressing Room, Room 5103; The door hardware at the women's dressing room is not compliant.

Provide compliant lever door hardware at this door.	P1
D28.3	Women's Dressing Room, Room 5103; The women's dressing room is not compliant as follows: 1. There is no wheelchair changing bench.

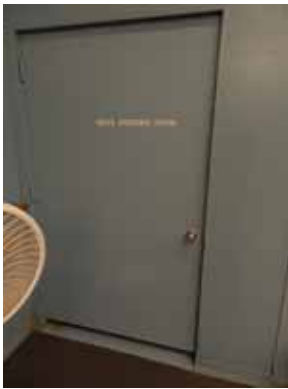
1. Provide a wheelchair accessible changing bench that is 18" deep x 30" wide against the wall with a 30"x48" clear transfer area adjacent.	P1
D28.4	Men's Dressing Room, Room 5102; The door hardware at the men's dressing room is not compliant.

Provide compliant lever door hardware at this door.	P1

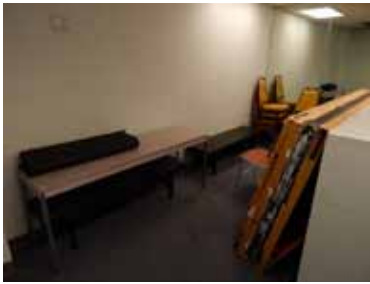
#	ITEM	PHOTO or DIAGRAM	MITIGATION MEASURE	SCHEDULE
D28.5	Men's Dressing Room, Room 5102; The men's dressing room is not compliant as follows: 1. There is no wheelchair changing bench.

1. Provide a wheelchair accessible changing bench that is 18" deep x 30" wide x 18" high, against the wall with a 30"x48" clear transfer area adjacent.	P1
Men				
D28.6	This restroom does not have any of the space requirements in order for the accessible features to be accommodated.

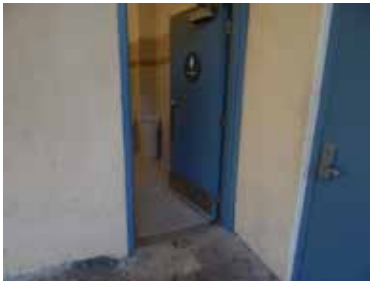
Reconfigure this restroom to meet the size and clearance requirements according to Appendices B.5 - B.17	P1
Women				
D28.7	The entry door to this restroom is not compliant as follows; 1. The door operating pressure exceeds 5 pounds maximum. 2. Door symbol is not contrasting in color from the finish of the door 3. The wall signage provided on the latch side of the door is not provided at 60" AFF.

1. Adjust the automatic closer on this door so that the pressure to operate does not exceed 5 pounds. 2. Replace the door symbol with a symbol that is 70% contrast in color from the finish of the door. OR Provide a white border 1" wide around the symbol. 3. Provide a compliant wall sign on the latch side of the door mounted at 60" AFF to the TOP of the sign and 4" from the jamb. (Refer to Appendix B.14- B.17)	P1

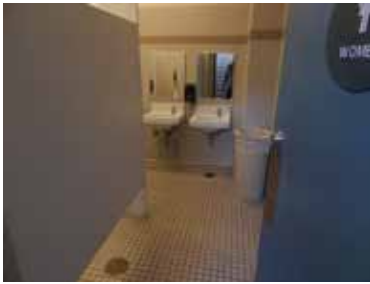
#	ITEM	PHOTO or DIAGRAM	MITIGATION MEASURE	SCHEDULE
D28.8	<p>The accessible lavatory is not compliant as follows;</p> <ol style="list-style-type: none"> 1. The hot water and drain pipes and sharp objects under the sink have not been insulated or covered adequately. 2. The required accessible hardware is not provided 3. The knee clearance does not meet the requirements

<ol style="list-style-type: none"> 1. Provide adequate insulation and covering of all exposed pipes and sharp objects under the sink. 2. Replace the existing hardware with compliant lever type hardware. 3. Modify the sink counter so that the required knee clearance is provided. (See Appendix B.1 for clearance profile) 	P1
D28.9	<p>The accessible toilet and stall are not compliant as follows;</p> <ol style="list-style-type: none"> 1. The rear grab bar does not extend 24" minimum beyond the centerline of the fixture on the wide side. 2. The side grab bar does not extend 54" minimum beyond the front edge of the fixture. 3. The toilet tissue dispenser is located too high or too far from the front of the toilet. 4. The stall door is not self closing.

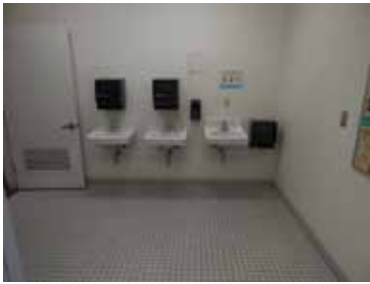
#	ITEM	PHOTO or DIAGRAM	MITIGATION MEASURE	SCHEDULE
D29.3	<p>The accessible lavatory is not compliant as follows;</p> <ol style="list-style-type: none"> 1. The hot water and drain pipes and sharp objects under the sink have not been insulated or covered adequately. 2. The required accessible hardware is not provided 3. The knee clearance does not meet the requirements

<ol style="list-style-type: none"> 1. Provide adequate insulation and covering of all exposed pipes and sharp objects under the sink. 2. Replace the existing hardware with compliant lever type hardware. 3. Modify the sink counter so that the required knee clearance is provided. (See Appendix B.1 for clearance profile) 	P1
D29.4	<p>The accessible toilet and stall are not compliant as follows;</p> <ol style="list-style-type: none"> 1. The rear grab bar does not extend 24" minimum beyond the centerline of the fixture on the wide side. 2. The side grab bar does not extend 54" minimum beyond the front edge of the fixture. 3. The toilet tissue dispenser is located too high or too far from the front of the toilet. 4. The stall door is not self closing.

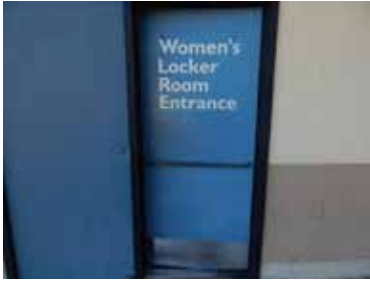
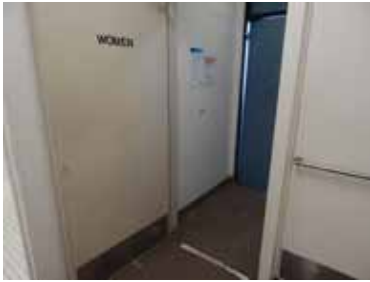
Women				
D29.5	<p>The entry door to this restroom is not compliant as follows;</p> <ol style="list-style-type: none"> 1. The door operating pressure exceeds 5 pounds maximum. 2. The required door signage is not provided 3. The required wall signage is not provided on the latch side of the door

<ol style="list-style-type: none"> 1. Adjust the automatic closer on this door so that the pressure to operate does not exceed 5 pounds. 2. Install compliant door signage according to Appendix B.14- B.17 3. Provide a compliant wall sign on the latch side of the door mounted at 60" AFF to the TOP of the sign and 4" from the jamb. (Refer to Appendix B.14- B.17) 	P1

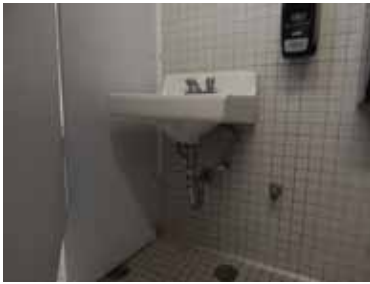
#	ITEM	PHOTO or DIAGRAM	MITIGATION MEASURE	SCHEDULE
D29.6	<p>The accessible lavatory is not compliant as follows;</p> <ol style="list-style-type: none"> 1. The hot water and drain pipes and sharp objects under the sink have not been insulated or covered adequately. 2. The required accessible hardware is not provided 3. The knee clearance does not meet the requirements

<ol style="list-style-type: none"> 1. Provide adequate insulation and covering of all exposed pipes and sharp objects under the sink. 2. Replace the existing hardware with compliant lever type hardware. 3. Modify the sink counter so that the required knee clearance is provided. (See Appendix B.1 for clearance profile) 	P1
D29.7	<p>The accessible toilet and stall are not compliant as follows;</p> <ol style="list-style-type: none"> 1. The centerline of the toilet is located too far or too close to the sidewall. 2. The side grab bar does not extend 54" minimum beyond the front edge of the fixture. 3. The toilet tissue dispenser is located too high or too far from the front of the toilet. 4. The toilet seat tissue dispenser is not located on an accessible route.

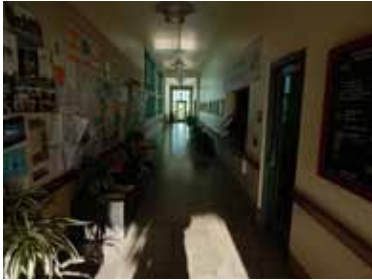
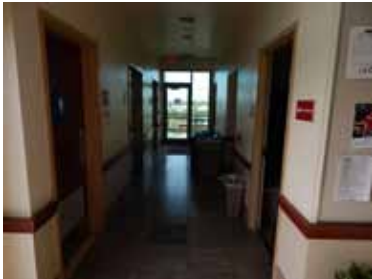
None required.	N/A
D31.3	The interior POT of this facility is not compliant. The required signage is not provided

Install compliant signage according to appendix D.8	P3
D31.4	The counter in the main lobby is compliant.

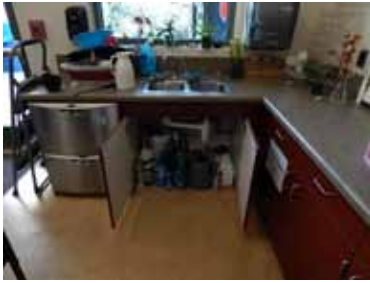
None required.	N/A
D31.7	The sink in the lab prep area is not compliant 1. The require knee and toe clearance is not provided.

1. Provide the required toe clearance according to appendix B.1	P3
D31.8	The drinking fountains are compliant.

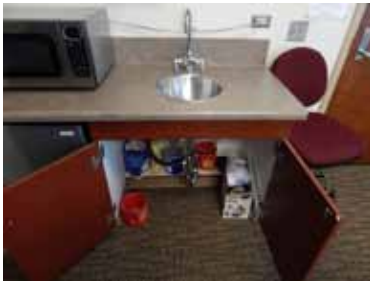
None required.	N/A
D31.10	The sink in the lab prep area is not compliant 1. The require knee and toe clearance is not provided.

1. Provide the required toe clearance according to appendix B.1	P3
D31.11	The interior of this class room is compliant.

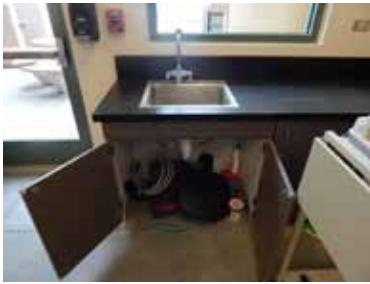
#	ITEM	PHOTO or DIAGRAM	MITIGATION MEASURE	SCHEDULE
D31.13	<p>The sink in the lab prep area is not compliant</p> <p>1. The require knee and toe clearance is not provided.</p>

1. Provide the required toe clearance according to appendix B.1	P3
D31.14	<p>The interior of this class room is compliant.</p>

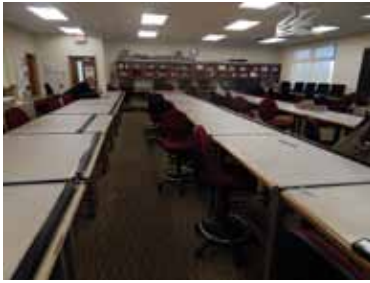
None required.	N/A
D31.15	<p>The interior of the CADD class is not compliant</p> <p>There is no wheelchair accessible work station provided.</p>

1. Provide a wheelchair accessible work station in this class room.	P3
D31.16	<p>The sink in the lab prep area is not compliant</p> <p>1. The require knee and toe clearance is not provided.</p> <p>2. The required clear floor space is obstructed by the adjacent desk.</p>

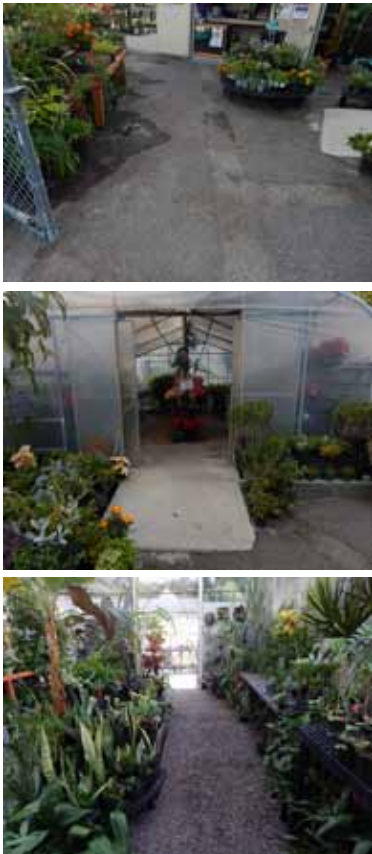
#	ITEM	PHOTO or DIAGRAM	MITIGATION MEASURE	SCHEDULE
D31.20	<p>The POT serving the retail nursery center at the horticultural center is not compliant.</p> <ol style="list-style-type: none"> 1. The required width is not maintained throughout the facility 2. There are ramps that do not meet the minimum requirements 3. The surface is broken and degrading

<ol style="list-style-type: none"> 1. Provided a 48" wheelchair accessible POT throughout the entire retail facility 2. Where ramps are required to access a retail area, reconstruct according to appendix C.1-C.3 & C.7 3. Repair any broken portions of the POT where the surface is inconsistent, Cracked, or crumbling 	P3
D31.21	<p>The transaction area of the retail nursery area is not compliant.</p> <p>The height of the service counter does not meet the requirements.</p>

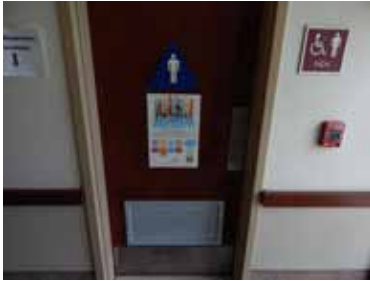
Men Second Floor				
D31.22	<p>The entry door to this restroom is not compliant as follows;</p> <ol style="list-style-type: none"> 1. The door operating pressure exceeds 5 pounds maximum. 2. The door symbol is mounted incorrectly and the sign finish is not non-glare. 3. Door symbol is not contrasting in color from the finish of the door 4. The wall signage provided on the latch side of the door is not provided at 60" AFF.

<ol style="list-style-type: none"> 1. Adjust the automatic closer on this door so that the pressure to operate does not exceed 5 pounds. 2. Replace the door symbol with a non-glare contrasting finish and mount at 60" AFF. 3. Replace the door symbol with a symbol that is 70% contrast in color from the finish of the door. OR Provide a white border 1" wide around the symbol. 4. Provide a compliant wall sign on the latch side of the door mounted at 60" AFF to the TOP of the sign and 4" from the jamb. (Refer to Appendix B.14- B.17) 	P3

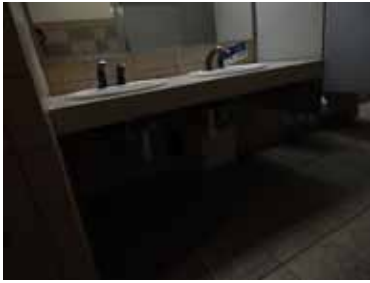
D31.23	<p>The accessible lavatory is not compliant as follows;</p> <ol style="list-style-type: none"> 1. The hot water and drain pipes and sharp objects under the sink have not been insulated or covered adequately.

<ol style="list-style-type: none"> 1. Provide adequate insulation and covering of all exposed pipes and sharp objects under the sink. 	P3
D31.24	The urinal is compliant

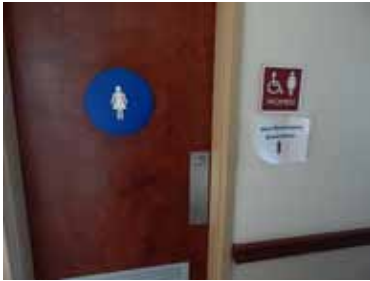
None required.	N/A
Women Second Floor				
D31.27	<p>The entry door to this restroom is not compliant as follows;</p> <ol style="list-style-type: none"> 1. The door operating pressure exceeds 5 pounds maximum. 2. The door symbol is mounted incorrectly and the sign finish is not non-glare. 3. Door symbol is not contrasting in color from the finish of the door 4. The wall signage provided on the latch side of the door is not provided at 60" AFF.

<ol style="list-style-type: none"> 1. Adjust the automatic closer on this door so that the pressure to operate does not exceed 5 pounds. 2. Replace the door symbol with a non-glare contrasting finish and mount at 60" AFF. 3. Replace the door symbol with a symbol that is 70% contrast in color from the finish of the door. OR Provide a white border 1" wide around the symbol. 4. Provide a compliant wall sign on the latch side of the door mounted at 60" AFF to the TOP of the sign and 4" from the jamb. (Refer to Appendix B.14- B.17) 	P3

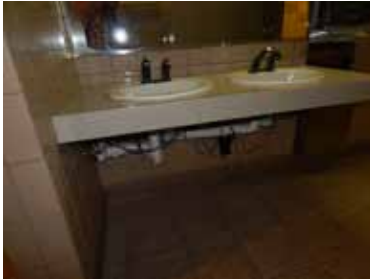
D31.28	<p>The accessible lavatory is not compliant as follows;</p> <ol style="list-style-type: none"> 1. The hot water and drain pipes and sharp objects under the sink have not been insulated or covered adequately.

<ol style="list-style-type: none"> 1. Provide adequate insulation and covering of all exposed pipes and sharp objects under the sink. 	P3
D31.29	<p>The accessible toilet and stall are not compliant as follows;</p> <ol style="list-style-type: none"> 1. The centerline of the toilet is located too far or too close to the sidewall. (20") 2. The rear grab bar does not extend 24" minimum beyond the centerline of the fixture on the wide side. (22") 3. The side grab bar does not extend 54" minimum beyond the rear wall. (52")

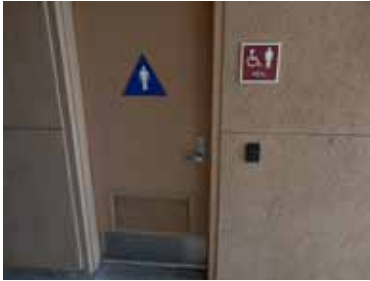
Men First Floor				
D31.30	<p>The entry door to this restroom is not compliant as follows;</p> <ol style="list-style-type: none"> 1. The door operating pressure exceeds 5 pounds maximum. 2. The door symbol is mounted incorrectly and the sign finish is not non-glare. 3. Door symbol is not contrasting in color from the finish of the door 4. The wall signage provided on the latch side of the door is not provided at 60" AFF.

<ol style="list-style-type: none"> 1. Adjust the automatic closer on this door so that the pressure to operate does not exceed 5 pounds. 2. Replace the door symbol with a non-glare contrasting finish and mount at 60" AFF. 3. Replace the door symbol with a symbol that is 70% contrast in color from the finish of the door. OR Provide a white border 1" wide around the symbol. 4. Provide a compliant wall sign on the latch side of the door mounted at 60" AFF to the TOP of the sign and 4" from the jamb. (Refer to Appendix B.14- B.17) 	P3

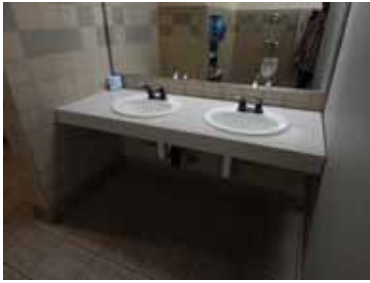
D31.31	<p>The accessible lavatory is not compliant as follows;</p> <ol style="list-style-type: none"> 1. The hot water and drain pipes and sharp objects under the sink have not been insulated or covered adequately.

<ol style="list-style-type: none"> 1. Provide adequate insulation and covering of all exposed pipes and sharp objects under the sink. 	P3
D31.32	<p>The urinal is compliant</p>

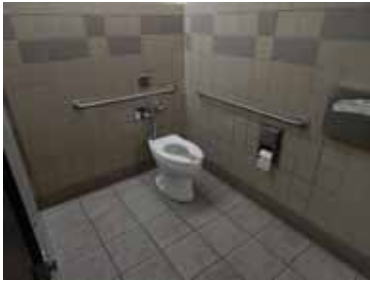
None required.	N/A
D31.33	<p>The accessible toilet and stall are not compliant as follows;</p> <ol style="list-style-type: none"> 1. The side grab bar does not extend 54" minimum beyond the rear wall. (52") 2. The stall door is not self closing.

<ol style="list-style-type: none"> 1. Replace the side grab bar or relocate the side grab bar so that it extends 54" beyond the rear wall 2. Adjust the stall door so that it is self-closing. 	P3

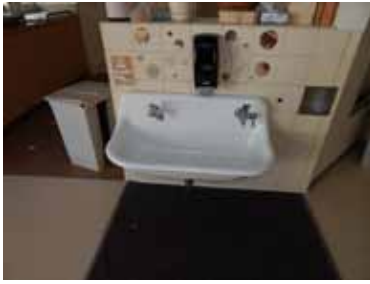
None required.	N/A
D32.9	The child's hand wash sink in each classroom is not compliant for a wheelchair user.

Provide hand wash sink in each of the classrooms that is accessible by a student in a wheelchair.	P3
D32.10	<p>The wheelchair accessible toilets in each of the classrooms are noncompliant as follows:</p> <ol style="list-style-type: none"> 1. The toilet is mounted too far from the wall at 19". 2. The grab bars are mounted too high at 29" AFF. 3. The toilet tissue dispenser is not located correctly. 4. There are movable objects such as cabinets obscuring the clear area in front of the toilet.

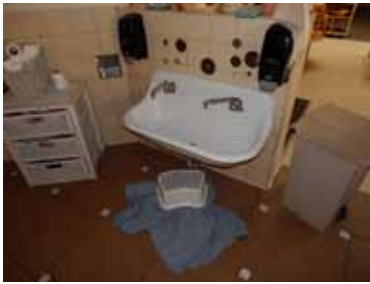
#	ITEM	PHOTO or DIAGRAM	MITIGATION MEASURE	SCHEDULE
D32.11	The child's hand wash sink in each classroom is not compliant for a wheelchair user.

Provide hand wash sink in each of the classrooms that is accessible by a student in a wheelchair. (See similar item above. Only one accessible sink needs to be provided in each classroom.)	N/A
D32.12	The interior doors in this facility are compliant in size, hardware, operation, configuration and clearances.

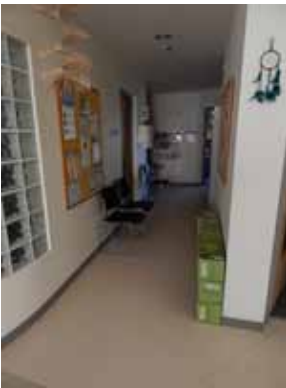
#	ITEM	PHOTO or DIAGRAM	MITIGATION MEASURE	SCHEDULE
D32.14	<p>The interior POT in some areas of this facility is not compliant as follows:</p> <ol style="list-style-type: none"> 1. The minimum clear width of the POT is obscured by movable furniture or storage of other items.

1. Maintain a clear POT throughout the facility of 36" minimum.	P3
D32.15	<p>The door into Workroom, 8008, is not compliant. The required pull side clearance is not provided at the door.</p>

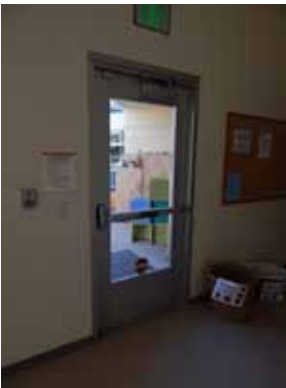
#	ITEM	PHOTO or DIAGRAM	MITIGATION MEASURE	SCHEDULE
D32.17	The exit doors in this facility are not compliant. They do not have the required tactile exit signage.

Provide tactile exit signage at each exit door in this facility mounted on the latch side of the door at 60" AFF according to the requirements of Appendix D.8	P3
D32.18	The outdoor sink area at the central patio is not accessible. Access to these sinks is blocked by storage of material and other removable items.

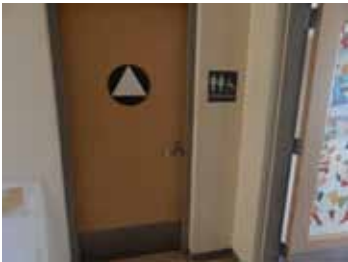
None required.	N/A
Unisex				
D32.24	The entry door to this restroom is not compliant as follows; 1. The door operating pressure exceeds 5 pounds maximum. 2. The wall signage provided on the latch side of the door is mounted incorrectly.

1. Adjust the automatic closer on this door so that the pressure to operate does not exceed 5 pounds. 2. Provide a compliant wall sign on the latch side of the door mounted at 60" AFF to the TOP of the sign and 4" from the jamb. (Refer to Appendix B.14- B.17)	P3
D32.25	The accessible lavatory is not compliant as follows; 1. The hot water and drain pipes and sharp objects under the sink have not been insulated or covered adequately. 2. The knee and toe clearance does not meet the requirements

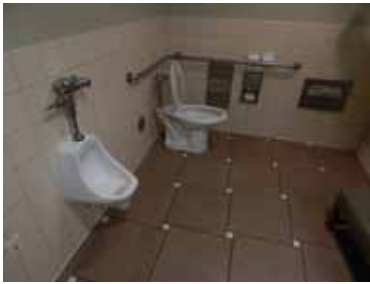
#	ITEM	PHOTO or DIAGRAM	MITIGATION MEASURE	SCHEDULE
D32.26	<p>The accessible toilet and stall are not compliant as follows;</p> <p>The rear grab bar does not extend 24" minimum beyond the centerline of the fixture on the wide side. (19")</p> <p>The urinal is compliant.</p>

<p>Replace the rear grab bar or relocate the rear grab bar so that it extends 24" beyond the centerline of the toilet to the wide side.</p> <p>Urinal: None required</p>	P3
Women				
D32.27	<p>The entry door to this restroom is not compliant as follows;</p> <ol style="list-style-type: none"> 1. The door operating pressure exceeds 5 pounds maximum. 2. The wall signage provided on the latch side of the door is mounted incorrectly.

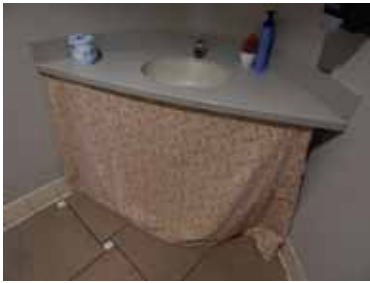
D32.28	<p>The accessible lavatory is not compliant as follows;</p> <ol style="list-style-type: none"> 1. The hot water and drain pipes and sharp objects under the sink have not been insulated or covered adequately. 2. The knee and toe clearance does not meet the requirements

<ol style="list-style-type: none"> 1. Provide adequate insulation and covering of all exposed pipes and sharp objects under the sink. 2. Modify the sink counter so that the required knee and toe clearance is provided. (See Appendix B.1 for clearance profile) 	P3
D32.29	<p>The accessible toilet and stall are not compliant as follows;</p> <p>The rear grab bar does not extend 24" minimum beyond the centerline of the fixture on the wide side. (19")</p>

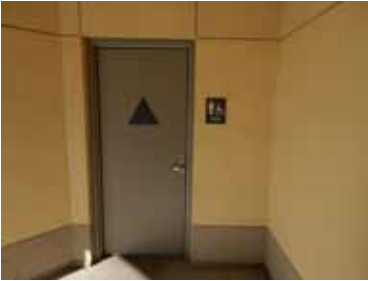
Men				
D32.30	<p>The entry door to this restroom is not compliant as follows;</p> <ol style="list-style-type: none"> 1. The door operating pressure exceeds 5 pounds maximum. 2. The wall signage provided on the latch side of the door is mounted incorrectly.

<ol style="list-style-type: none"> 1. Adjust the automatic closer on this door so that the pressure to operate does not exceed 5 pounds. 2. Provide a compliant wall sign on the latch side of the door mounted at 60" AFF to the TOP of the sign and 4" from the jamb. (Refer to Appendix B.14- B.17) 	P3
D32.31	<p>The accessible lavatory is not compliant as follows;</p> <ol style="list-style-type: none"> 1. The hot water and drain pipes and sharp objects under the sink have not been insulated or covered adequately. 2. The knee and toe clearance does not meet the requirements

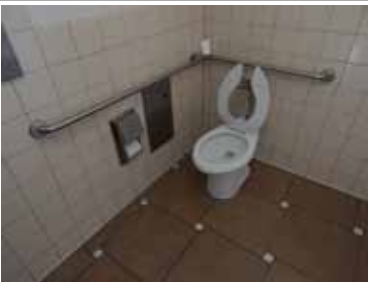
D32.32	<p>The accessible toilet and stall are not compliant as follows;</p> <p>The rear grab bar does not extend 24" minimum beyond the centerline of the fixture on the wide side. (17")</p>

Replace the rear grab bar or relocate the rear grab bar so that it extends 24" beyond the centerline of the toilet to the wide side.	P3
Women				
D32.33	<p>The entry door to this restroom is not compliant as follows;</p> <ol style="list-style-type: none"> 1. The door operating pressure exceeds 5 pounds maximum. 2. The wall signage provided on the latch side of the door is mounted incorrectly.

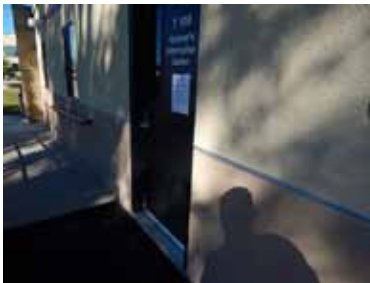
D33.1	<p>The entrance to this facility is not compliant</p> <p>The required smooth surface at the base of the door is not provided.</p>

<ol style="list-style-type: none"> 1. Remove the door stop. 	P2
D33.2	<p>The counter in the main lobby is not compliant</p> <p>The height exceeds 34" AFF</p>

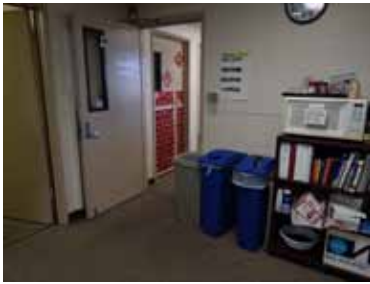
#	ITEM	PHOTO or DIAGRAM	MITIGATION MEASURE	SCHEDULE
D33.3	The interior POT of this facility is not compliant. The required signage is not provided

Install compliant signage according to appendix D.8	P2
D33.4	The are multiple doors that do not provide the required 18" pull side clearance

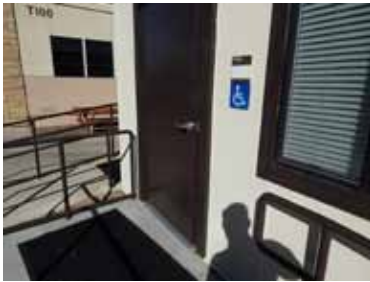
D34.1	The entrance to this facility is not compliant. The threshold does not meet the requirements.

1. Install a compliant threshold according to appendix A.15	P2
D34.2	The interior POT of this facility is not compliant. The required signage is not provided

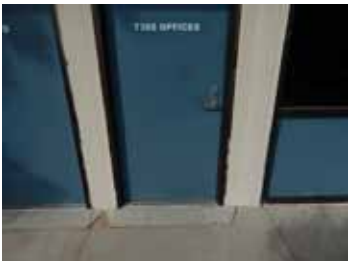
D35.1	The entry doors to this classroom is not compliant. The door operating pressure exceeds 5 pounds maximum.

Adjust the automatic closer on this door so that the pressure to operate does not exceed 5 pounds.	P3
-------	--	---	--	----

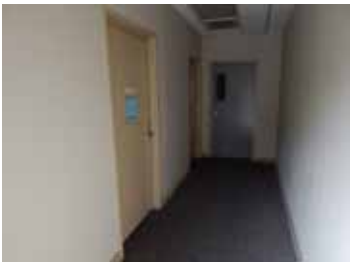
#	ITEM	PHOTO or DIAGRAM	MITIGATION MEASURE	SCHEDULE
D35.2	The interior POT of this facility is not compliant. The required signage is not provided

1. Install compliant signage according to appendix D.8	P3
D35.3	The interior of this class room is compliant.

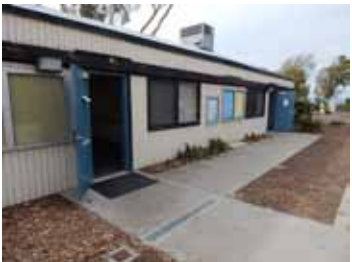
D36.1	<p>The main entry doors into this building are not compliant as follows:</p> <ol style="list-style-type: none"> 1. The thresholds at both exterior doors of this building are not compliant. There is an abrupt change of level at each threshold. 2. Tactile room signage is not provided at the exterior of each door.

<ol style="list-style-type: none"> 1. Reconstruct the exterior paving at each exterior door so that it is flush with the bottom of the threshold and has a compliant profile according to Appendix A.15 2. Provide tactile room number signage on the left side of each door according to Appendix B.16 	P3
D36.2	<p>Classroom, T313;</p> <p>The interior of the classrooms in this building are compliant except as follows:</p> <ol style="list-style-type: none"> 1. There are no student desks available that are wheelchair compliant.

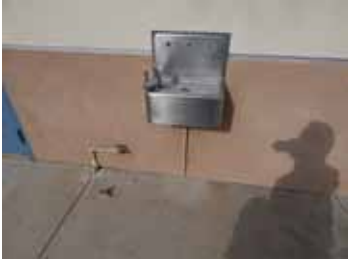
D37.1	The exterior entrance doors into this building are compliant.	[No photo provided]	None required.	N/A
D37.2	This drinking fountain is not compliant. It must be a dual height unit to comply.

Remove this unit or replace with a dual height unit that meets the current applicable standards.	P3
D37.3	The entry doors to this classroom is not compliant. The door operating pressure exceeds 5 pounds maximum.

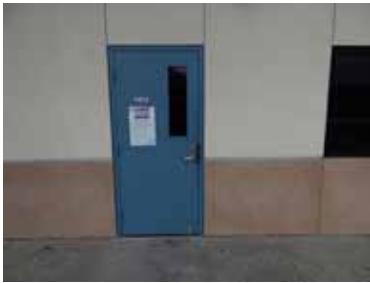
#	ITEM	PHOTO or DIAGRAM	MITIGATION MEASURE	SCHEDULE
D37.5	The entry doors to this classroom is not compliant. The door operating pressure exceeds 5 pounds maximum.

Adjust the automatic closer on this door so that the pressure to operate does not exceed 5 pounds.	P3
D37.6	The interior of this class room is compliant.

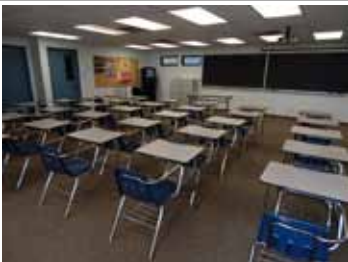
None required.	N/A
D38.2	The interior of the classrooms in this building are compliant Except as follows: 1. The POT through the furniture in the room is too narrow. 2. There are no student desks available that are wheelchair compliant.

1. Arrange the furniture so that there is a POT to the front of the room that is 36" wide minimum. 2. Provide a wheelchair compliant student desk equal to 5% of the total seating or one minimum per classroom.	P3

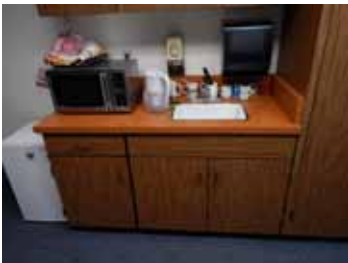
#	ITEM	PHOTO or DIAGRAM	MITIGATION MEASURE	SCHEDULE
D38.3	<p>The faculty work room is noncompliant as follows:</p> <ol style="list-style-type: none"> 1. Adequate wheelchair turning space is not provided. 2. The sink is not compliant.

<ol style="list-style-type: none"> 1. Arrange furniture and other movable items to provide a 60" minimum turning circle within this room. 2. Modify the sink cabinet so the top is no higher than 34" AFF and there is adequate clearance below the sink according to Appendix B.1 	P3
D39. Bldg. T420 - Nursing / Applied Health Admin. Offices				
D39.1	The exterior entrance doors into this building are compliant.	[No photo provided]	None required.	N/A
D39.2	The transaction area in this building is not compliant. It is too high at 39" AFF.

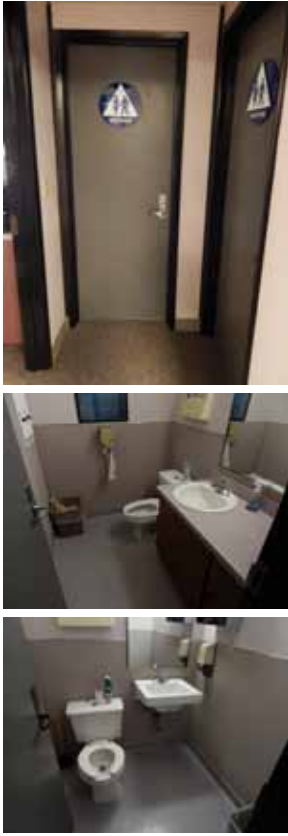
#	ITEM	PHOTO or DIAGRAM	MITIGATION MEASURE	SCHEDULE
D39.3	<p>The hallway leading to the two unisex toilet rooms is not compliant. It is too narrow and does not provide adequate clearance at the doors.</p> <p>The interior space in both unisex toilet rooms is inadequate to provide the required clearance for a wheelchair user.</p>

<p>The top photograph shows a narrow hallway with two doors, each marked with a unisex symbol. The middle and bottom photographs show the interior of the toilet rooms, which are small and cramped, with a toilet and sink visible.</p>	Reconfigure these two toilet rooms into one unisex toilet room that complies with all of the requirements for a single occupancy toilet room as indicated in Appendix B. 13	P3

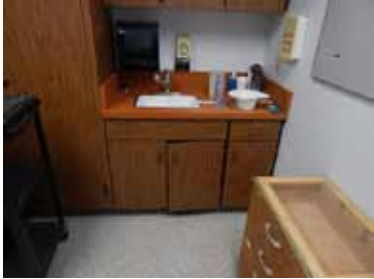
D40.1	<p>The sink in the Lab services room is not wheelchair compliant.</p>

<p>The photograph shows a lab services room with a wooden cabinet and a sink. A wooden cart is visible in the foreground.</p>	Modify the sink counter so that the top of the sink is at 34" AFF and compliant the clearances provided below the sink according to Appendix B.1	P3
-------	---	--	--	----
