ADA Self Evaluation and Transition Plan

MiraCosta College, **Oceanside Campus**

Board Approved on 05-18-2017

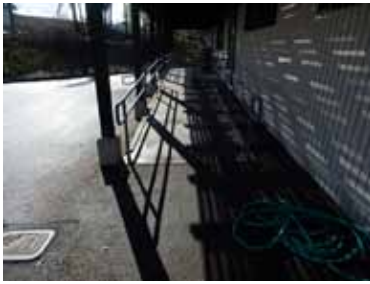
None required.	N/A
D41.2	The ramp is not compliant. There are no DWDs provided at the flush transition into the parking area.

Install DWDs according to appendix A.13 - A.14 extending the full width of the flush transition	P3
D41.3	The ramp is not compliant. There are no DWDs provided at the flush transition into the parking area.

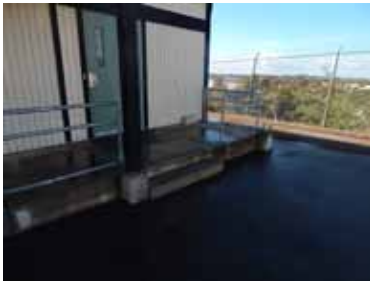
Install DWDs according to appendix A.13 - A.14 extending the full width of the flush condition	P3
D41.4	The stairs are not compliant. The required handrails are not provided

1. Install compliant handrails according to appendix C.4 and C.5	P3

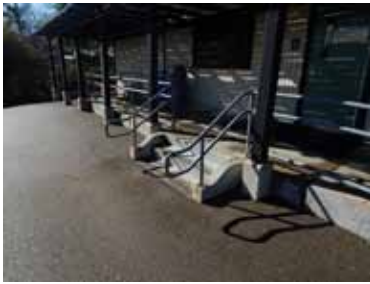
#	ITEM	PHOTO or DIAGRAM	MITIGATION MEASURE	SCHEDULE
D41.5	The stairs are not compliant. The required handrails are not provided

1. Install compliant handrails according to appendix C.4 and C.5	P3
D41.6	The front counter and lobby area is compliant.
