ADA Self Evaluation and Transition Plan

MiraCosta College
Technology Center Institute, Carlsbad, CA
05-08-2017

Client: Steinberg, Joe Sion
 Prepared by: Izor and Associates, Inc.; Greg Izor, CASp-014
 Site Name & Location: MiraCosta College, Technology Center Institute, 2075 Las Palmas Dr., Carlsbad, CA
 Scope of Review: Parking and Exterior Path of Travel, Interior Spaces and Interior Common and Staff Areas
 Dates of Site Review: 10-14-2016
 Dates of Draft Report: 10-14-2016
 Date of Final Report: 05-08-2017 CASp Determination: Inspected by a CASp
 File Name: 170508 TCI CASp Report-Final
 Adopted by MiraCosta College Board of Trustees on: TBD

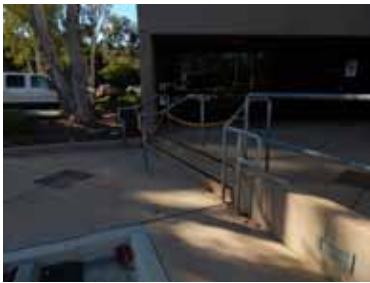
#	ITEM	PHOTO or DIAGRAM	MITIGATION MEASURE	Phase
C. Onsite Path of Travel				
C1	These stairs are compliant

None required	N/A
C2	The POT leading from the parking to the wheelchair accessible ramp is compliant

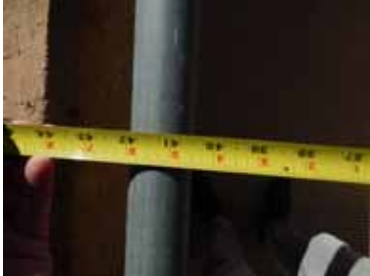
None required	N/A
C3	The ramp is not compliant. The required width of 48" is not provided. (44")

1. Reconstruct the ramp and handrails according to appendix C.2, C.3 and C.7 to provide 48" minimum width.	P2

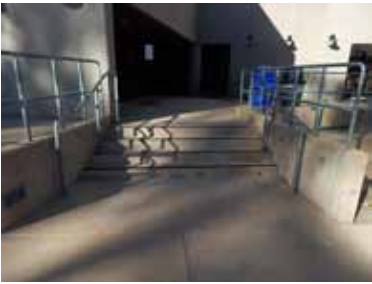
#	ITEM	PHOTO or DIAGRAM	MITIGATION MEASURE	Phase
C4	These stairs are compliant

None required	N/A
C5	This exterior POT is compliant

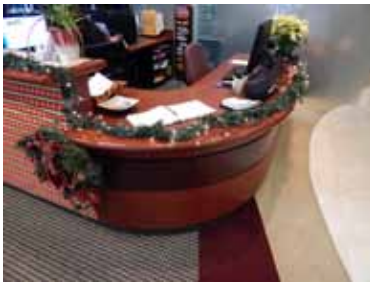
E1	Reception, Room 1; The counter and path of travel is compliant.

None required.	N/A
E2	SBDC Reception, Room 3; The transaction counter is too high and not compliant. (35")

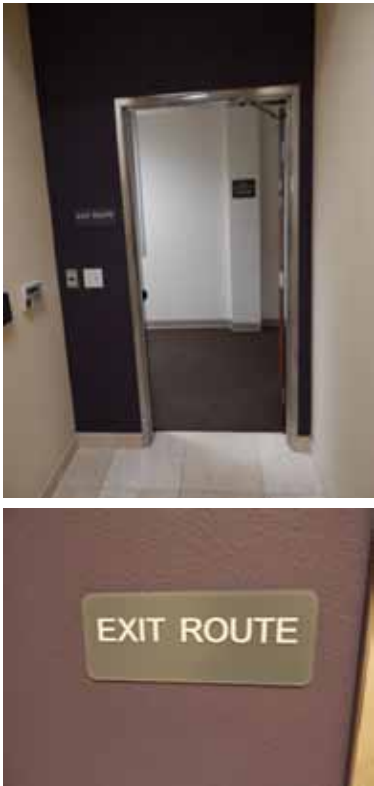
#	ITEM	PHOTO or DIAGRAM	MITIGATION MEASURE	Phase
E3	Exit signage in the corridors throughout the facility are compliant.

None required.	N/A
E4	Conference Room, Room 2; The path of travel and seating in this room is compliant.

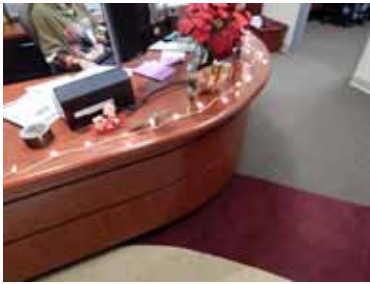
#	ITEM	PHOTO or DIAGRAM	MITIGATION MEASURE	Phase
E5	Sharon's Space, Room 23; The counter is compliant.

None required.	N/A
E6	Corridor F; Tactile exit signage is not provided at this exit door.

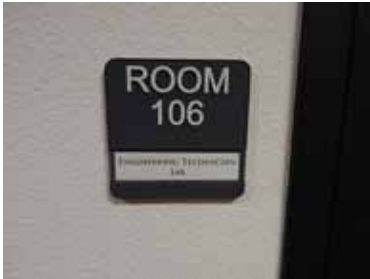
Provide a tactile exit sign mounted at 60" AFF on the latch side of the door according to Appendix D.8	P1
E7	Room signage in the corridors throughout the facility are complaint.

None required.	N/A
E8	Door hardware, swing clearances and operating forces throughout the facility are complaint.

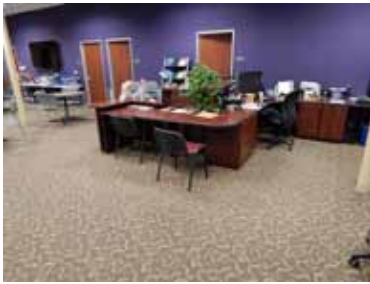
#	ITEM	PHOTO or DIAGRAM	MITIGATION MEASURE	Phase
E16	Student Center, Room 41; The path of travel and workstations in this classroom are compliant.

None required.	N/A
E17	Kitchen, Room 42; The path of travel, counters, sink and appliances in this room are compliant except as follows; 1. The oven/range has controls in the back of the appliance.

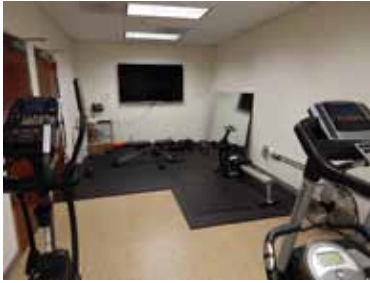
1. Replace the oven/range with a unit that has front controls.	P1
E18	Gym, Room 55; The path of travel and access to the equipment is compliant.

None required.	N/A

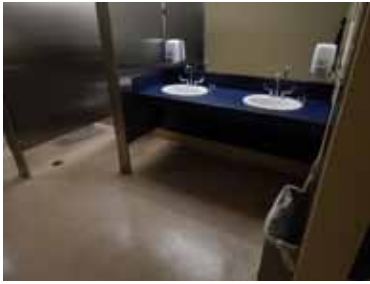
1. Replace the door symbol with a symbol that is 70% contrast in color from the finish of the door. OR Provide a white border 1" wide around the symbol.	P1
F2	The accessible lavatory is compliant as follows

None Required	N/A
F3	The accessible urinal is not compliant as follows; 1. The urinal alcove is more than 24" deep and is not wide enough.	[No photo provided]	1. Provide 36" minimum width at the alcove.	P1

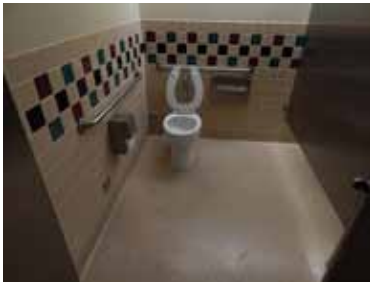
#	ITEM	PHOTO or DIAGRAM	MITIGATION MEASURE	Phase
F4	<p>The accessible toilet and stall are not compliant as follows;</p> <p>1. The toilet tissue dispenser is located too high or too far from the front of the toilet.</p>

<p>1. Relocate the toilet tissue dispenser so that it is located 7"- 9" on the front of the toilet and 19" AFF. (Locate to the centerline of the dispenser)</p>	P1
F5	<p>The drinking fountain is not compliant as follows;</p> <p>1. The lower unit is mounted too low and does not provide 27" min. knee clearance.</p>

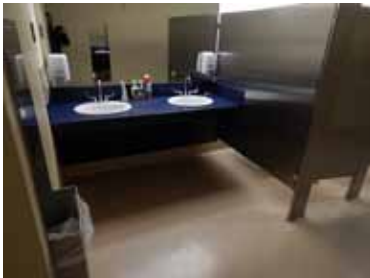
F7	<p>The accessible lavatory is compliant as follows</p>

None Required	N/A

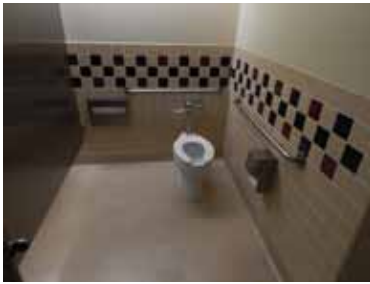
#	ITEM	PHOTO or DIAGRAM	MITIGATION MEASURE	Phase
F8	<p>The accessible toilet and stall are not compliant as follows;</p> <p>1. The toilet tissue dispenser is located too high or too far from the front of the toilet.</p>

<p>1. Relocate the toilet tissue dispenser so that it is located 7"- 9" on the front of the toilet and 19" AFF. (Locate to the centerline of the dispenser)</p>	P1
Unisex Toilet, Room 16				
F9	<p>The entry door to this restroom is not compliant as follows;</p> <p>1. Door symbol is not contrasting in color from the finish of the door</p>

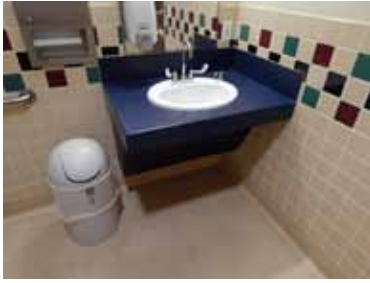
<p>1. Replace the door symbol with a symbol that is 70% contrast in color from the finish of the door. OR Provide a white border 1" wide around the symbol.</p>	P1
F10	<p>The accessible lavatory is compliant.</p>

None Required	N/A

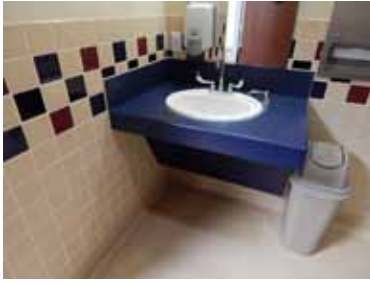
<ol style="list-style-type: none"> 1. Replace the door symbol with a symbol that is 70% contrast in color from the finish of the door. OR Provide a white border 1" wide around the symbol. 	P1
F13	<p>The accessible lavatory is compliant.</p>

None Required	N/A

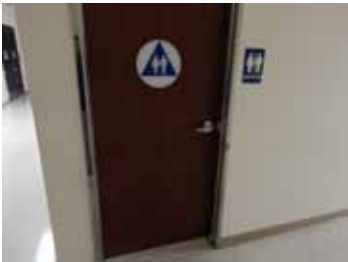
Staff Restroom, Room 46				
F15	The entrance to this restroom is compliant

None Required	N/A
F16	The lavatory is compliant

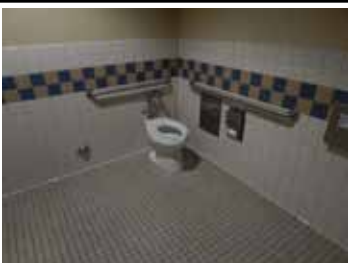
None Required	N/A
F17	The toilet is compliant

None Required	N/A
End of Report
